Docket No. 272 – Development and Management Plan Inspection

Beseck Switching Station Inspection

Date: December 4, 2007

Location: Beseck Switching Station

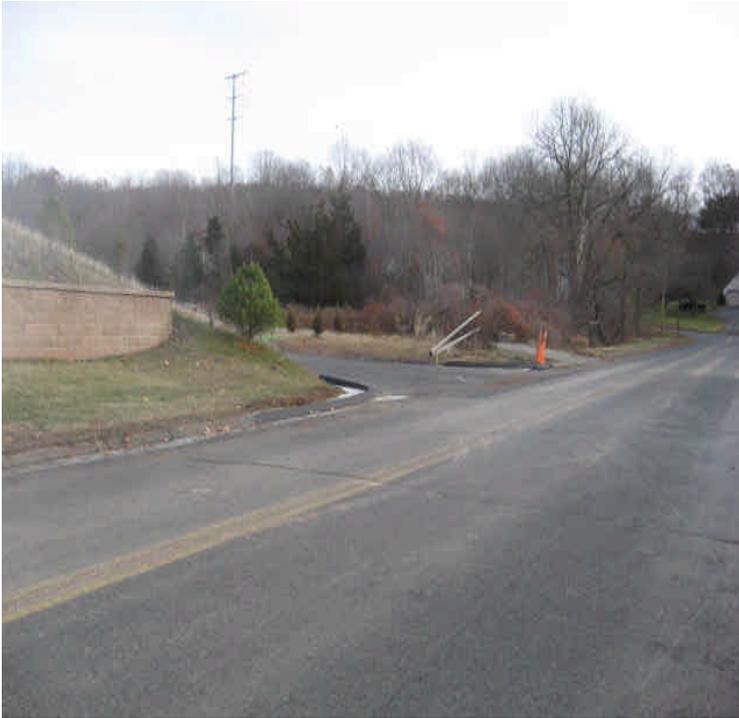
Eastern side of the site, view from Carpenter Lane. The curbing installed last week appears to help detain run-off.

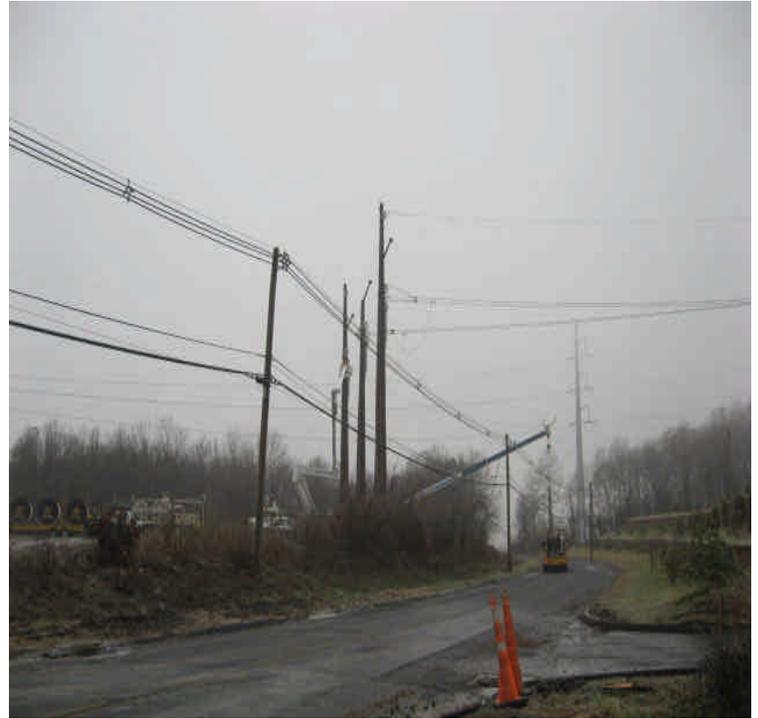
Line work was underway, connecting the 2A lines to Beseck.

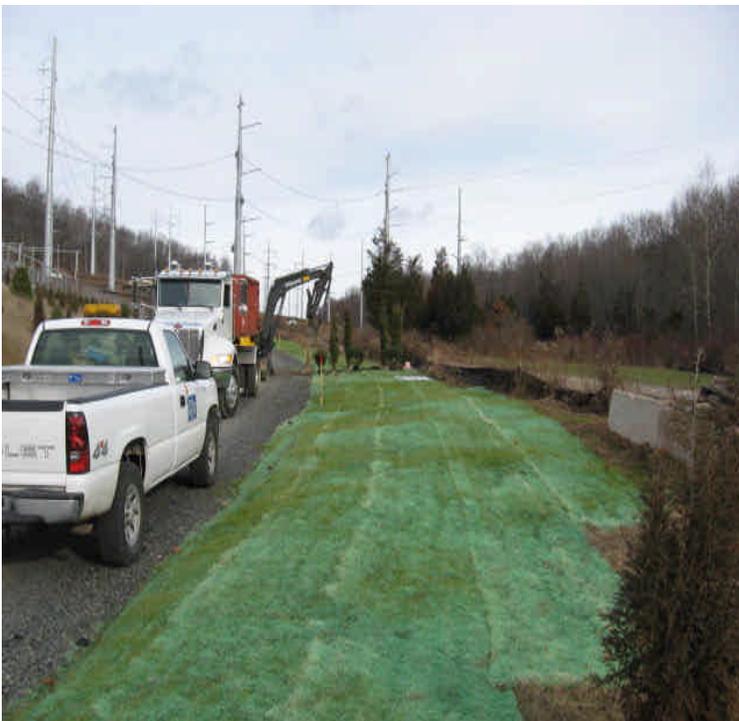
New landscaping and a gate being installed along the eastern site

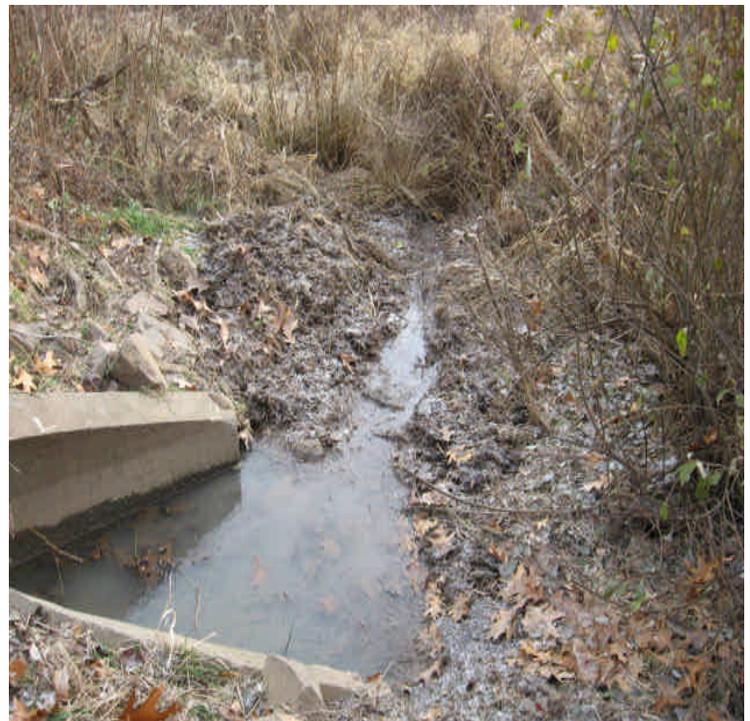
Areas of Inspection	Observation	Recommended Action	Corrected Action
	and wetland was mostly clear with only slight turbidity. 12/4/07	12/04/07	
Inland Wetland and Watercourse encroachment and mitigation	Haybales have been removed from the outlet and the wetlands across Carpenter Lane (10/23). Sediment accumulation was noted within and around the outlet where the haybales had been. 10/23-12/4/07	Continue to remove all visible sediment from within and around the outlet (and whatever is feasible from within the pipe). Seed the area with a wetland seed mix for final stabilization. The edges of the access roads are not fully stabilized, therefore haybales should be replaced during heavy rain. 10/23-12/4/07	Sediment needs some additional attention.
State species of concern, threatened and endangered species.	According to the D&M plan, state-listed species are not located in this work area. 12/4/07 Several different species of frogs, turtles, and salamanders have been noted in wetlands south of Carpenter Ln. and east of Beseck this spring and last year. 12/4/07	None. 12/4/07 Although these species were not state-listed, it indicates good habitat. Continue to make good efforts to reduce impacts to these wetlands to the extent possible. 12/4/07	NA NA

A small channel appears to have been created to allow drainage into the wetlands at the across Carpenter Lane. Slightly turbid water remains at the outlet. Sediment removal is still needed in this area.
