Docket No. 272 – Development and Management Plan Inspection

Beseck Switching Station Inspection

Date: December 11, 2007

Location: Beseck Switching Station

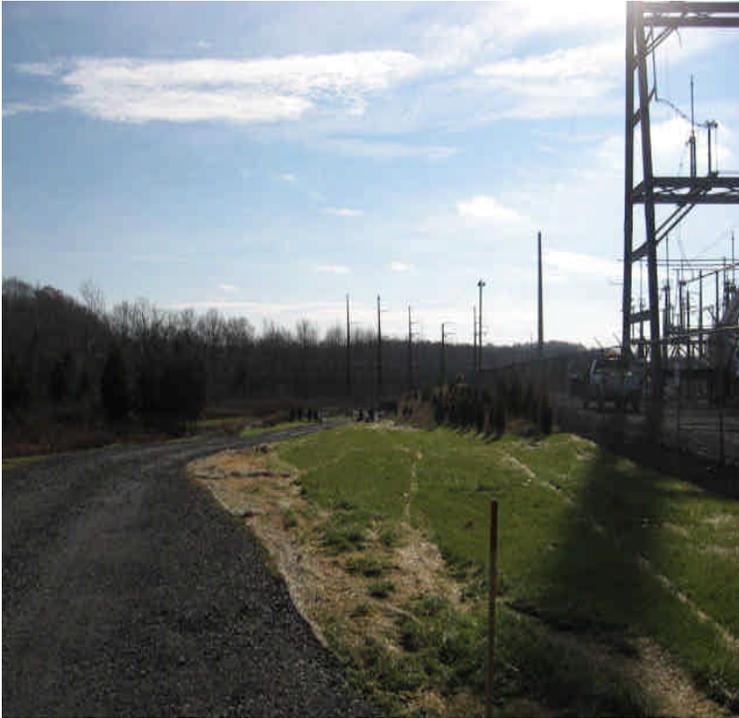
| Areas of Inspection | Observation | Recommended Action | Corrected Action |
|---|--|--|---|
| Access roads and adjacent roadways | Erosion control mats and seed remain in place over previously disturbed soil shoulders along the eastern site access. Grass cover was noted but soils are not fully stabilized. No run-off was noted at the eastern access road. A gate and landscape plantings have been installed. 12/11/07 | Continue to monitor for turbid run-off until the site is at final stabilization with established vegetative cover. Add controls as needed to contain sediment. 12/11/07 | Not Applicable (NA) at this time. |

Eastern site access; view looking towards Carpenter Lane.

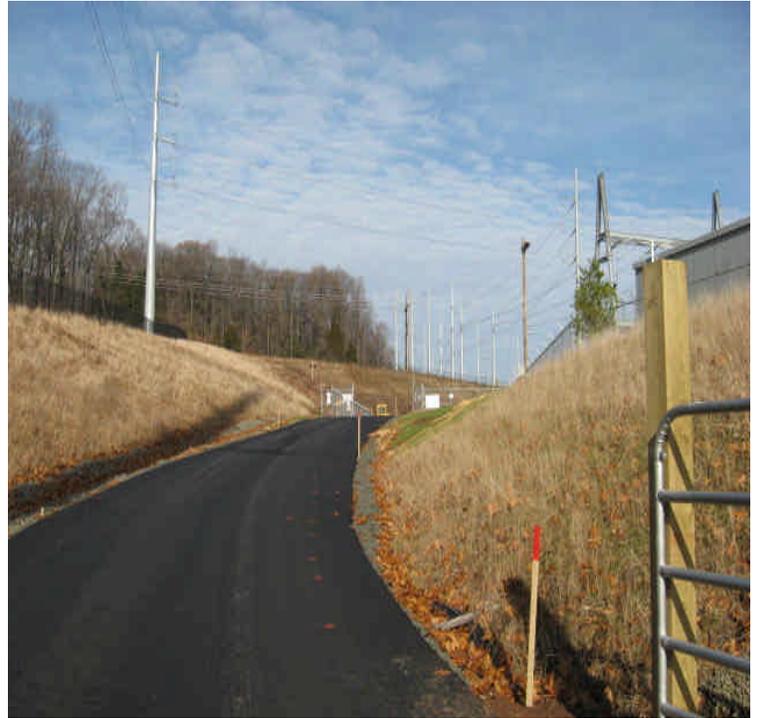
| Areas of Inspection | Observation | Recommended Action | Corrected Action |
|---|--|--|---|
| | Erosion control mats remain in place along the shoulders of the western site access. Curbing at this drive also helps to detain water. 12/11/07 | None at this time. 12/11/07 | NA at this time. |

Western site access, view looking from Carpenter Lane.

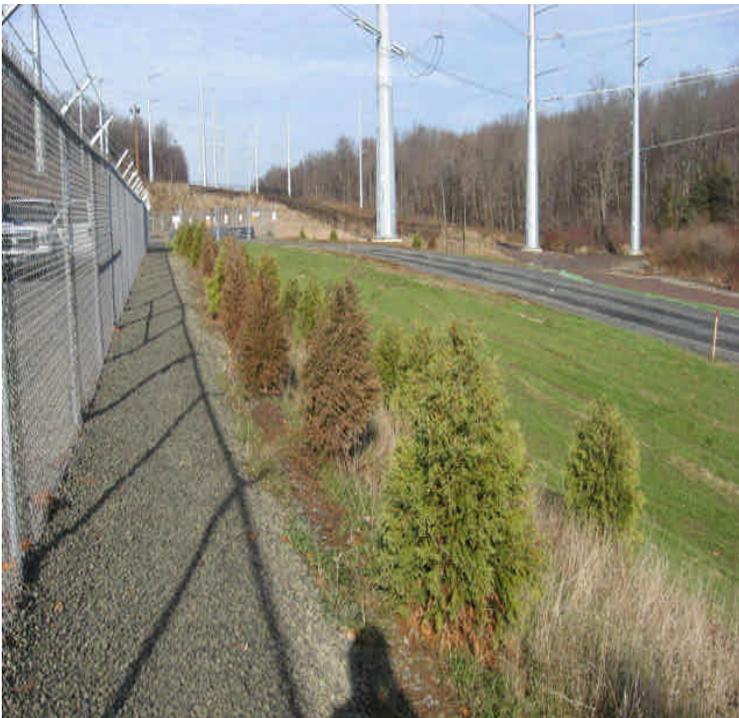
Mortality was noted in some shrubs previously planted along the eastern site fence. This will have to be evaluated and with the landscaper and individuals should be replaced.

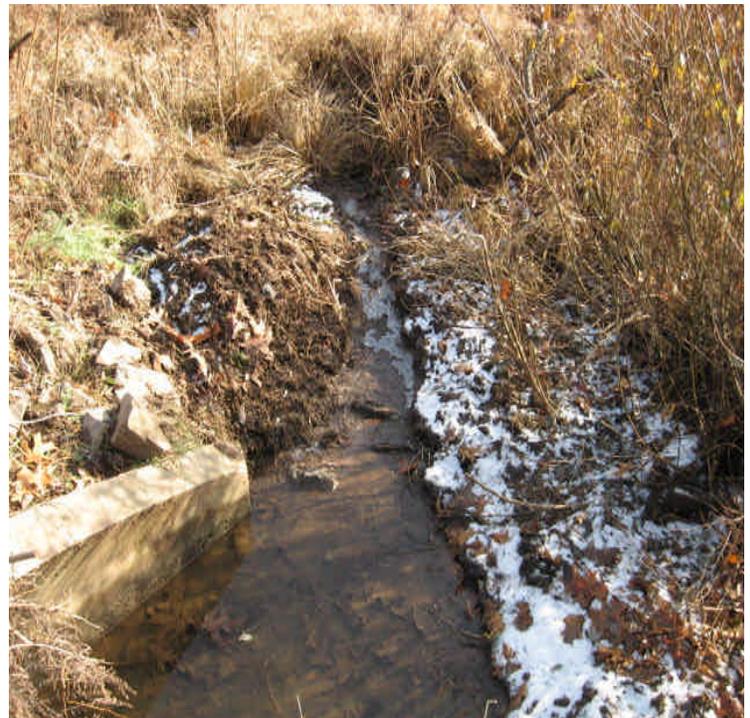
| Areas of Inspection | Observation | Recommended Action | Corrected Action |
|---|--|---|---|
| Inland Wetland and Watercourse encroachment and mitigation | Haybales have been removed from the outlet and the wetlands across Carpenter Lane (10/23). Sediment accumulation was noted within and around the outlet where the haybales had been. 10/23-12/11/07 | Continue to remove all visible sediment from within and around the outlet (and whatever is feasible from within the pipe). Seed the area with a wetland seed mix for final stabilization. The edges of the access roads are not fully stabilized, therefore haybales should be replaced during heavy rain. 10/23-12/11/07 | Sediment needs some additional attention. |

A small channel appears to have been created to allow drainage into the wetlands across Carpenter Lane. Sediment removal is still needed in this area.
