Docket No. 272 – Development and Management Plan Inspection

Beseck Switching Station Inspection

Date: December 26, 2007

Location: Beseck Switching Station

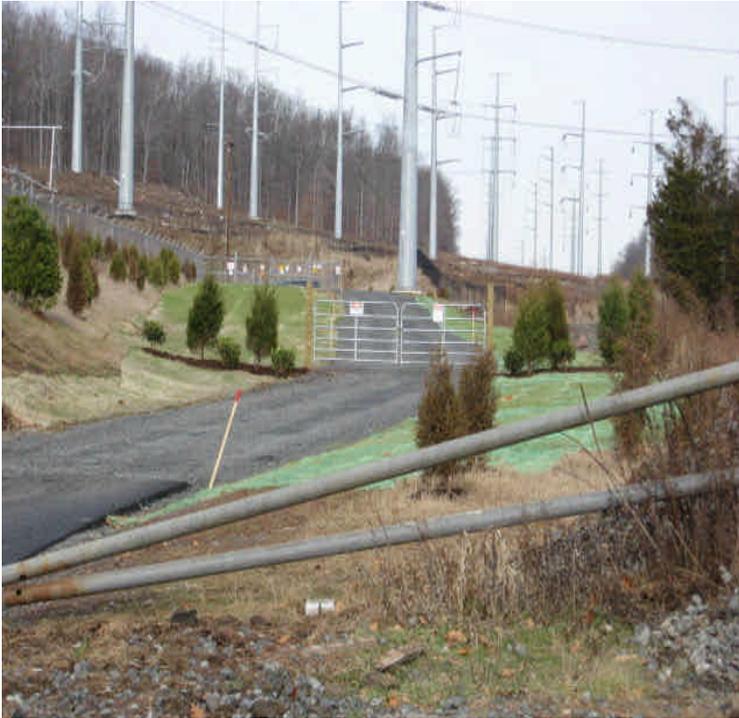
View along the eastern site access from Carpenter Lane.

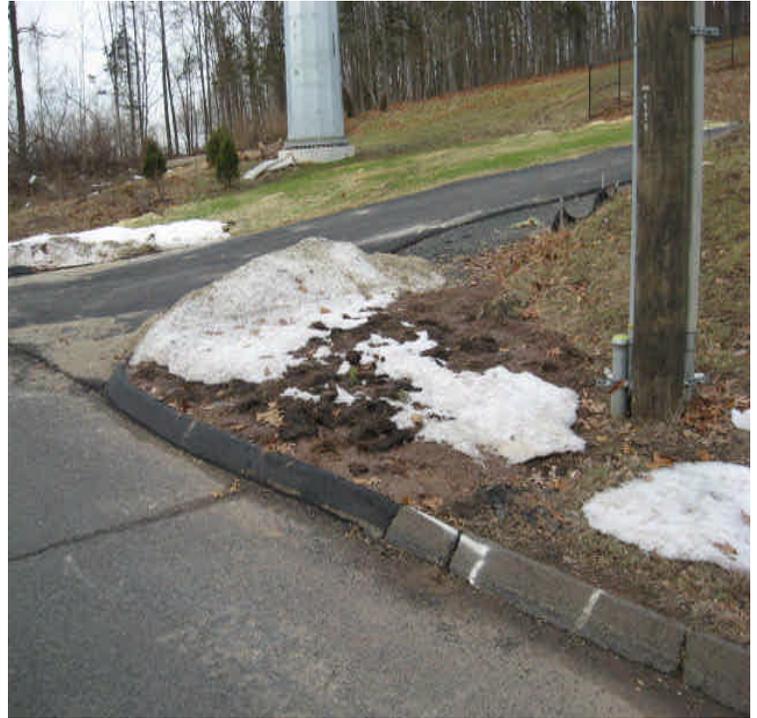
Western site access, view looking from Carpenter Lane. A small disturbed area was noted at the curb, likely a result of plowing Monitor for run-off.

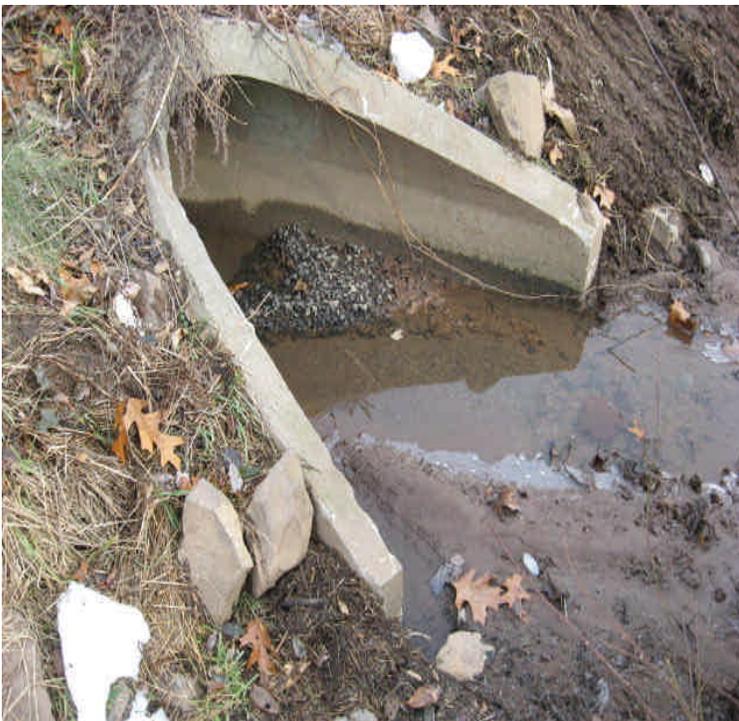
Sediment accumulation remains within the culvert across Carpenter Ln. When crews return from break, they should remove the sediment prior to the next storm or frozen conditions. They have made several attempts but may need oversight to complete the job.

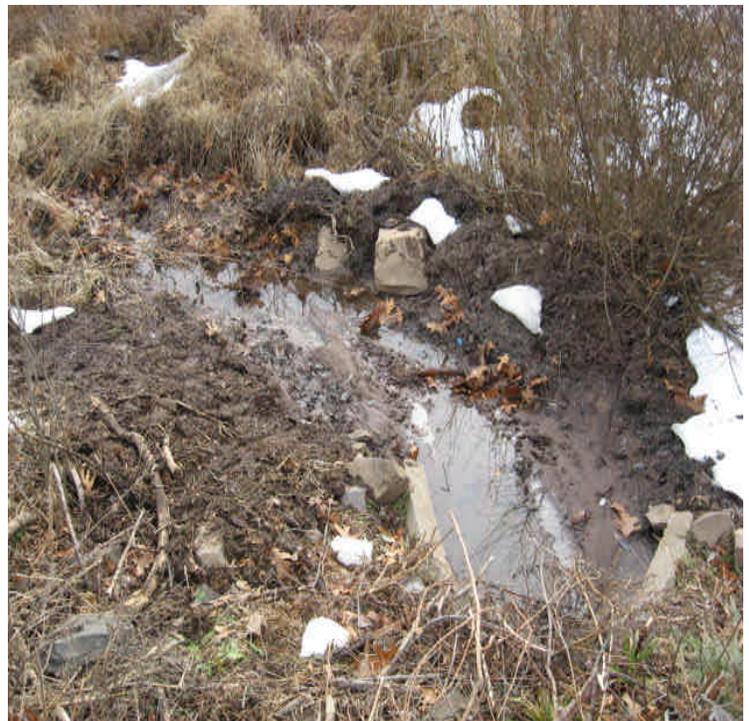
The small channel appears to have widened, possibly from snow melt combined with stormwater. Sediment removal is still needed in this area.
