**Docket No. 272 – Development and Management Plan Inspection**

**East Devon Substation Inspection**

**Date:** November 16, 2007

**Location:** East Devon Substation

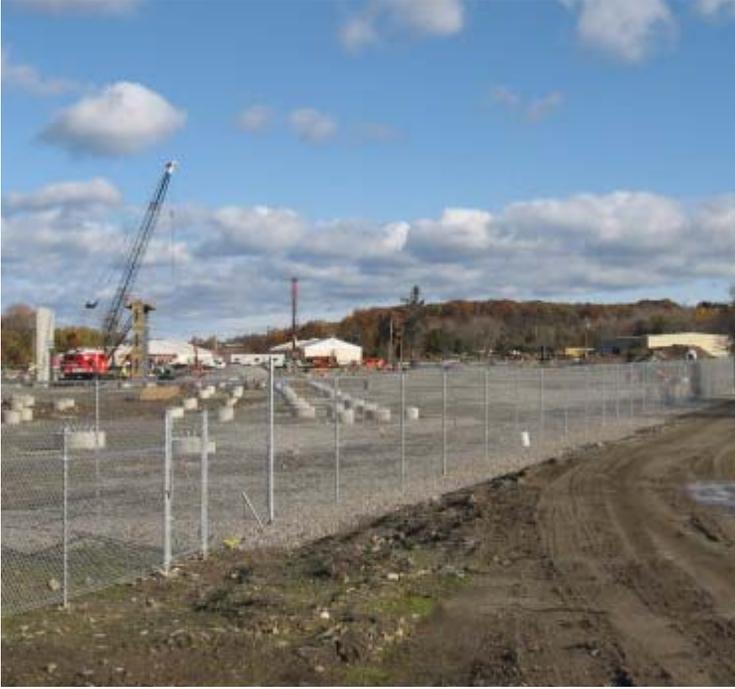
East Devon Substation (Milford): A general view of construction at the substation.

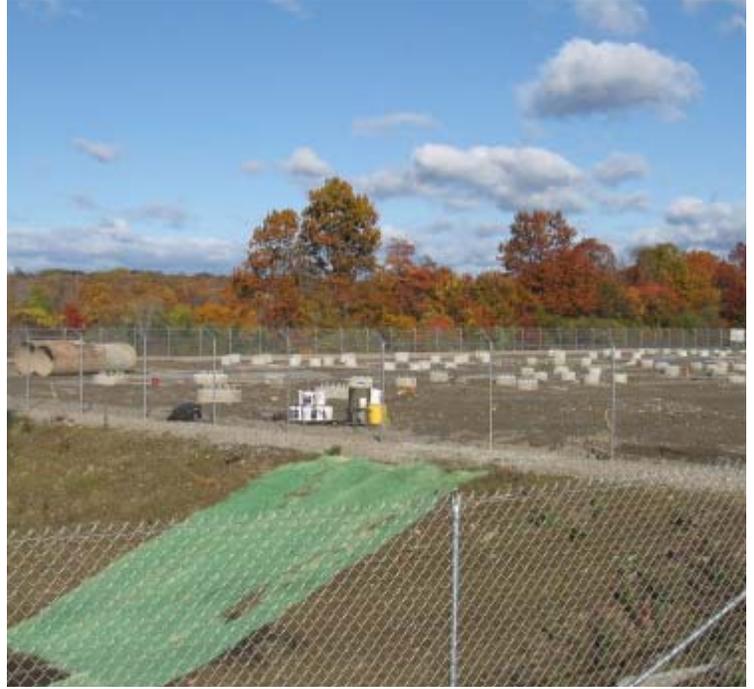
East Devon Substation: An additional view of the construction at the substation.

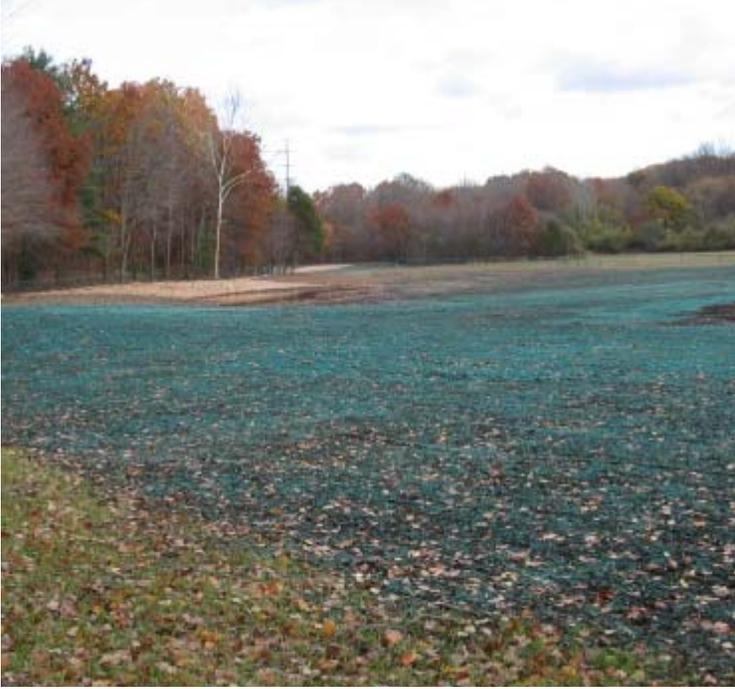
Eisenhower Park: A view of the wetland mitigation area looking south.

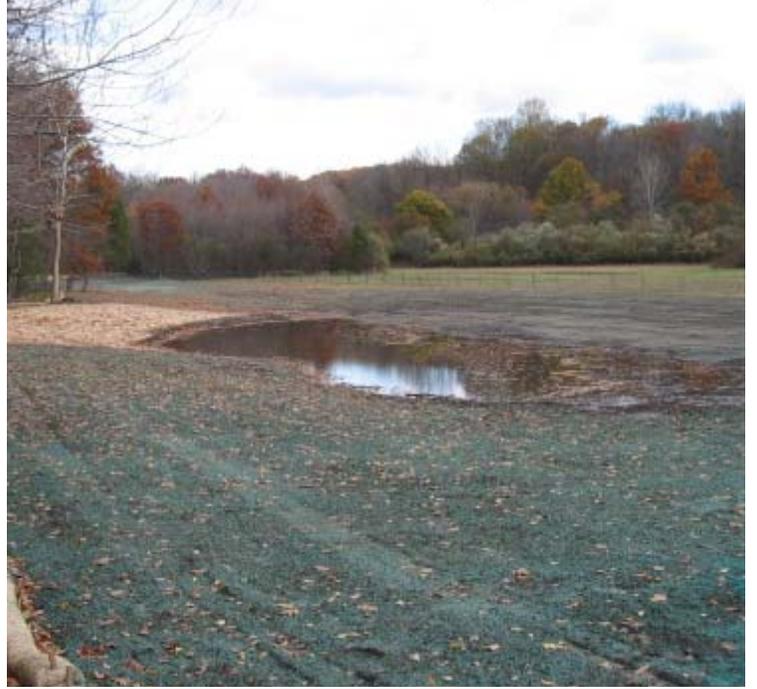
Eisenhower Park: A view of the center pool.

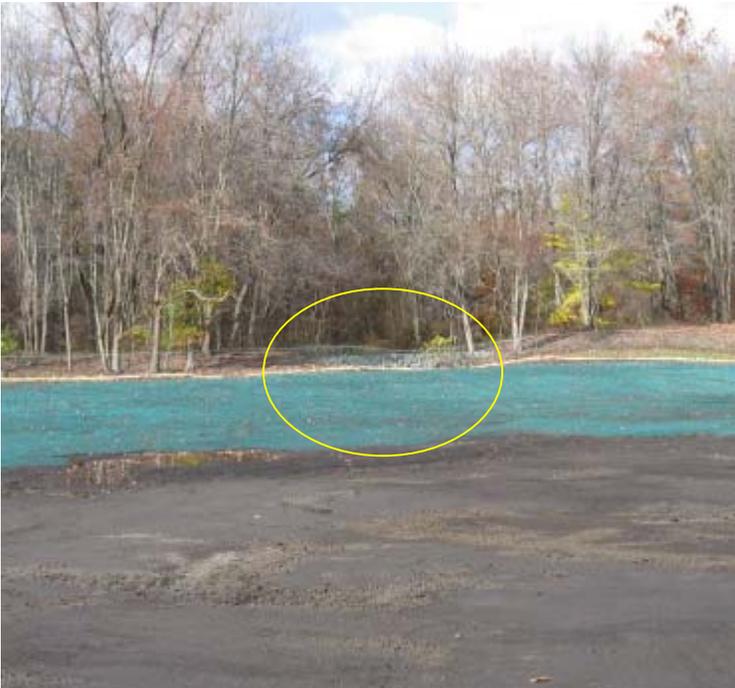
<p>State species of concern, threatened and endangered species.</p>	<p>According to the D&amp;M plan, state-listed species are not located in this work area. 11/16/07</p>	<p>None. 11/16/07</p>	<p>NA</p>
<p>Vegetative clearing or stabilization</p>	<p>Vegetation has been cleared within the limits of the substation site and along the newly re-located Shelland Street. 11/16/07</p> <p>Stone has been spread throughout the site for stabilization. 11/16/07</p> <p>Exposed soils were observed in a portion of the vegetated swale. 11/8-11/16/07</p>	<p>None at this time. 11/16/07</p> <p>Continue to monitor. 11/16/07</p> <p>Apply mulch or similar to temporarily stabilize soils over the winter. Erosion controls may be necessary at the outlet. 11/16/07</p>	<p>NA</p> <p>NA</p> <p>Needs attention/evaluation</p>

Eisenhower Park: A view of the stone check dam located at the outlet of the mitigation area.

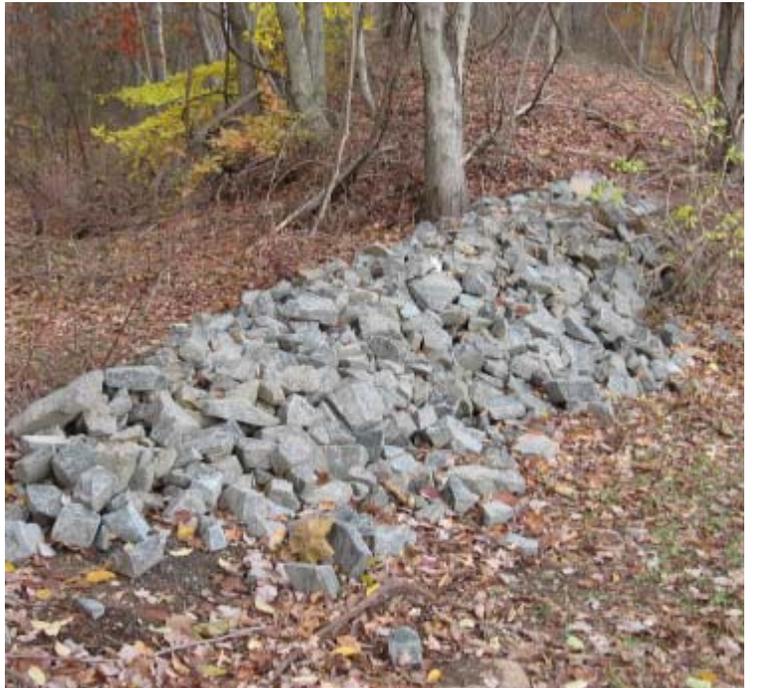
Eisenhower Park: Close up of the stone check dam.
