**Docket No. 272 – Development and Management Plan Inspection**

**Segment 1b (Royal Oaks Bypass) Inspection**

**Date:** December 31, 2007

**Location:** Segment 1b (Royal Oaks Bypass)

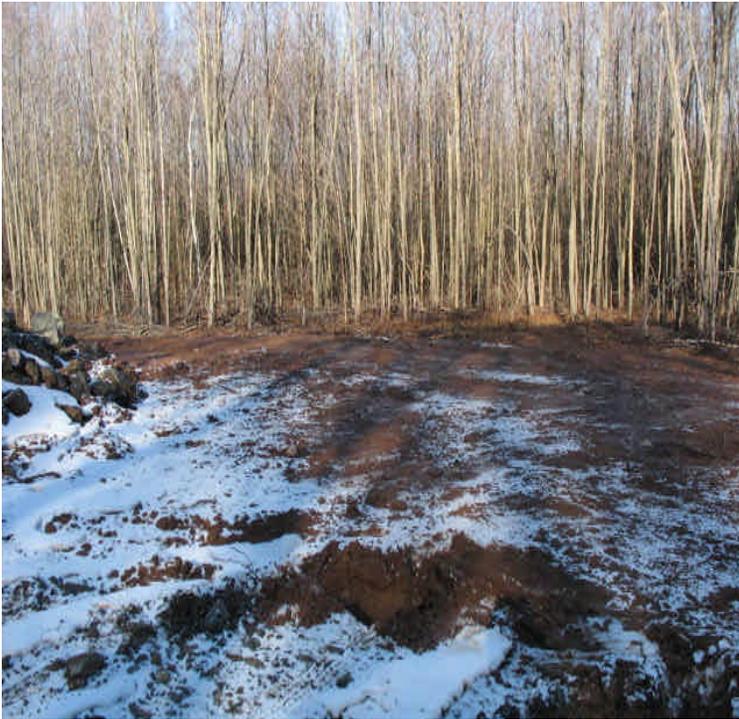
**View of an area of exposed soil east of Rte. 17. The area has been reclaimed but still requires temporary stabilization until vegetative cover can establish.**

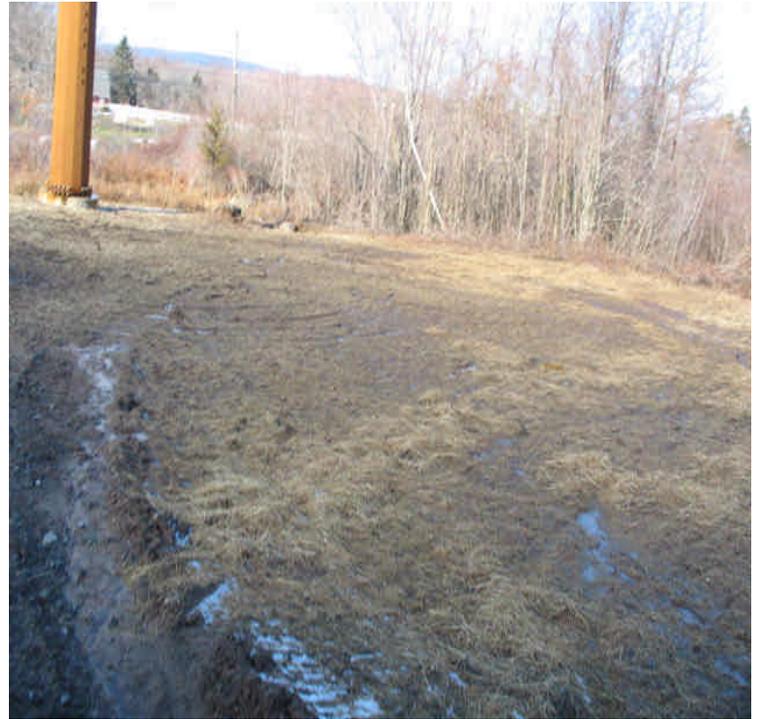
**View of previously exposed area east of Rte 17 with mulch and seed in place.**

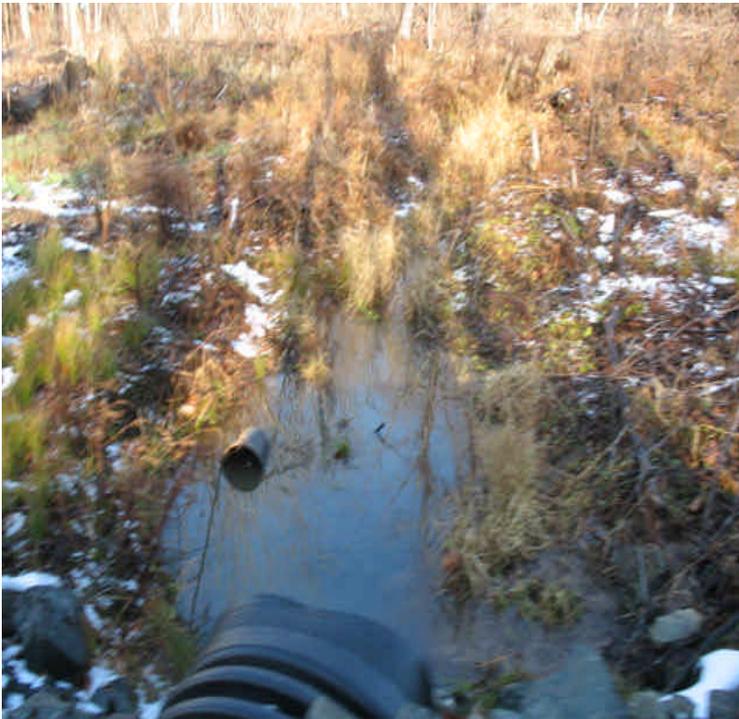
<b>Slightly turbid water has been noted at the receiving yard during times of heavy traffic and precipitation. New stone is in place in some areas. Minor sediment/turbidity was noted in the stream adjacent to the receiving yard. 12/31/07</b>	<b>Monitor stone for effectiveness. See erosion control section for details. 12/31/07</b>	<b>Stone was added to the access drive but more attention may be needed.</b>
		<b>Identify where the turbidity is entering the stream and add controls as needed. 12/31/07</b>	<b>Needs evaluation</b>

**Slightly turbid water within the wetland at the edge of the contractor yard.**

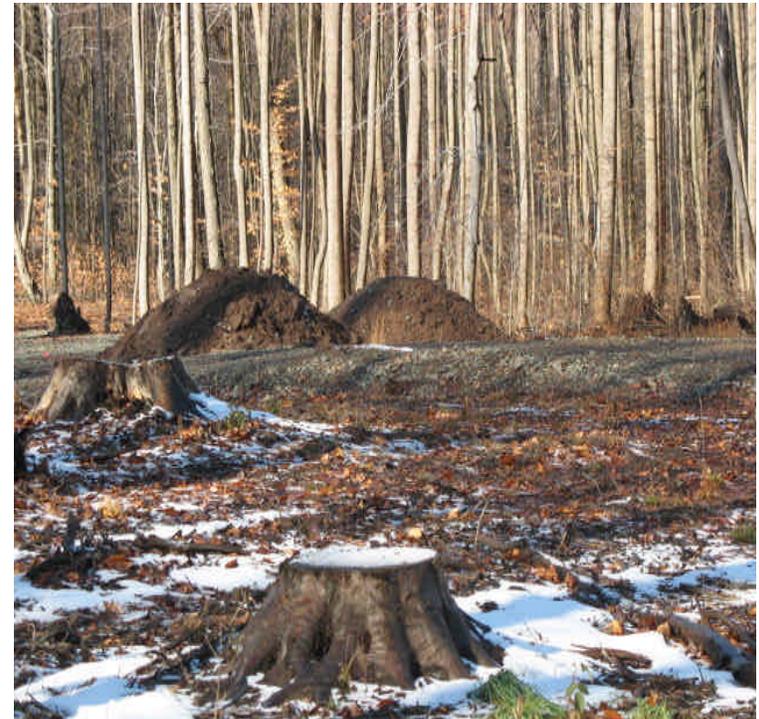
**Small stockpiles at the turn in the ROW towards Little Lane. Controls are needed.**
