Docket No. 272 – Development and Management Plan Inspection

Segment 2a Inspection

Date: November 27, 2007

Location: Segment 2a – Beseck Switching Station to Cheshire/Hamden Town Line

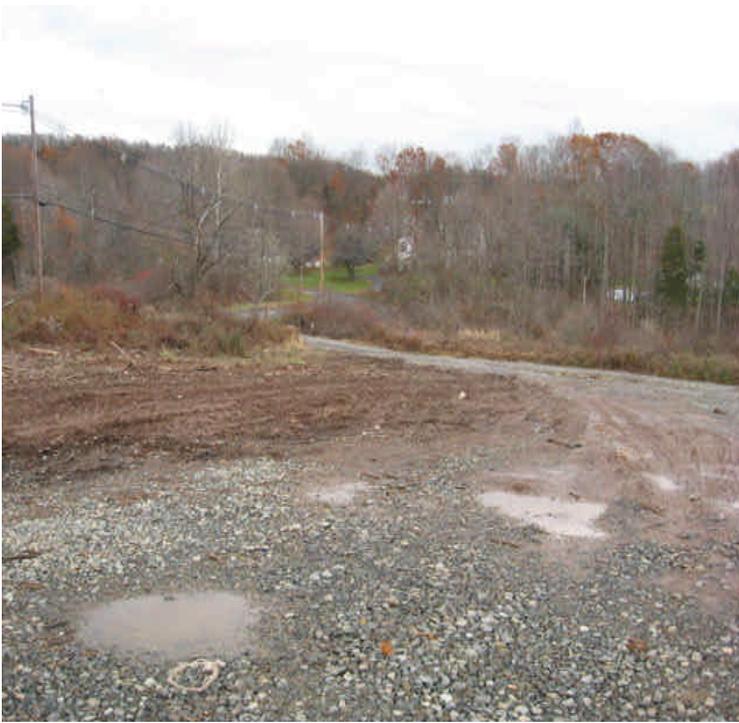
Carpenter Ln: Disturbed soils remains upgradient from wetlands. Reinforced controls and winter stabilization are needed here.

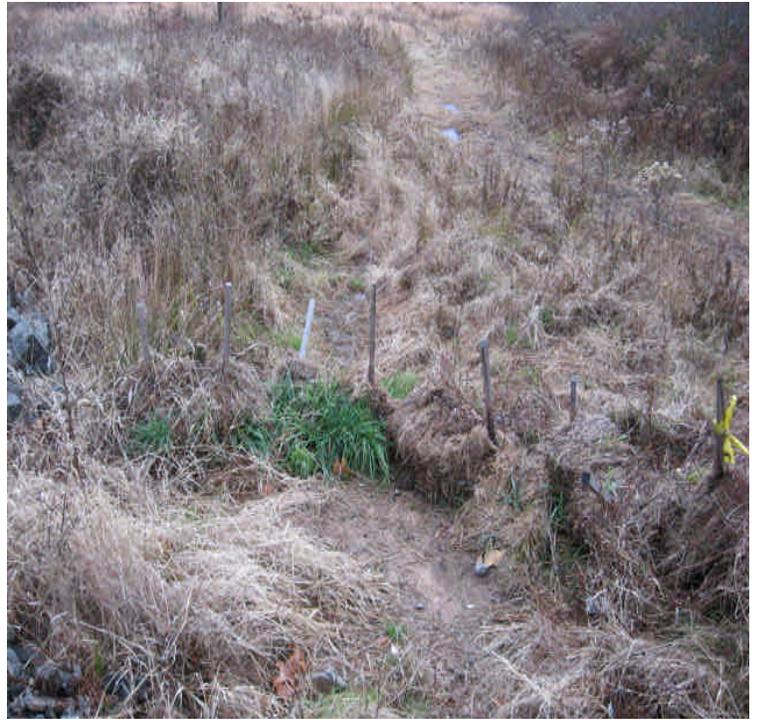
Carpenter Ln: Deteriorating controls and sediment accumulation was noted at the wetland outlet. This area still receives turbid run-off during rain events.

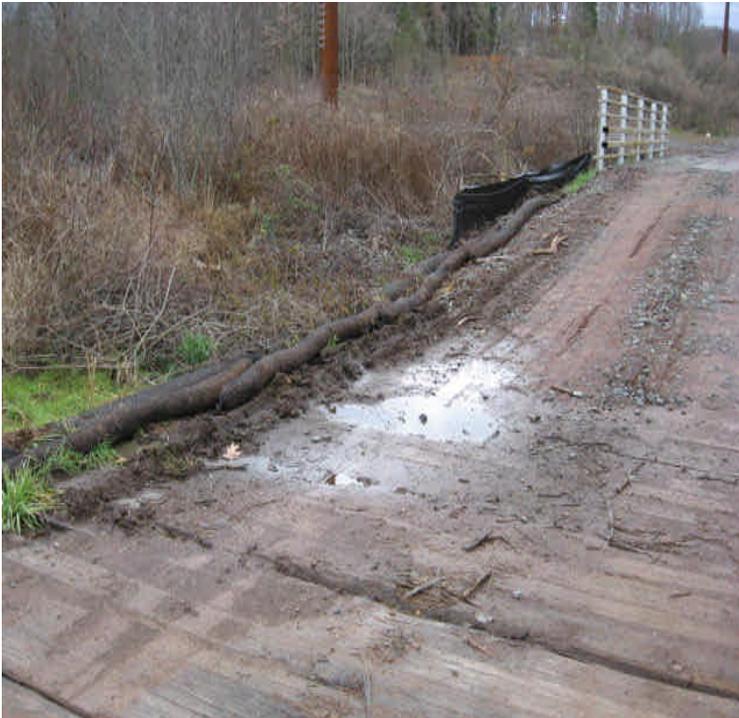
Durham Rd: View of the wetland/stream crossing.

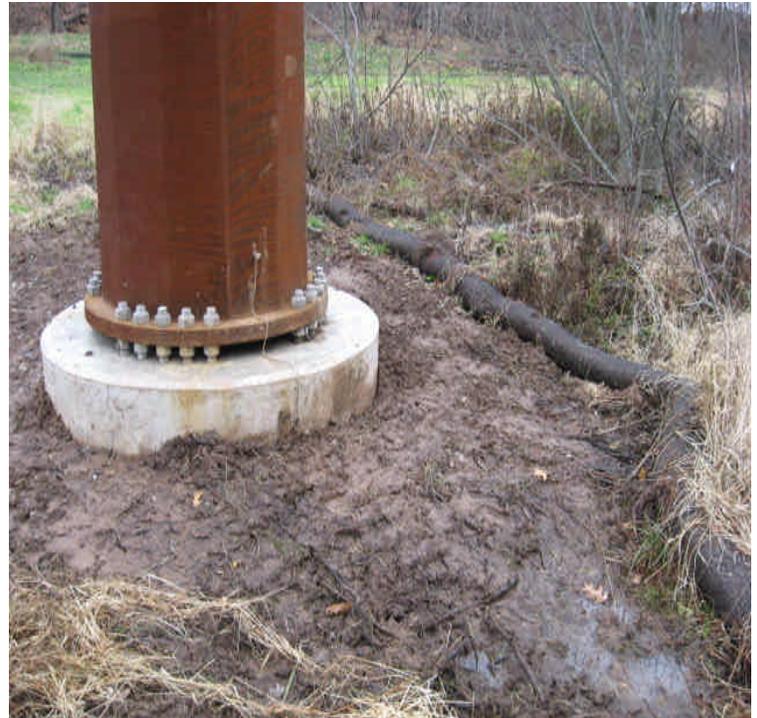
Liney Hall: Area around the foundation was disturbed from the installation of grounding wires. The concrete spoil has been removed from this area.

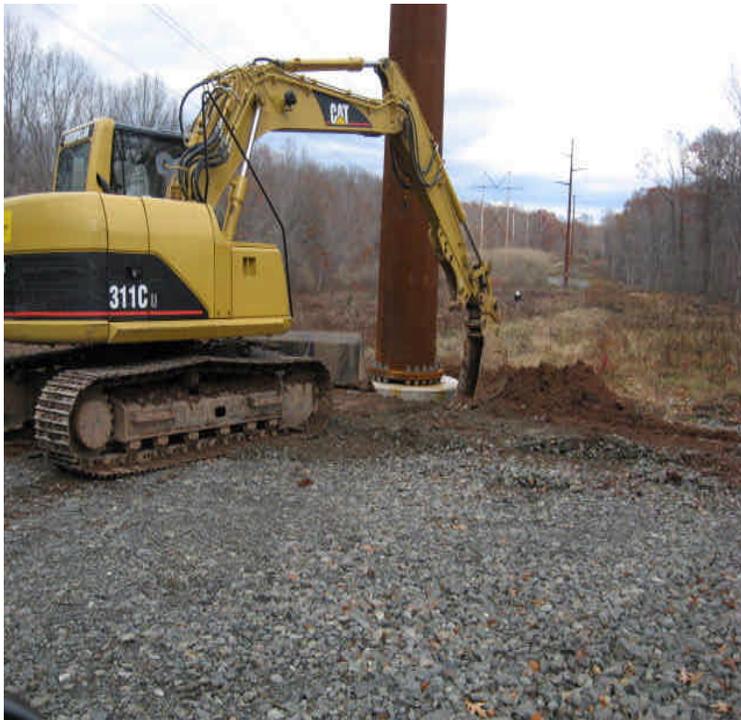
Stony Brook Rd: Installation of grounding wires.

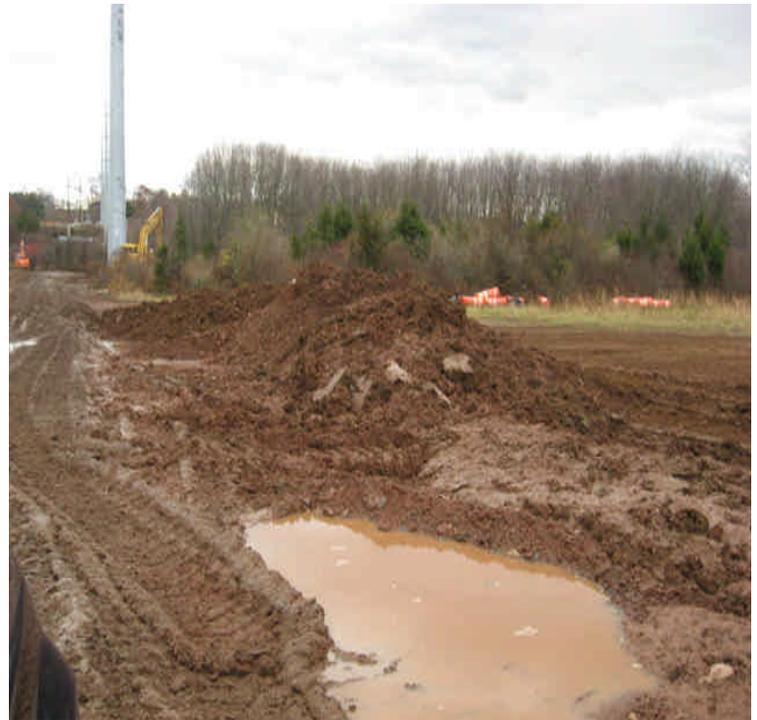
Pond Hill: Soil stockpile remaining from final grading and pad/timber mat removal. Monitor controls and stabilize disturbed soils within appropriate timeframes.

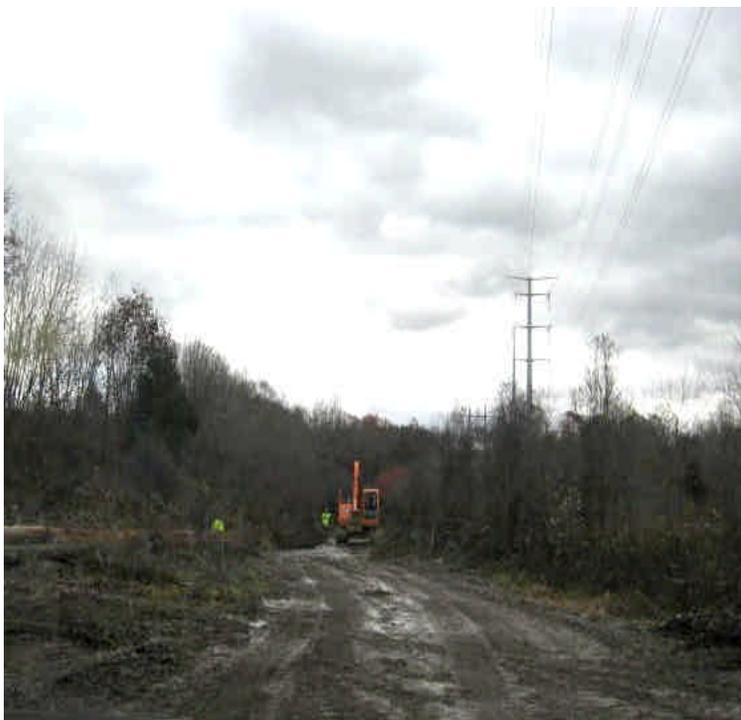
Pond Hill: Timber mat removal was occurring within wetlands.

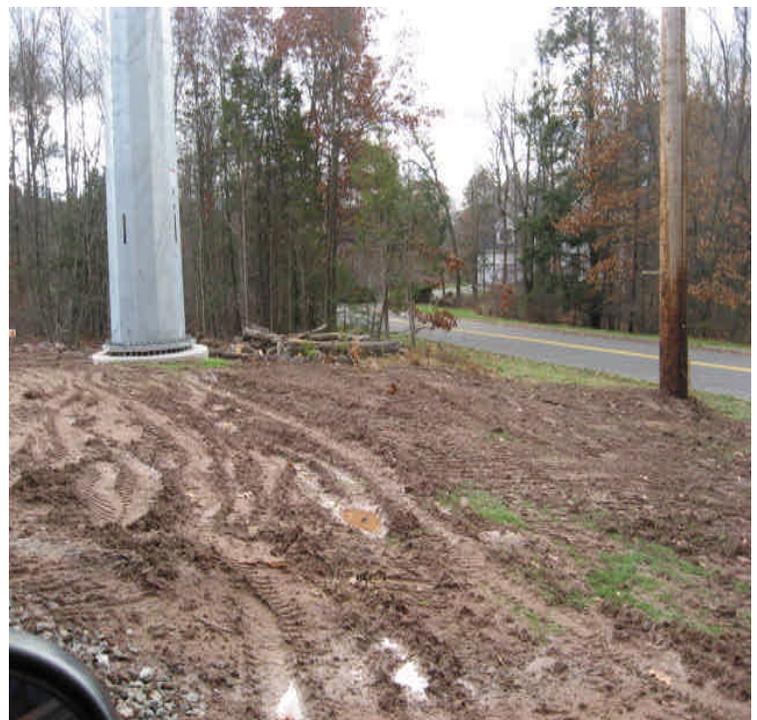
Old Farms Rd: Disturbed area upgradient from the roadway. Turbid run-off has been noted leaving this site and entering roadway catch basins.
