Docket No. 272 – Development and Management Plan Inspection

Segment 2a Inspection

Date: December 4, 2007

Location: Segment 2a – Beseck Switching Station to Cheshire/Hamden Town Line

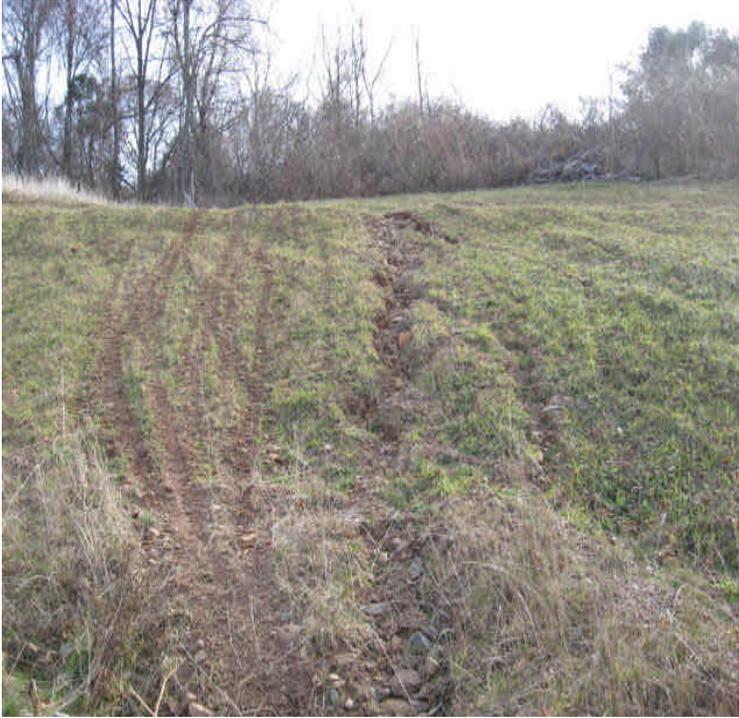
High Hill Rd: Small eroded channel and ATV tracks were noted along the vegetated slope.

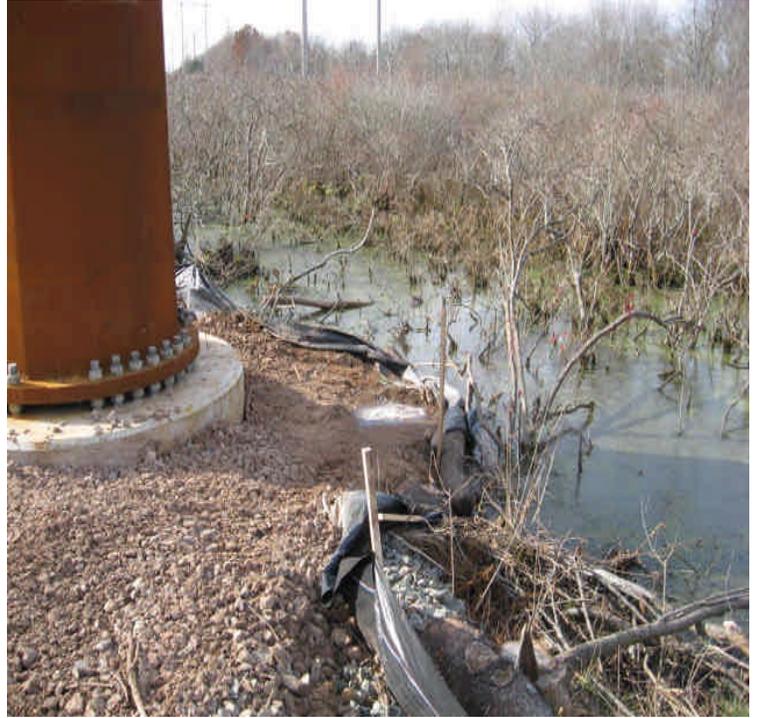
Tamarack Swamp Rd: Additional sediment was pushed over the controls due to grounding wire installation. Pull all sediment back and reinforce controls as soon as possible.

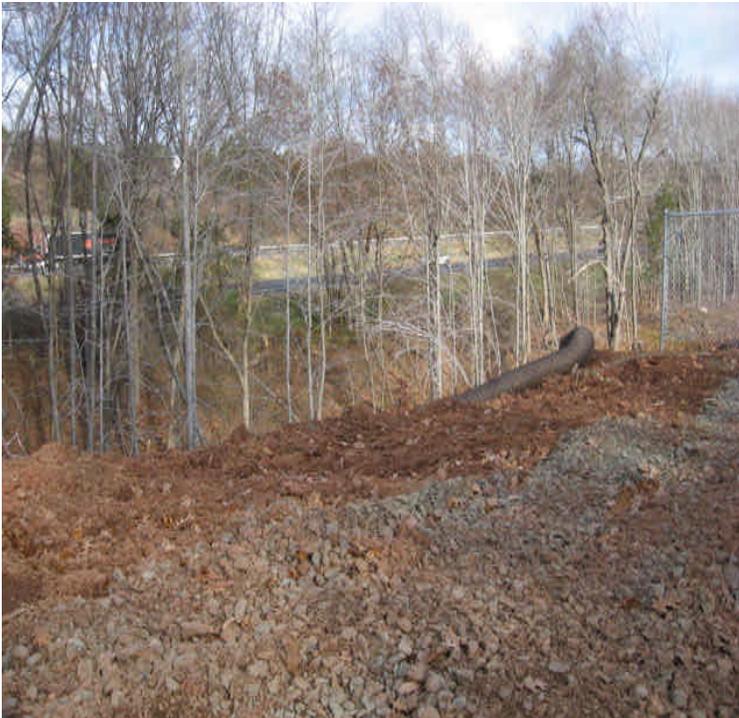
Harrison Ave: Soil stockpile has been removed. Provide temporary stabilization sufficient for winter months.

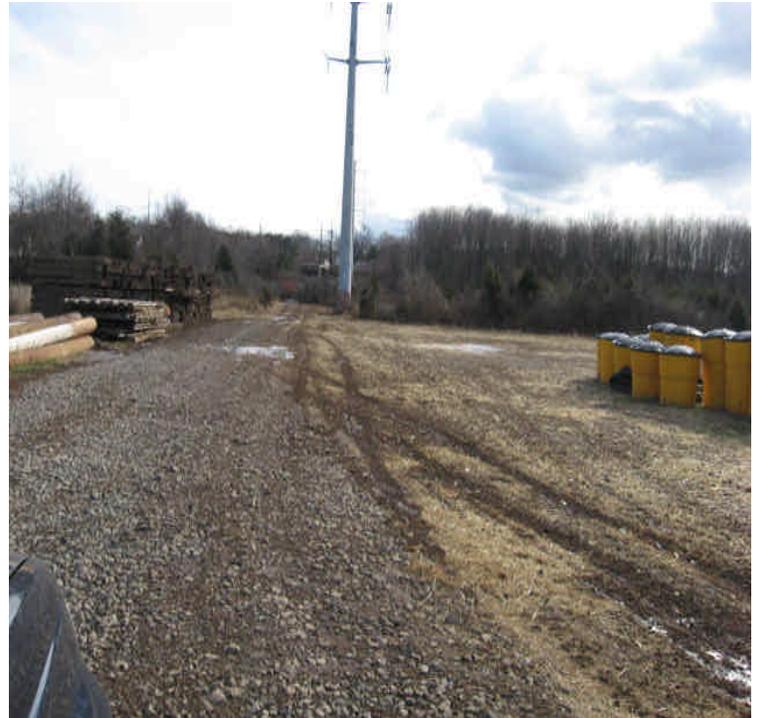
Pond Hill Rd.: The soil stockpile had been removed and hay mulch and seed had been applied on the exposed soil.

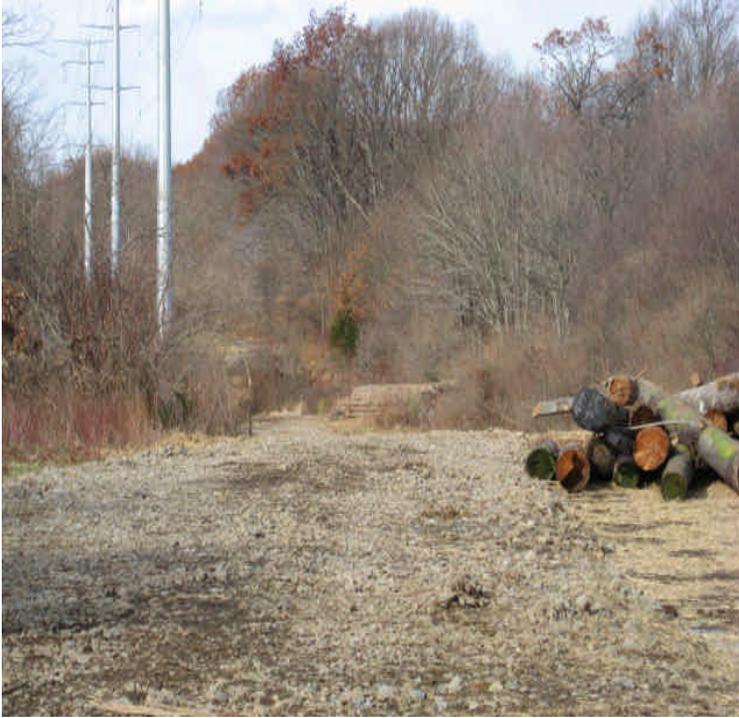
Pond Hill Rd: Stockpiles of timber mats and removed poles were noted. The timber mat access road through the wetlands had been removed/reclaimed. The area was mulched and will be permanently stabilized in the spring

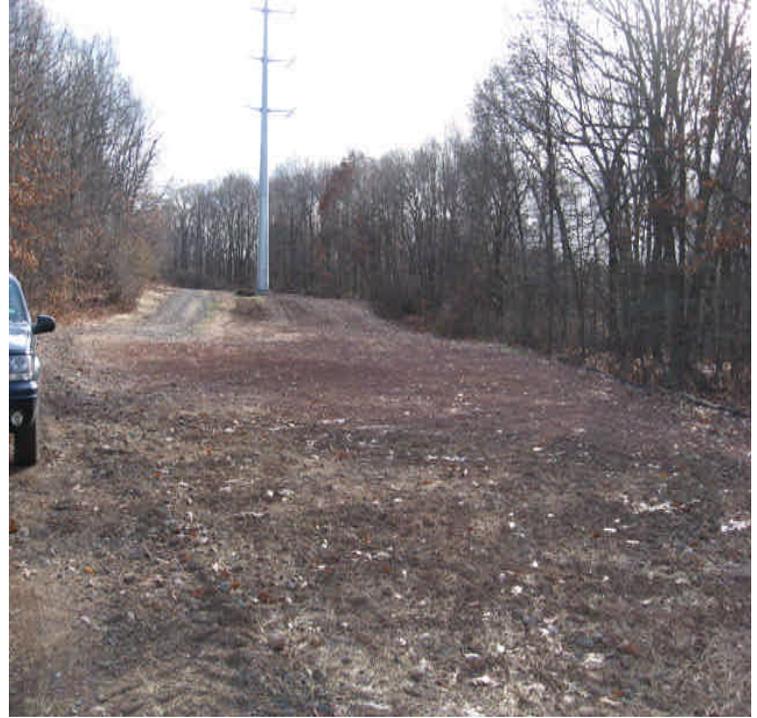
Docker Dr: Areas of exposed soils remain upgradient from wetlands. The previously applied mulch has either washed away or been disturbed by ATV traffic. The area should be temporarily stabilized sufficiently for winter months.

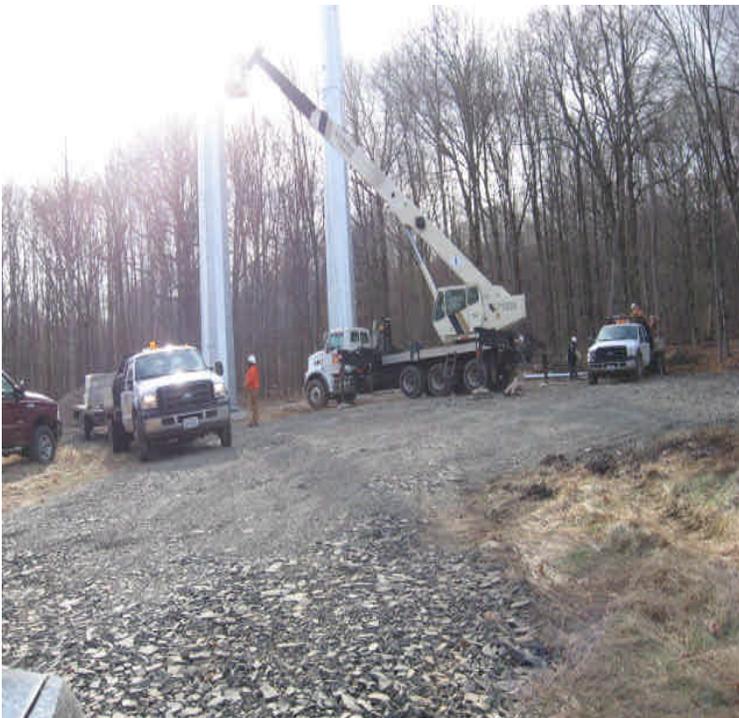
Mansion Rd: Line pulling crews were working in this area.

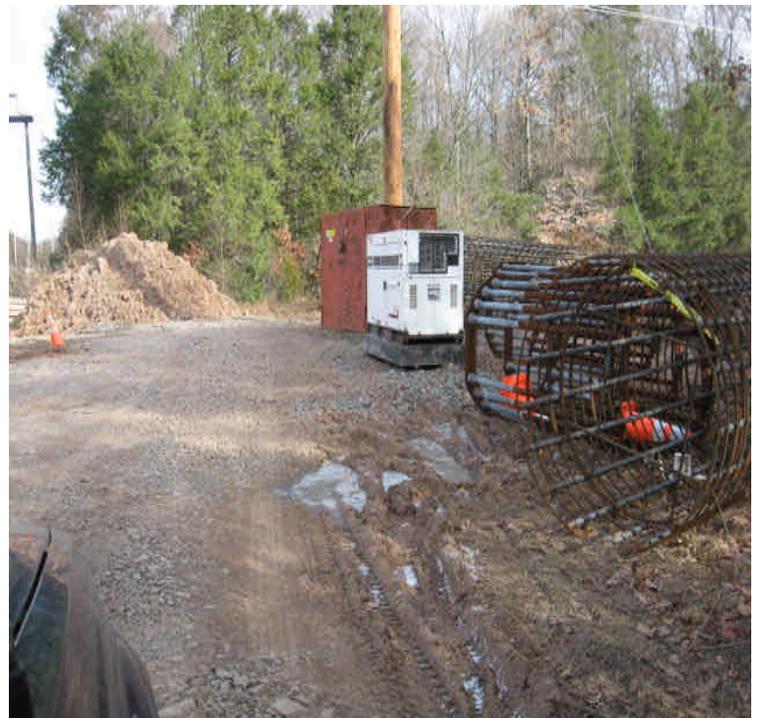
Old Farms Rd: Storage unit and generator were located upgradient from the wetland. A stockpile also remains here.
