Docket No. 272 – Development and Management Plan Inspection

Segment 2a Inspection

Date: December 11, 2007

Location: Segment 2a – Beseck Switching Station to Cheshire/Hamden Town Line

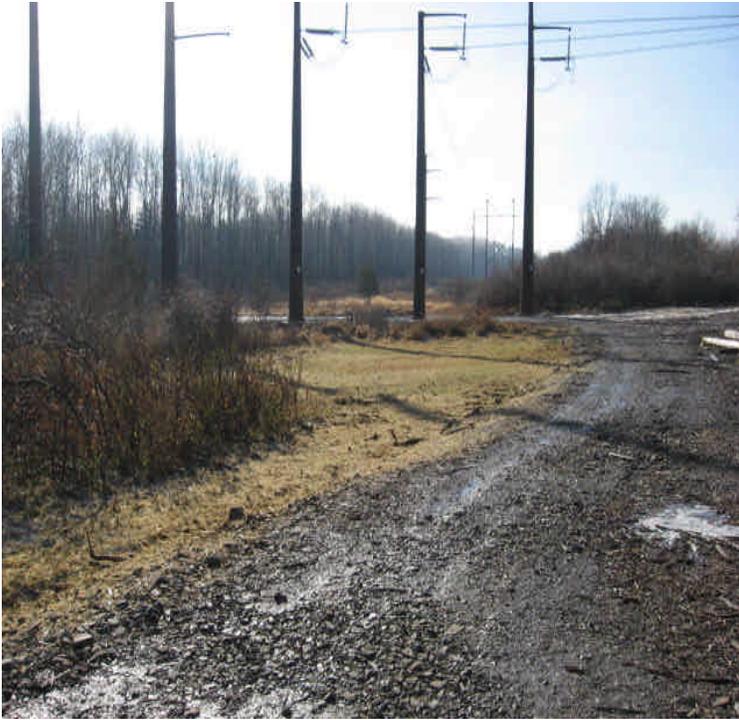
Carpenter Lane: Disturbed areas have been re-mulched and seeded.

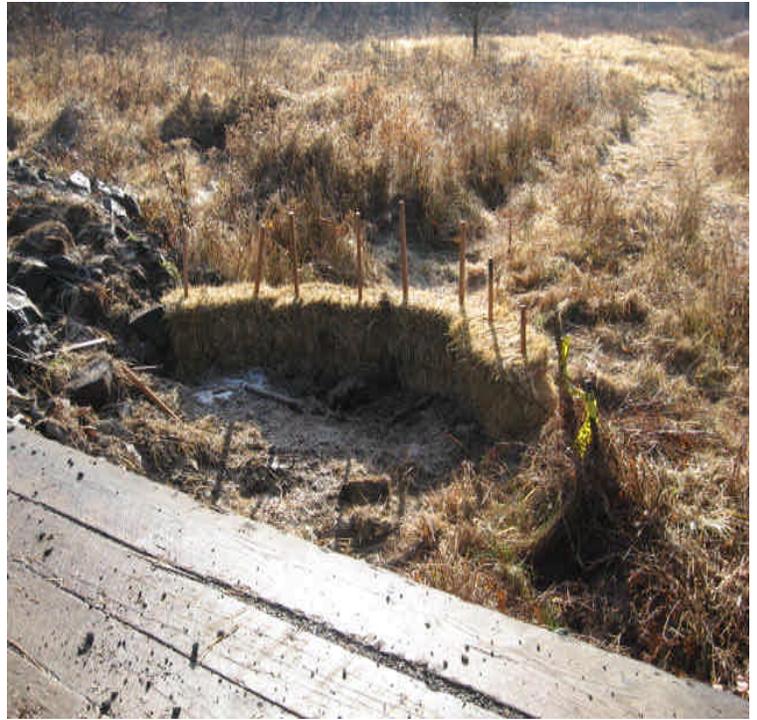
Carpenter Lane: New haybales were installed at the outlet.

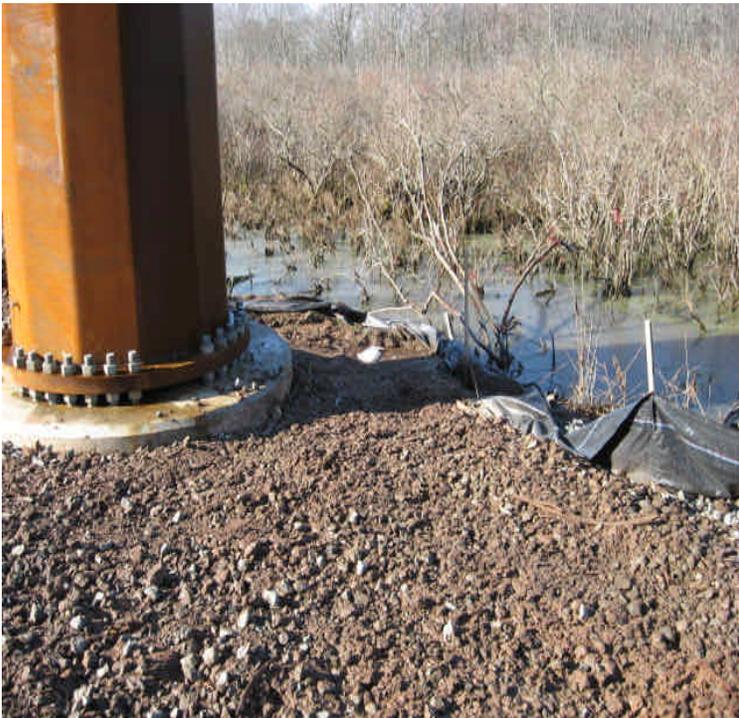
Tamarack Swamp Rd: Additional sediment was pushed over the controls due to grounding wire installation. Pull all sediment back and reinforce controls as soon as possible.

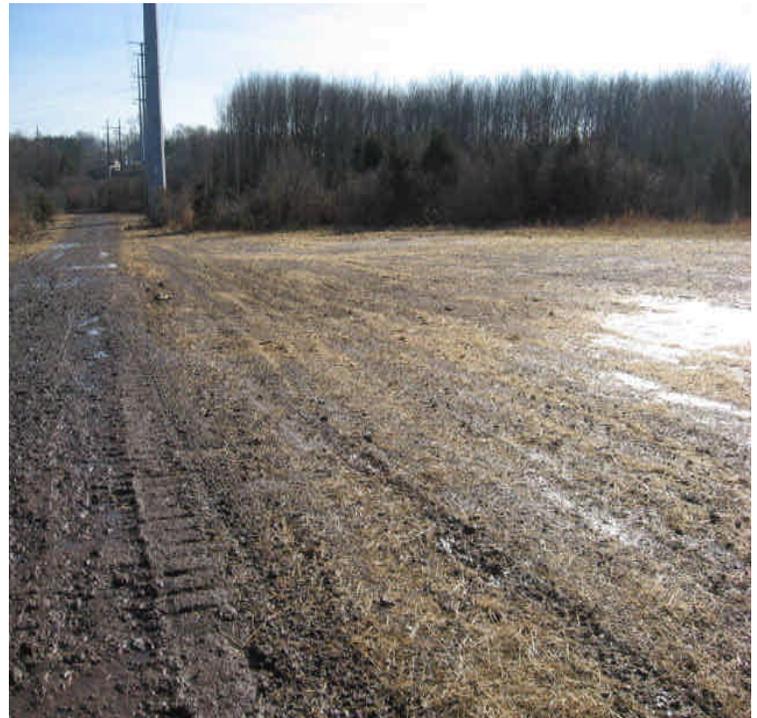
Pond Hill Rd.: Hay mulch and seed remaining the previously disturbed area where the soil stockpiles had been. Ensure that cover is sufficient for winter months.

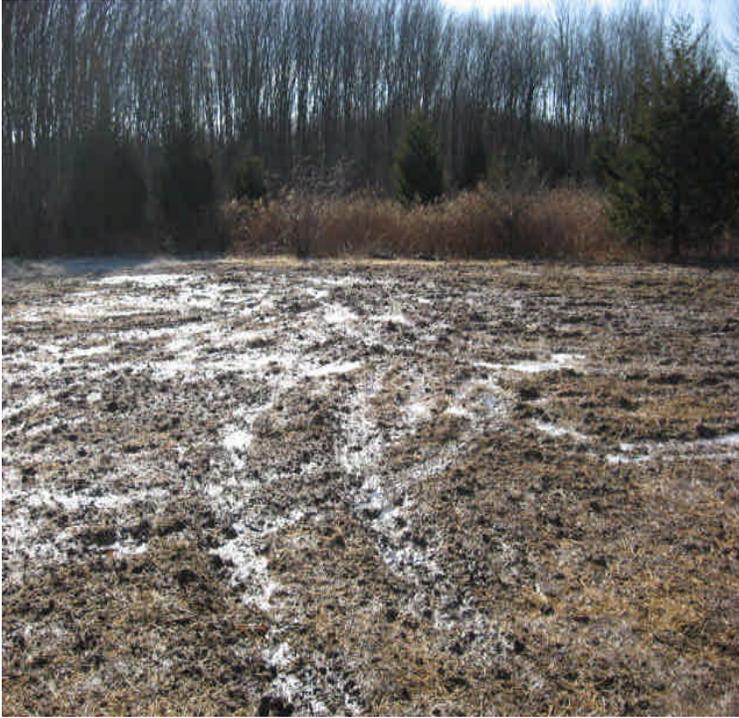
Pond Hill: Previously reclaimed areas continue to deteriorate and be disturbed through ATV tracking.

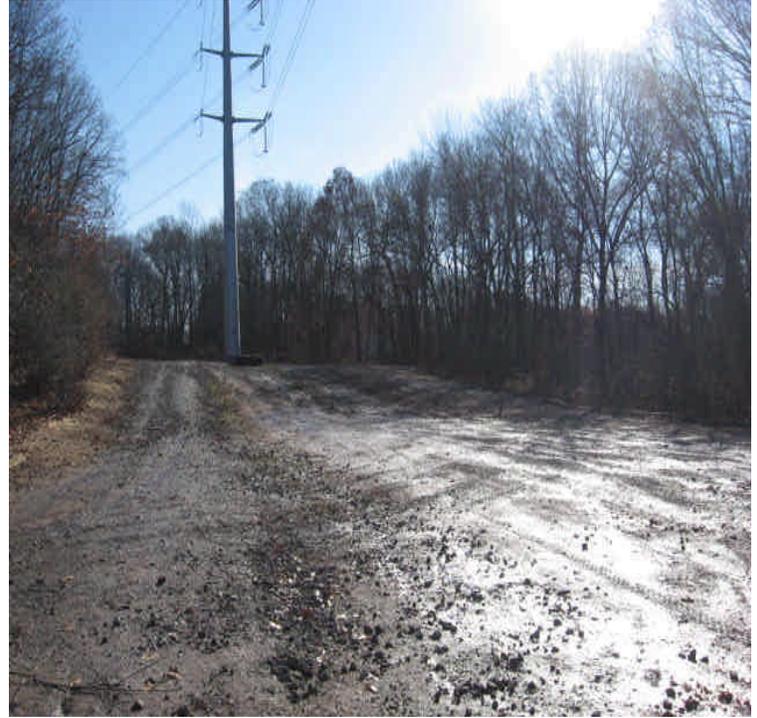
Docker Dr: Areas of exposed soils remain upgradient from wetlands. The previously applied mulch has either washed away or been disturbed by ATV traffic. The area should be temporarily stabilized sufficiently for winter months.

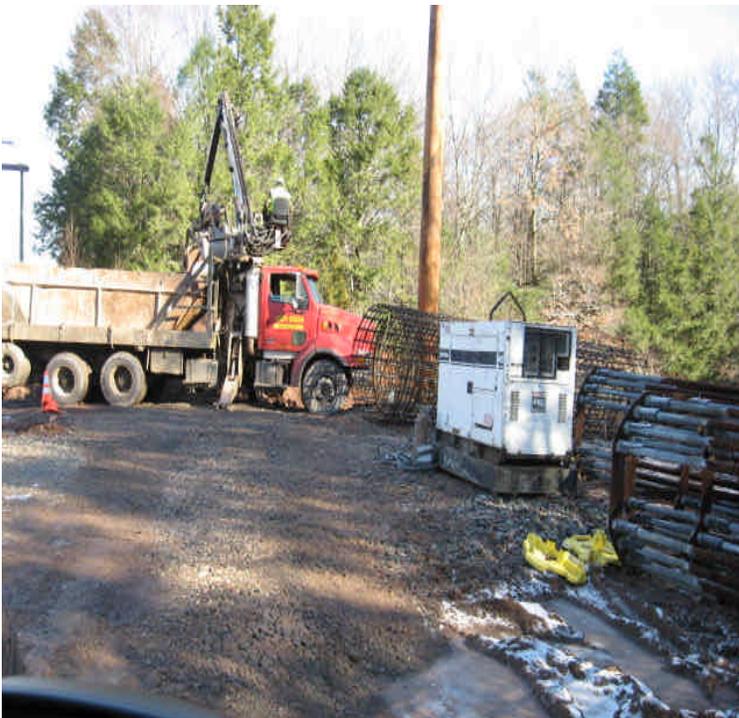
Old Farms Rd: Crews continue to stockpile soil upgradient from the wetlands. Ensure controls are in place to contain the soil. The storage container has been removed.

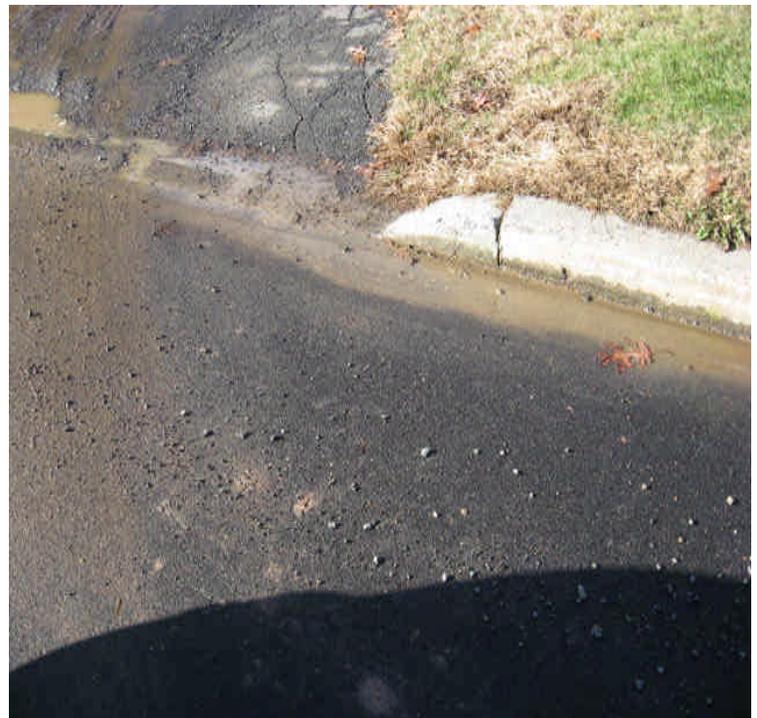
Old Farms Rd: Turbid water flowing off site from the ROW into a catch basin within the roadway. (See contractor update in report)
