Docket No. 272 – Development and Management Plan Inspection

Segment 2b Inspection

Date: December 20, 2007

Location: Segment 2b – Cheshire/Hamden Town Line to East Devon Substation

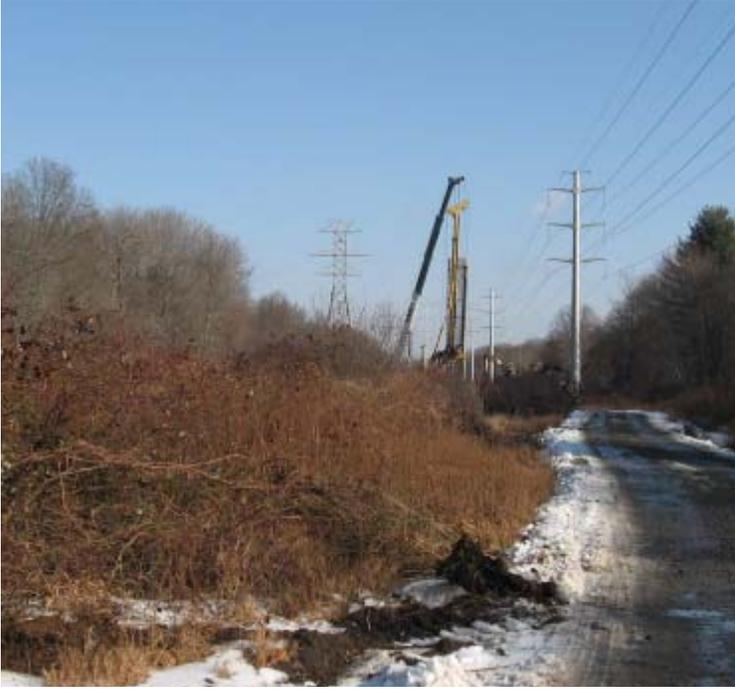
West River St (Milford): Foundation drilling continues in this area.

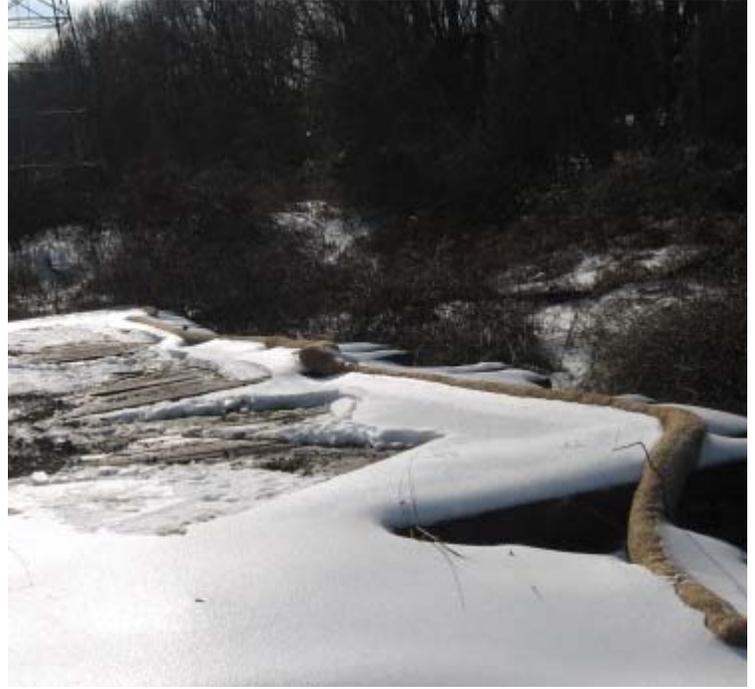
Rimmon Rd (Woodbridge): A "fiber roll" has been installed along the crane timbermat at proposed structure #24105.

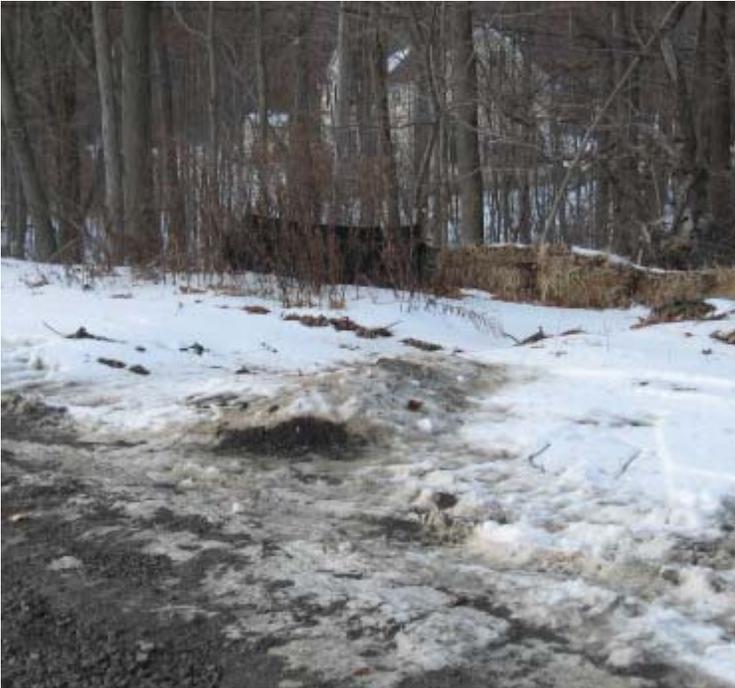
Pease Rd (Woodbridge): The waterbar, located at the access off Pease Rd, is no longer functional.

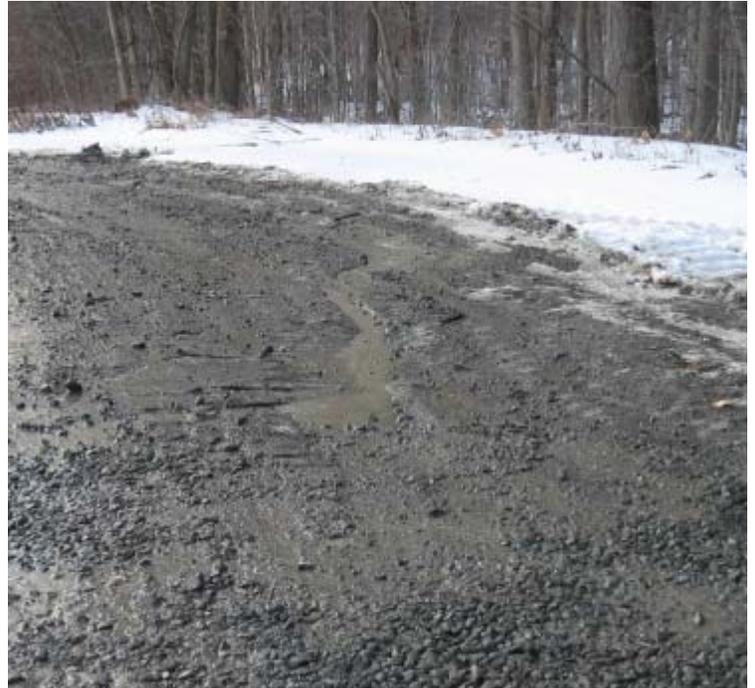
Pease Rd: Stormwater has begun to erode the access road. Turbid water was observed flowing off site.
