Docket No. 272 – Development and Management Plan Inspection

Segment 3 Underground Line

Date: December 5, 2007

Location: East Devon Substation to the Housatonic River Crossing

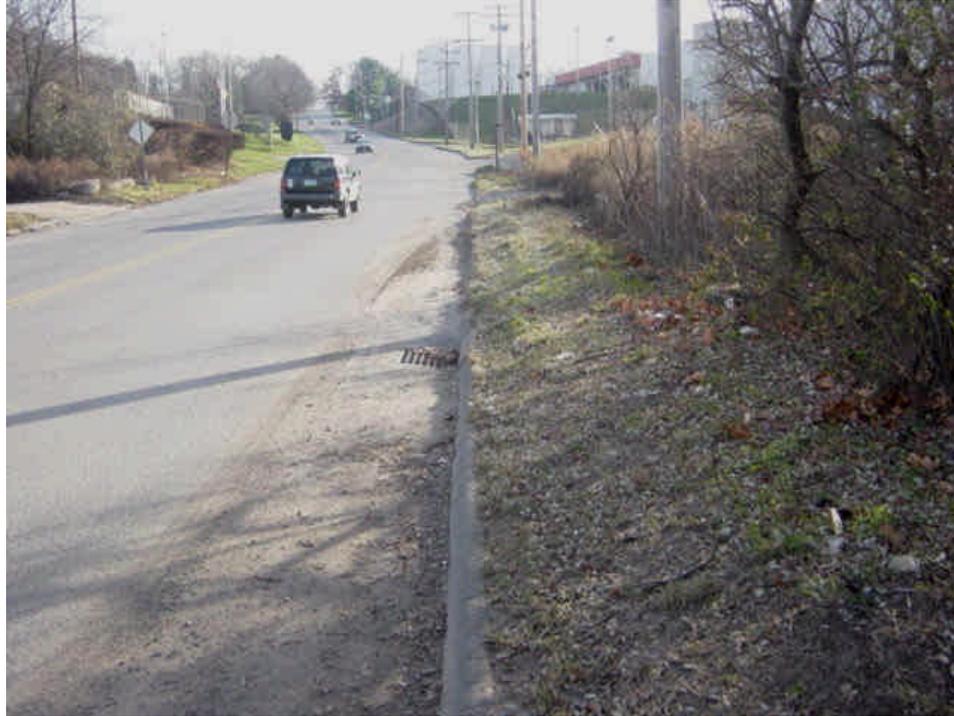
Sediment accumulation continues along Caswell Street and the catch basin is not protected. The tracking is not associated with this portion of the project. This responsibility should be coordinated with overhead contractors. See the 2B report.

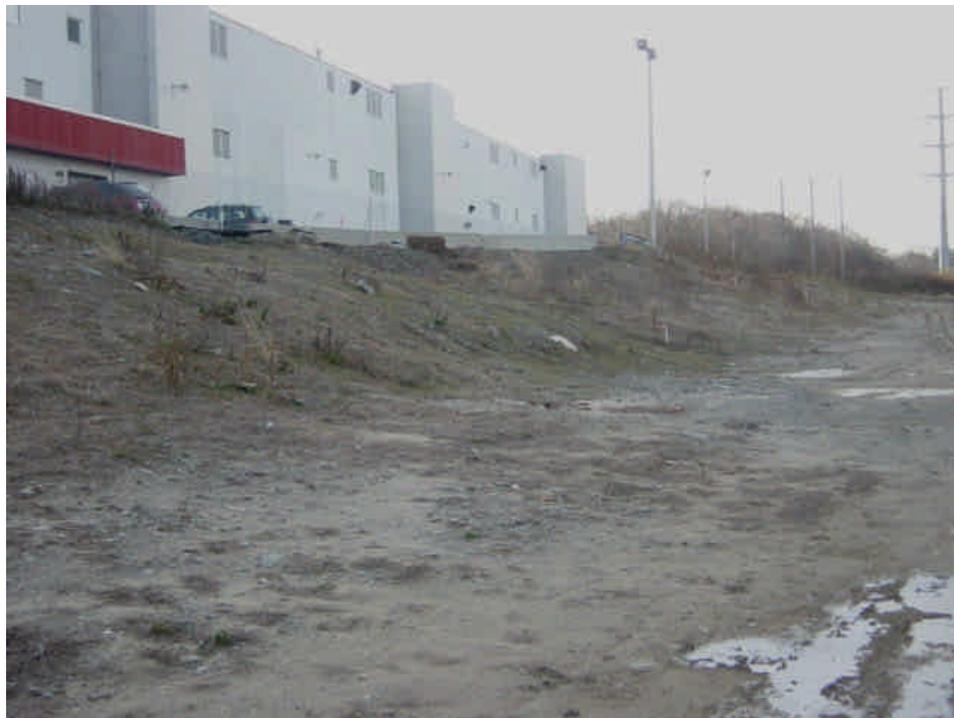
The exposed soil along the slope near sta. #1080 has naturally vegetated. Final restoration plans need to be coordinated with the land-owner and implemented during the appropriate time of year.
