Docket No. 272 – Development and Management Plan Inspection

Segment 4a Underground Line

Date: November 28, 2007

Location: Singer Substation to Fairfield/Westport Town Line

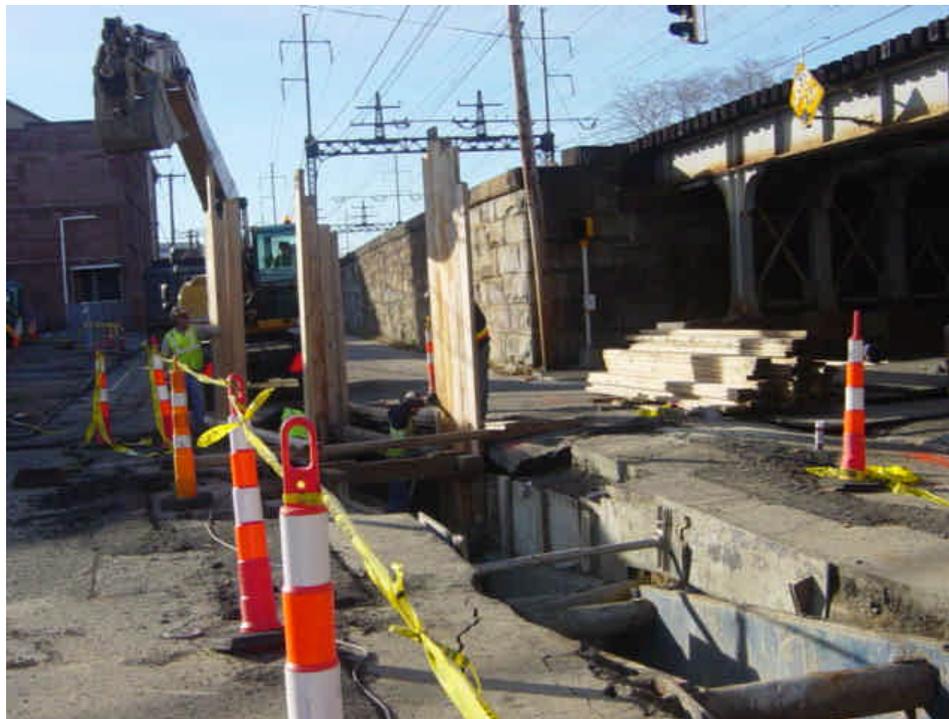
Active trench work continues along Railroad Avenue near sta. #792.

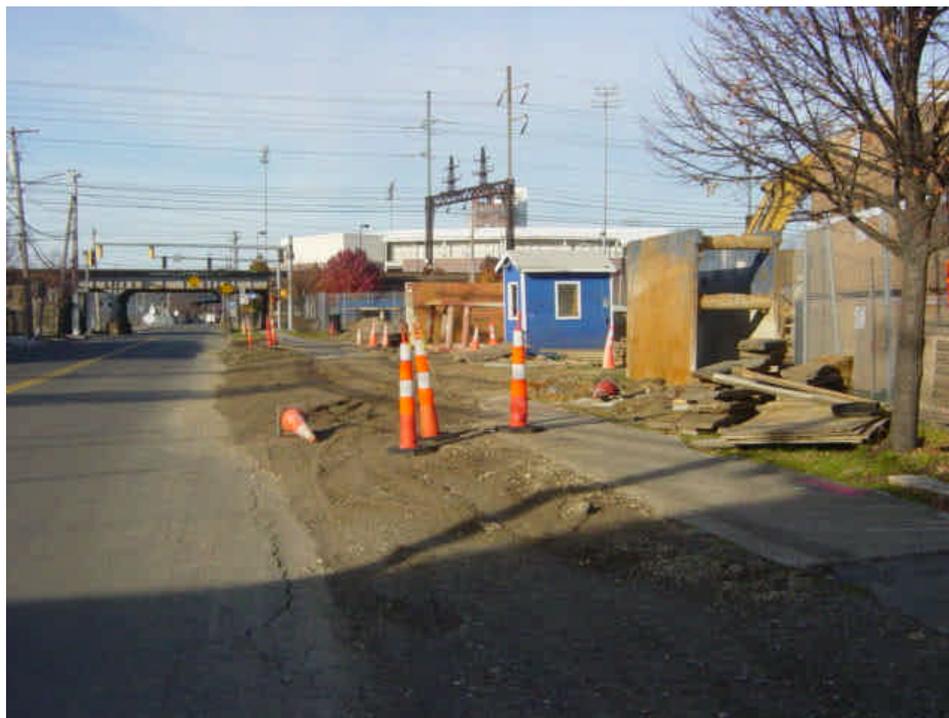
Minor sediment tracking/migration was observed along the shoulder of the roadway near sta. #801-803 (vault #49) where soils were recently backfilled and remain exposed. 11/21-11/28/07	Sweep roadway, stabilize exposed soils with hay mulch and provide measures sufficient for winter months. See soils section for more details. 11/28/07	Needs attention.
Kings Highway Lay-down Yard (Off Kings Highway, near Rt. 1 rotary)	Perimeter controls remain in place. Neither sediment tracking nor dust migration were an issue this week. 11/28/07	Continue to monitor and maintain controls, sweep the roadway as necessary. 11/28/07	No issues but needs regular attention.
Bostwick Ave. Lay-down Yard	Perimeter controls remain in place. Minor sediment tracking was observed near the yard entrance. Dust migration was not an issue. 11/28/07	Continue to monitor and maintain controls, sweep the roadway as necessary. 11/28/07	Needs regular attention.

Area between sta. #801-803 has been backfilled. Exposed soils need to be stabilized sufficiently for winter months. Minor sediment tracking/migration was observed along the shoulder of the roadway.
