Docket No. 272 – Development and Management Plan Inspection

Segment 4a Underground Line

Date: December 5, 2007

Location: Singer Substation to Fairfield/Westport Town Line

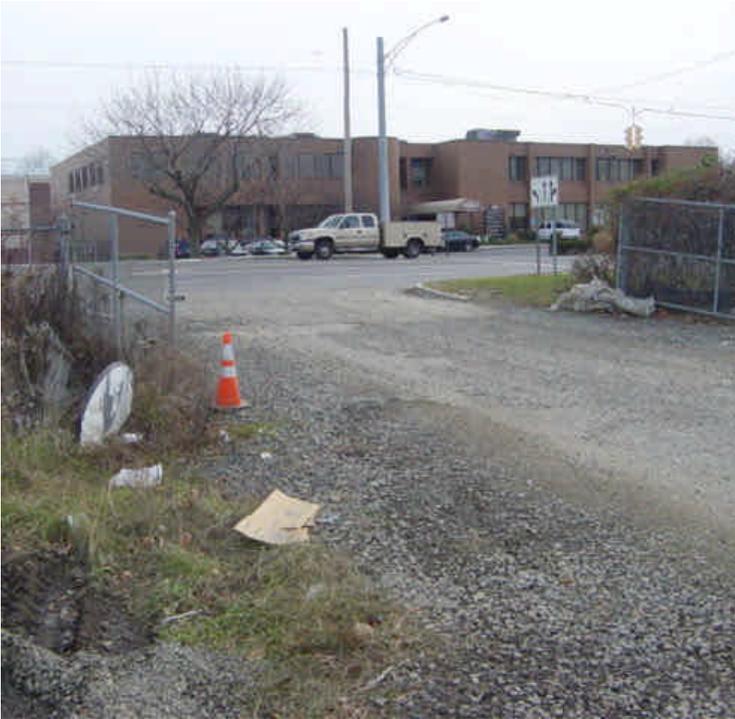
Perimeter controls remain in place at King's Highway lay down yard. Neither sediment tracking nor dust migration were issues this week. Some debris was observed near the yard entrance and should be removed for appearances.

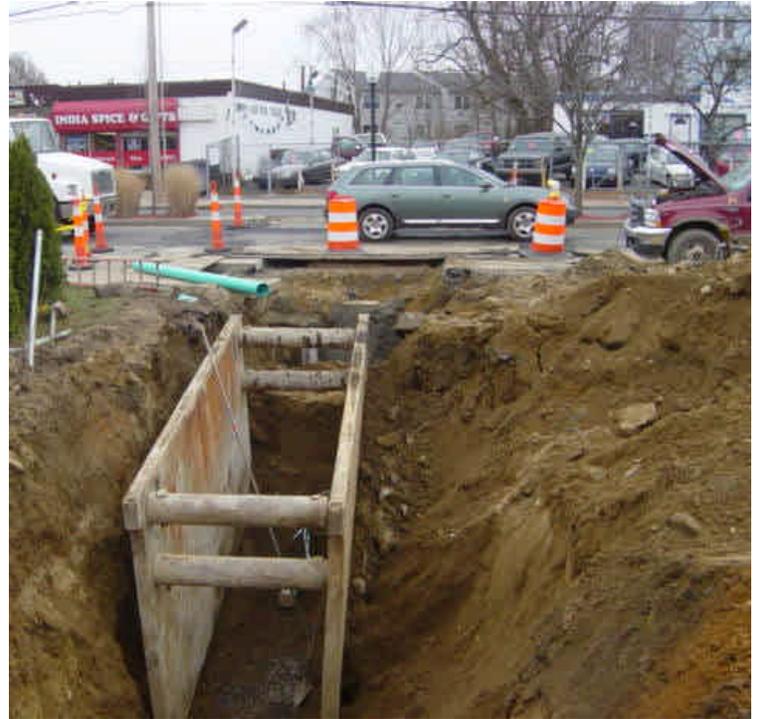
Sewer relocation continues at stations #649-650.

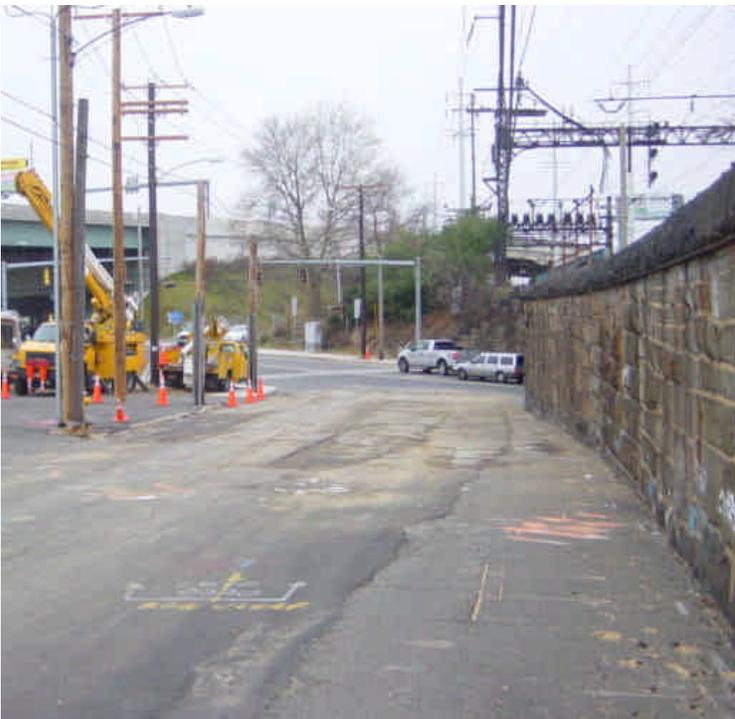
Sediment tracking was observed along the roadway near sta. #719- 720. It does not appear to be related to project activities as other contractors were working in the area.

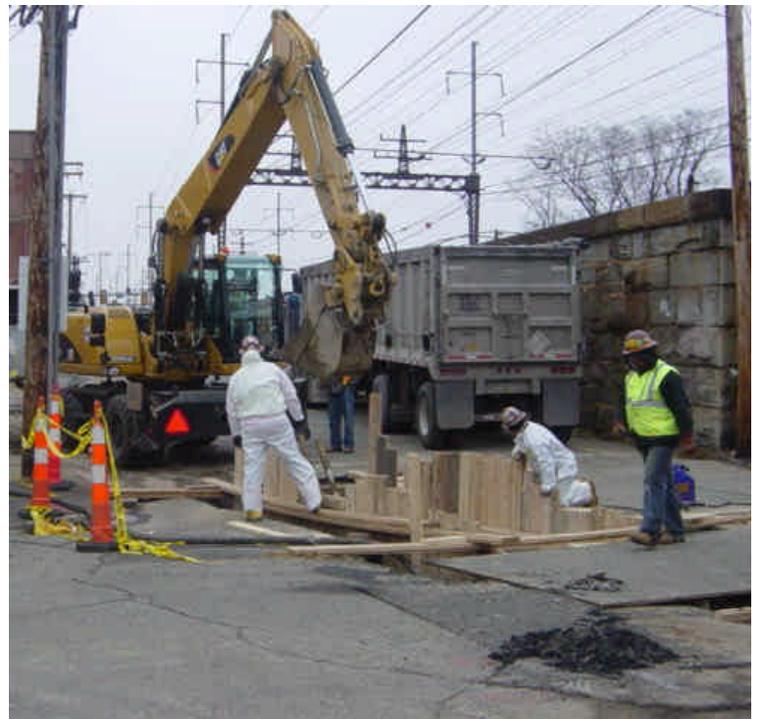
PCB-affected soil removal was in progress near sta. #791-792.
