Docket No. 272 – Development and Management Plan Inspection

The Connecticut Light and Power Company Certificate of Environmental Compatibility and Public Need for the construction of a new 345-kV electric transmission line and associated facilities between Scovill Rock Switching Station in Middletown and Norwalk Substation in Norwalk, Connecticut, including reconstruction of portions of existing 115-kV and 345-kV electric transmission line, the construction of Beseck Switching Station in Wallingford, East Devon Substation in Milford, (and Singer Substation in Bridgeport), modifications at Scovill Rock Switching Station and Norwalk Substation, and the reconfiguration of certain interconnections.

Segment 4b Underground Line

Date: November 28, 2007

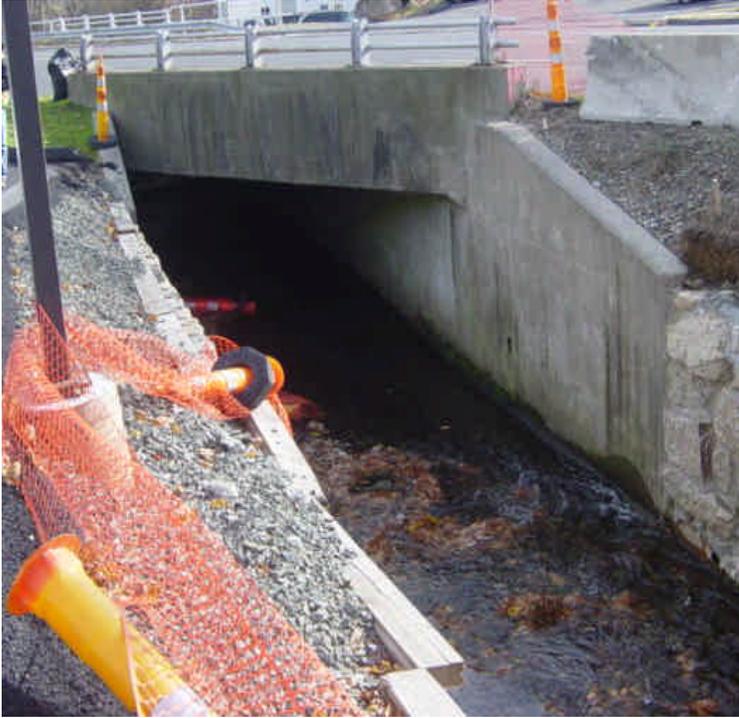
Construction fencing and markers/cones have fallen into Stony Brook near sta. #216.

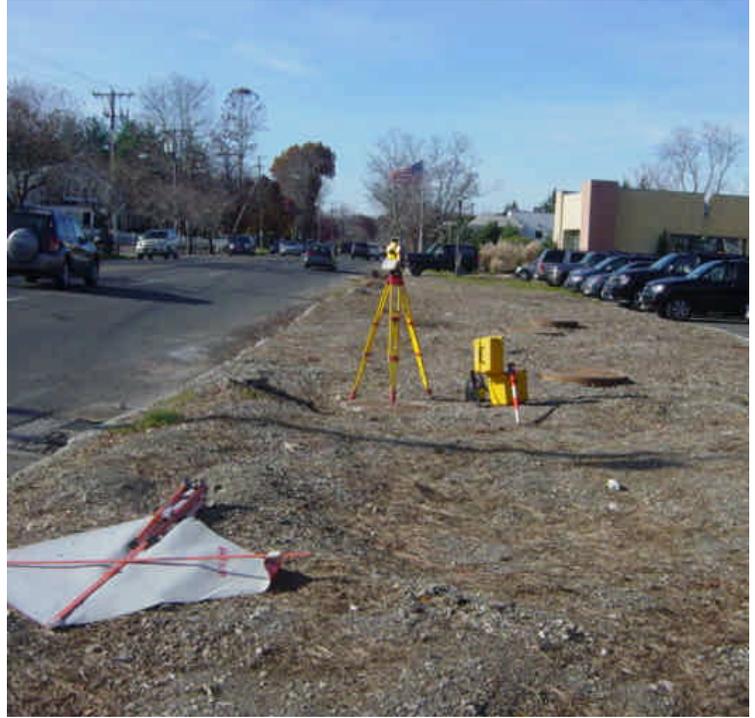
Minor sediment accumulation remains along the shoulder of the roadway near sta. #381-383 (vault #23). The accumulation was heavier in areas where the curbing has deteriorated. Hay bales are providing some control, but the bales are also deteriorating.

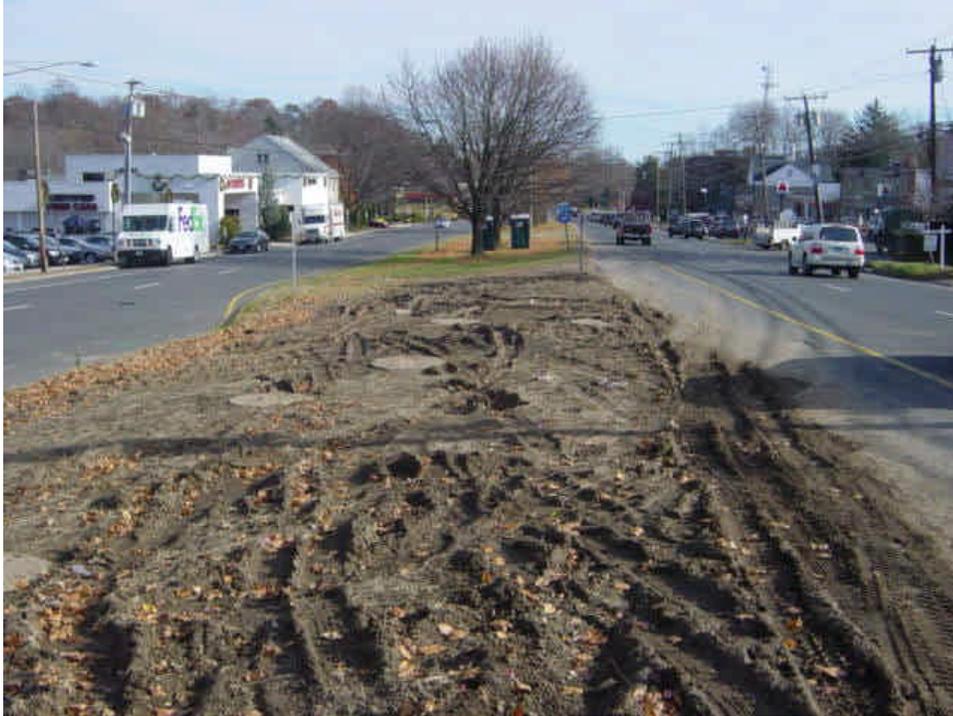
Ruts and tracking were observed near sta. #316-318. Hay mulch was previously applied over the exposed soils but the area should be refreshed so it has sufficient temporary stabilization for the winter months. Sediment needs to be removed from the curb/gutter and swept up.
