Docket No. 272 – Development and Management Plan Inspection

Segment 4b Underground Line

Date: December 5, 2007

Location: Fairfield/Westport Town Line to Westport Avenue in Norwalk

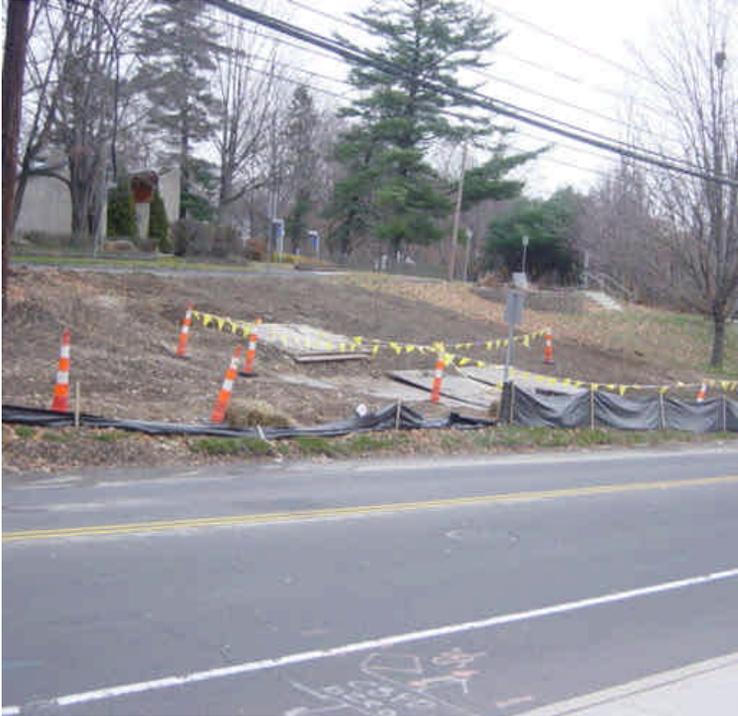
Silt fence along the curb line near sta. #81 (vault #5) is in need of repair. Exposed soils upgradient should be stabilized sufficiently for winter months when active work is complete.

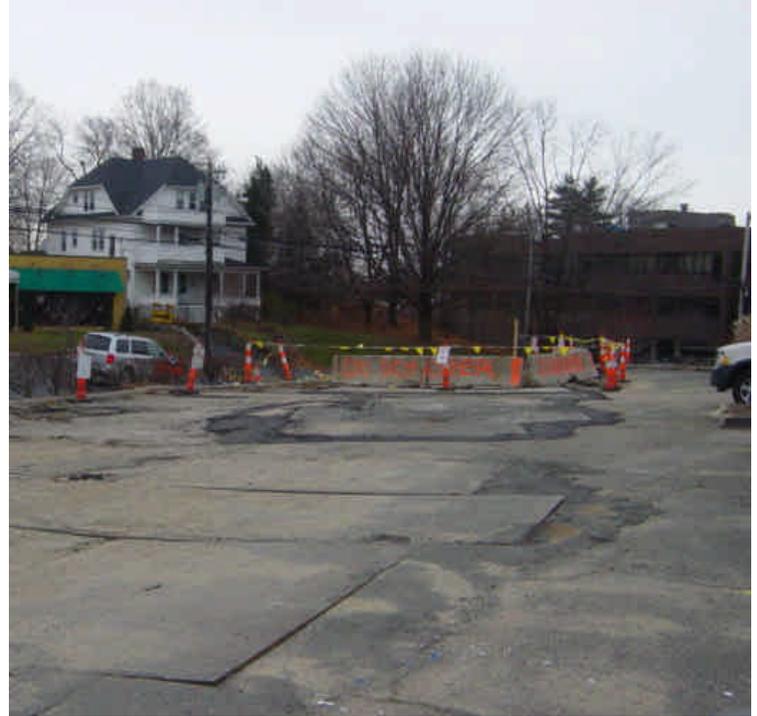
Sediment was observed over the steel plates and parking lot area near sta. #96-98. Tracking was minor.

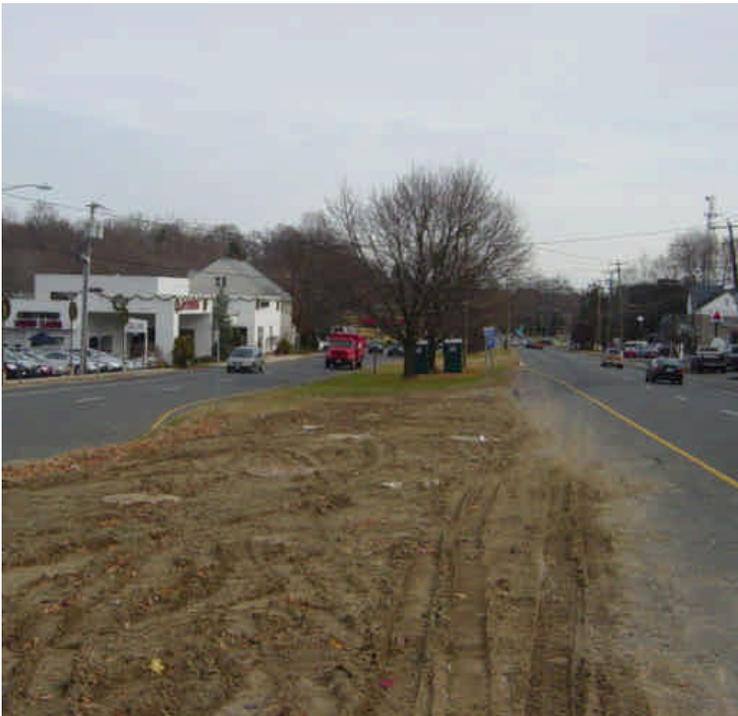
Areas of Inspection	Observation	Recommended Action	Corrected Action
	Heavy ruts and sediment accumulation remains in the area of sta. #316-318 (vault #19). 11/28-12/05/07	12/05/07 See the erosion control section. The area needs sufficient stabilization for the winter. 11/28-12/05/07	Needs attention.
Dewatering	Dewatering activities were not being conducted at the time of the inspection. 12/05/07	Appropriately contain and/or filter discharge water. When dewatering stormwater from contained, completed vaults, minimize future impacts by connecting hoses to discharge the water directly into a catch basin rather than allowing flow over exposed soils and roadways. 12/05/07	NA
Spills and Material Storage	Spill cleanup materials/kits were observed in the storage yard. 12/05/07 A light post and associated concrete footings were being stored at sta. #148. Materials appear to be project related. 10/4-12/05/07	Ensure that spill kits are also present with each vehicle during active construction. 12/05/07 Remove or attend to materials when feasible. 10/4-12/05/07	NA Needs attention when feasible

Ruts and tracking were observed near sta. #316-318. Hay mulch was previously applied over the exposed soils but the area should be refreshed so it has sufficient temporary stabilization for the winter months. Sediment needs to be removed from the curb/gutter and swept up.

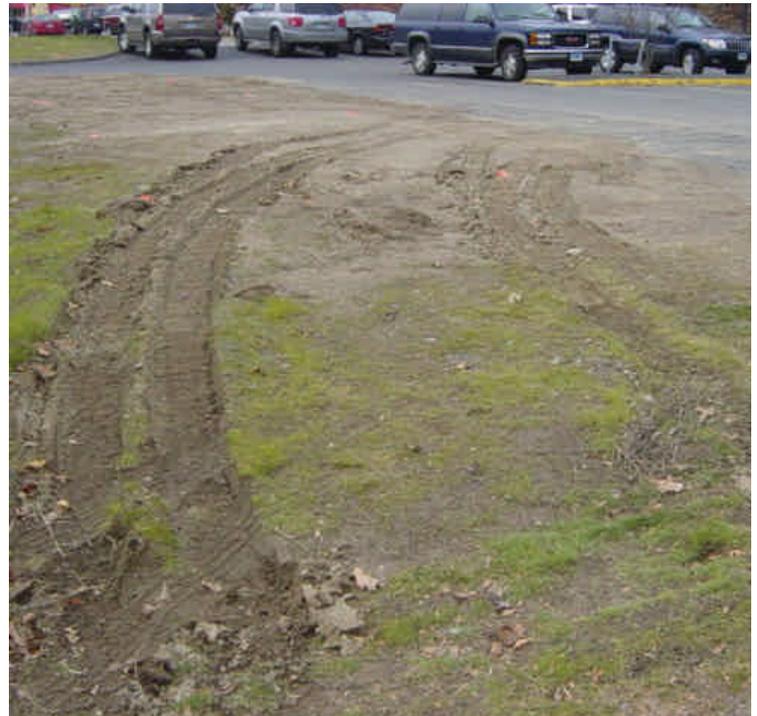
Vehicle ruts were noted in the previously seeded areas near sta #334 (vault 20). Patrons of the diner and plaza continue to park in this area. Coordinate with the landowner to determine what the solution should be in terms of final cover here. Grading and re-seeding may be needed in the spring with barriers to prevent parking.
