Docket No. 272 – Development and Management Plan Inspection

Segment 4b Underground Line

Date: December 31, 2007

Location: Fairfield/Westport Town Line to Westport Avenue in Norwalk

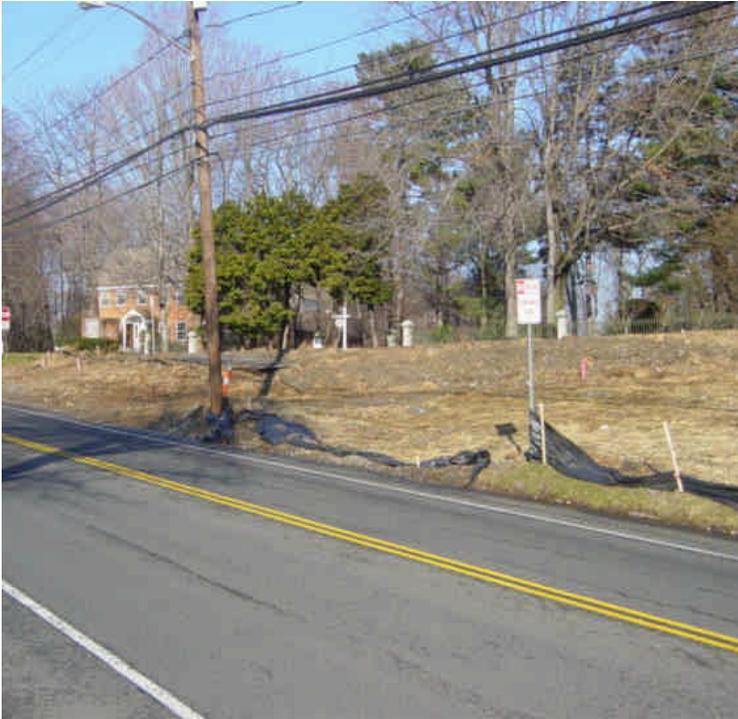
Silt fence was removed from the curb line near sta. #81 (vault #5) either due to construction or snow plowing. Exposed soils were partially mulched with hay. Continue to stabilize and sweep along the curb as needed.

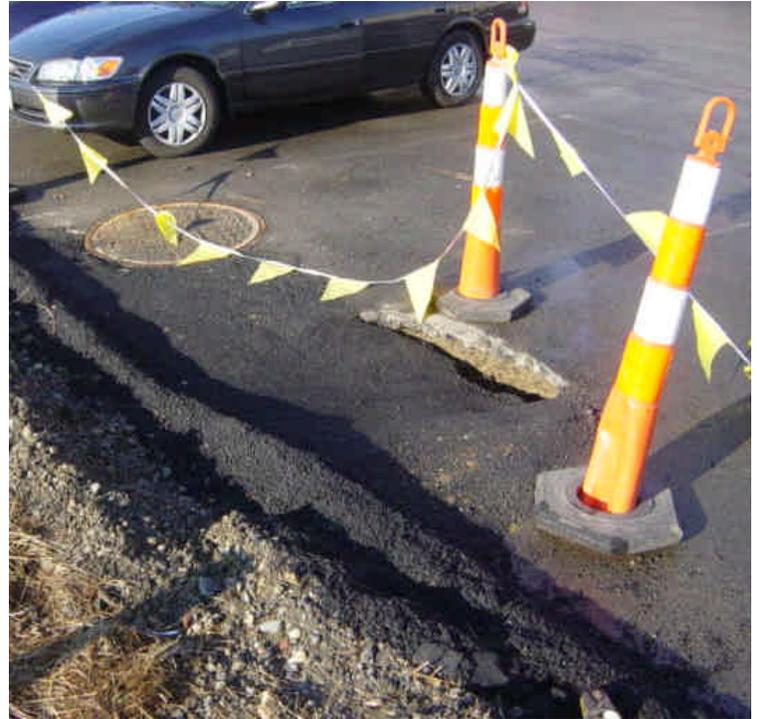
Backfilled soil near sta. #129-131 had been mulched with hay. A bituminous curb was installed and the lot has been temporarily paved. The pavement has settled and created a minor depression in the parking lot area. 12/31/07	Sweep area if necessary and continue to monitor for stabilization. Evaluate any safety issues and take necessary precautions. Repair temporary pavement in parking lot area. 12/31/07	Needs attention.
	Sediment accumulation was previously observed on the roadway near sta. #146 (vault #9). Landscaped areas/ exposed soils adjacent to the work site have the potential to erode. (Since 11/08) Area has been temporarily stabilized and steel plates cover the work zone over the break. 12/31/07	Provide additional stabilization, sufficient for winter months, to adjacent landscaped areas and work site once active work is complete in an area. 12/31/07	Needs attention to stabilize any completed areas.

Temporary pavement near sta. #130 has settled, creating a small depression in the parking lot area. Evaluate any safety issues and provide necessary precautions.

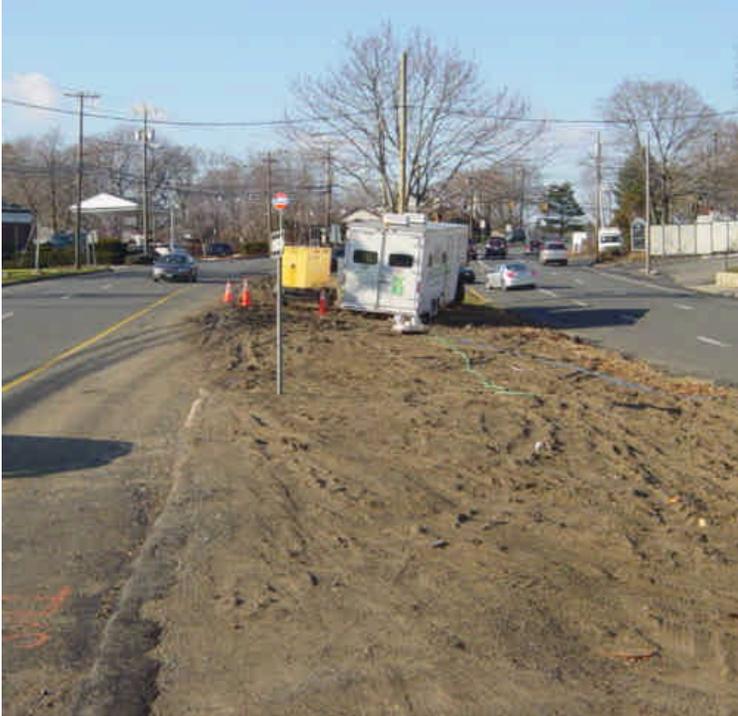
Sediment tracking and heavy rutting was	Remove the sediment accumulated along the	Needs attention.

Heavy rutting continues within the median near sta. #316-318. Some sediment was observed along the shoulder and encroaching into the roadway.

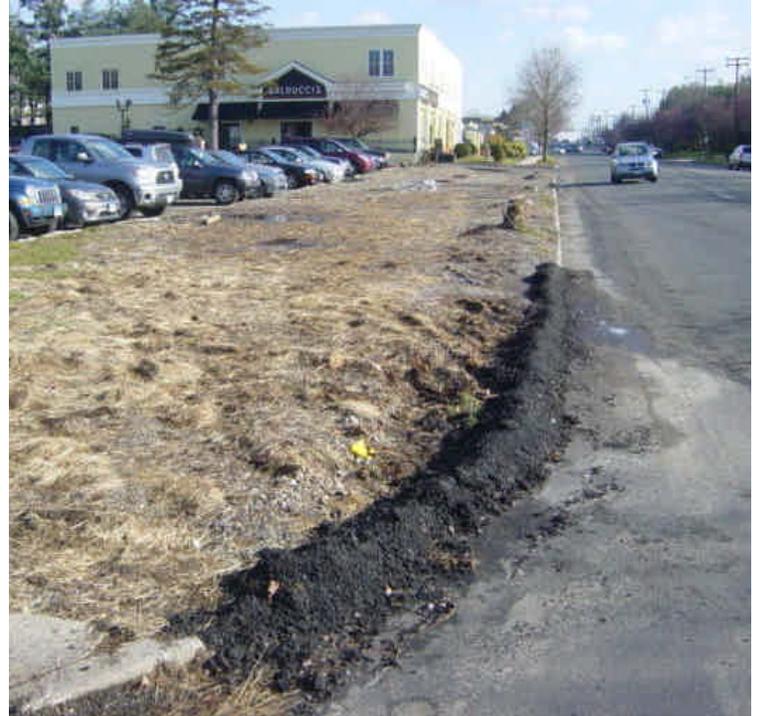
A temporary bituminous curb remains in place near sta. #181 to minimize the potential for sedimentation.
