Docket No. 272 – Development and Management Plan Inspection

Segment 4c Underground Line

Date: December 12, 2007

Location: Westport Avenue to the Norwalk Substation in the City of Norwalk

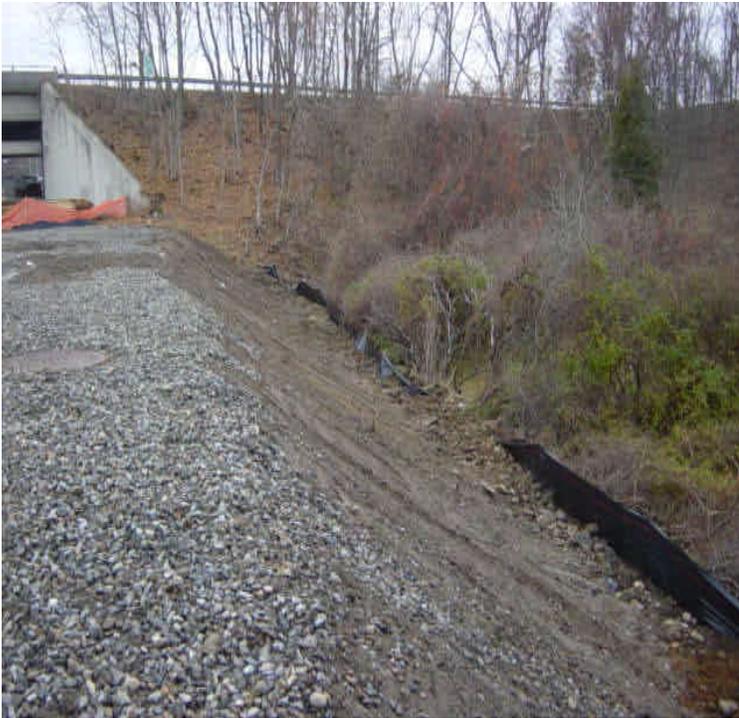
Silt fence has been proactively installed along the base of the slope near sta. #15-16. In several places, the soil/stone had piled up and was overtopping the fence.

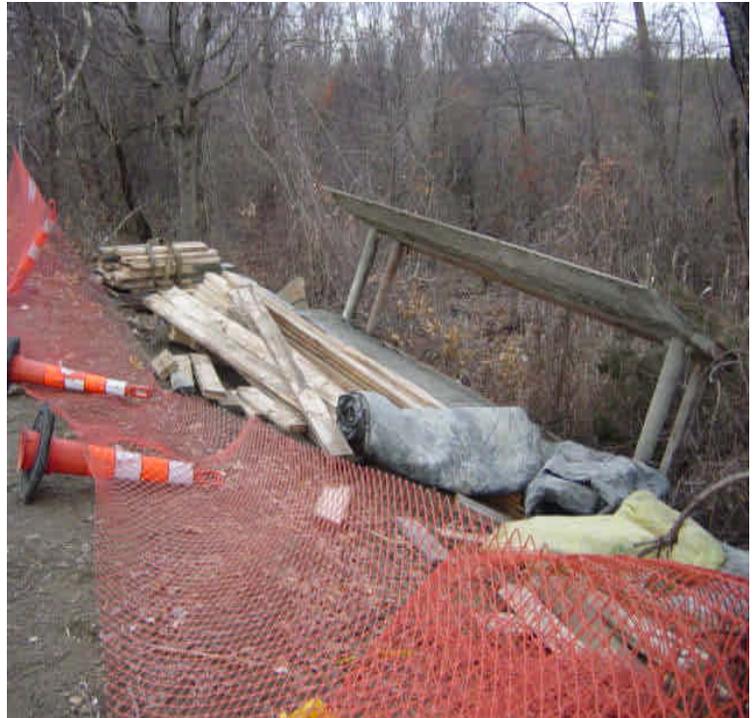
Haybales previously placed along the downgradient side of the slope near sta. #18 have been moved and no longer form a continuous barrier. Exposed soils remain. Materials were being stored in the area.

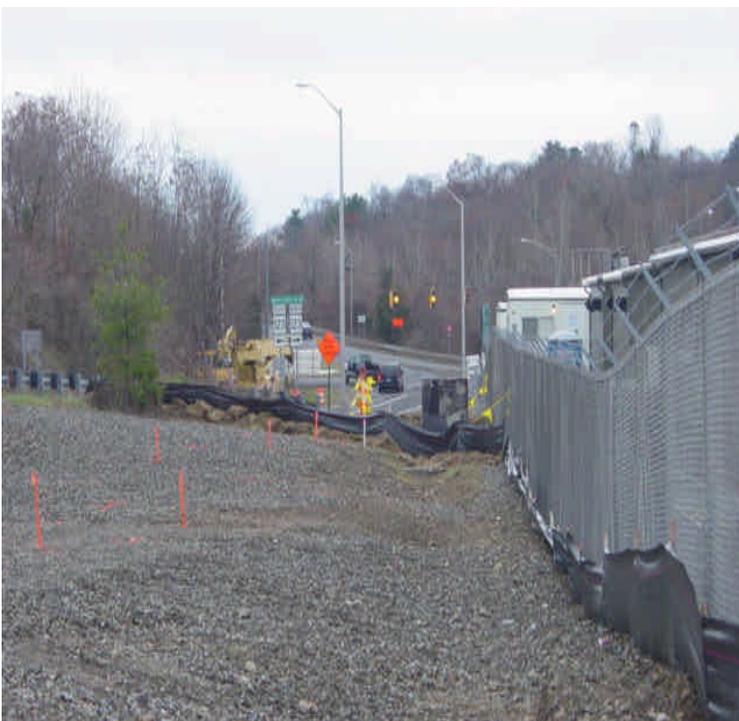
Trenching continues along the off-ramp to Rt. 7 near sta. #5-7 and adjacent to the Norwalk substation.

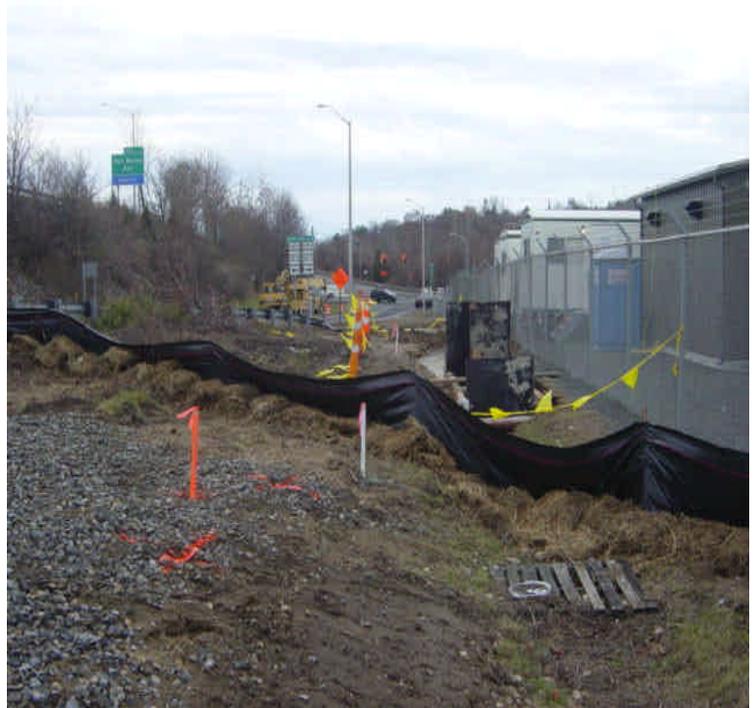
A large area of backfilled soil remains exposed between sta. #6-10 along the shoulder of the Rt. 7 off-ramp. New silt fence was installed at sta. #6. Minor rutting was observed in this area but tracking was not an issue at this time. The drainage swale downgradient from this area still needs evaluation.
