Docket No. 272 – Development and Management Plan Inspection

Segment 4c Underground Line

Date: December 21, 2007

Location: Westport Avenue to the Norwalk Substation in the City of Norwalk

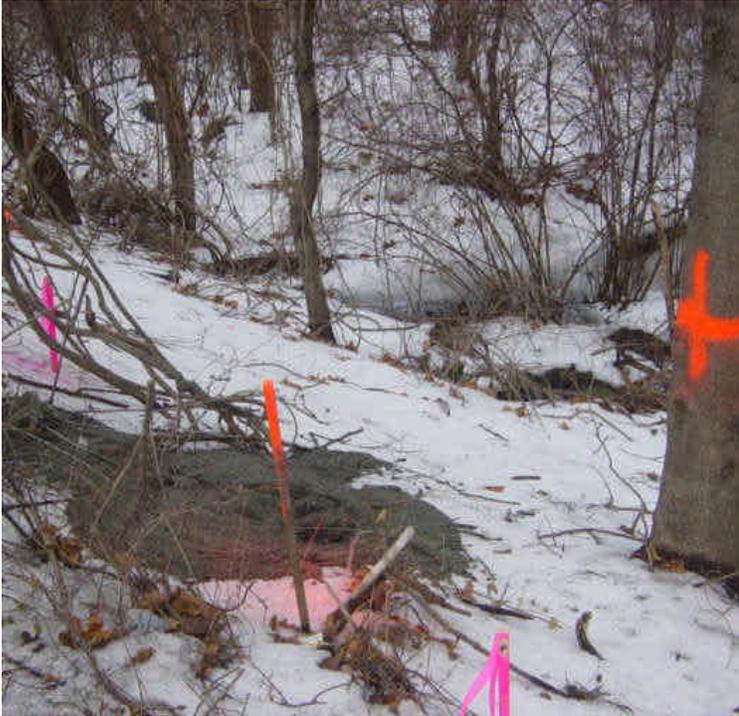
A concrete washout was noted on the slope near the work at sta. #16-18. Haybales have not been reset and there are no controls between the work and what appears to be a resource area down-gradient. Trees were marked for removal in this area.

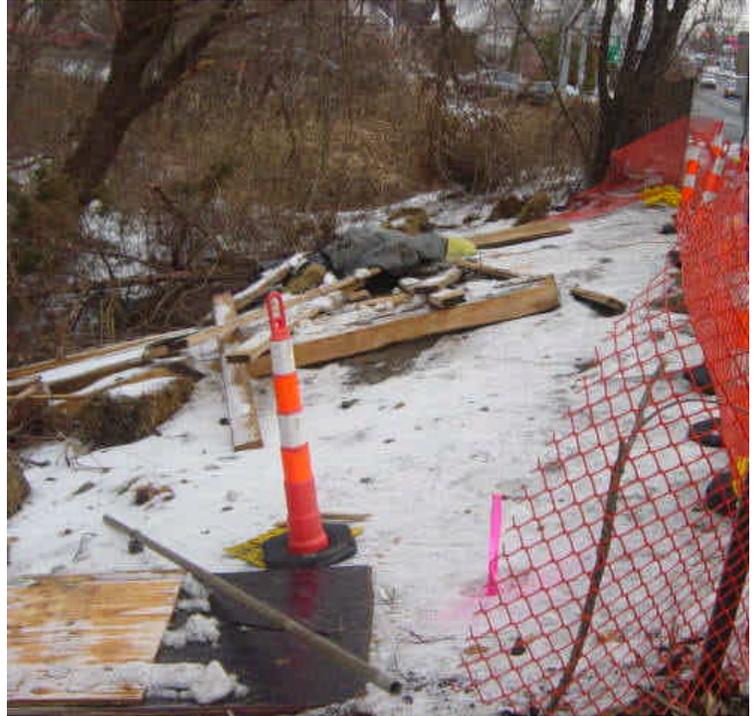
Materials were still being stored along the slope near sta#18. Haybales have not been reestablished along the slope. Controls are needed here.

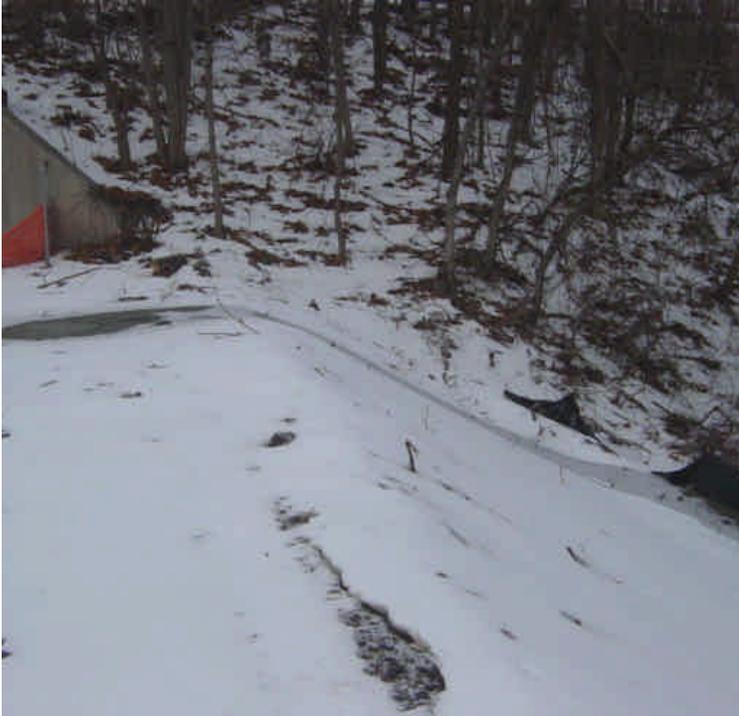
View of the slope near sta #15 and vault #1 The silt fence here was still overtopped with stone and needs repair. A concrete washout was also observed along the slope with run-off to the silt fence. A second washout was noted near the roadway shoulder. The material needs to be removed and future washouts need containment.

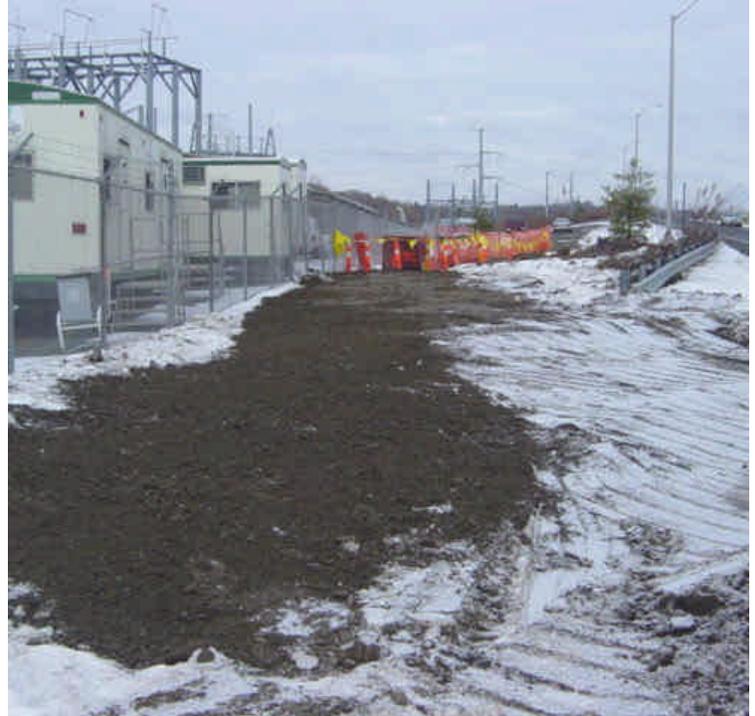
Trenching continues in the area of sta # 5-7 near the Rt. 7 off-ramp. Portions have been backfilled. The contractor stated that they would reestablish the pre-construction drainage swale once work is complete in this area.
