Docket No. 272 – Development and Management Plan Inspection

East Devon Substation Inspection

Date: April 11, 2008

Location: East Devon Substation

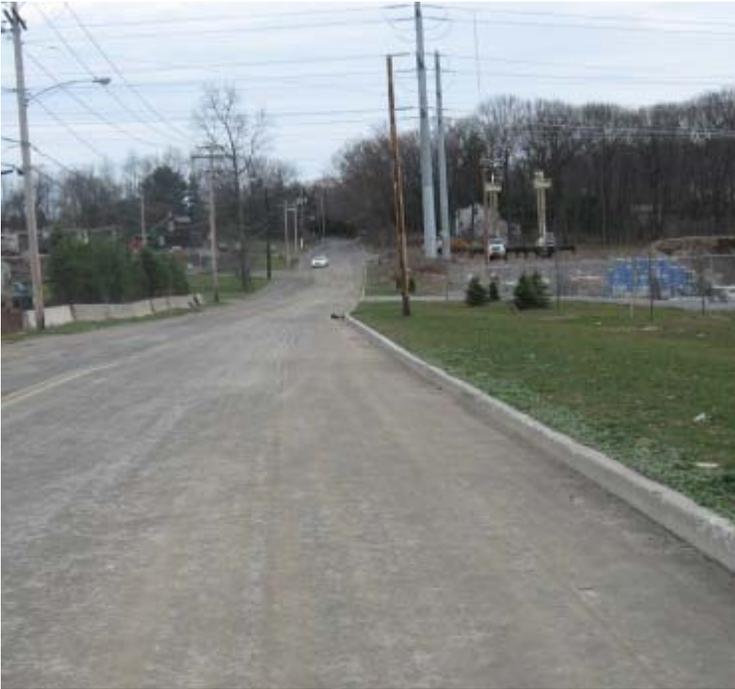
Plains Rd (East Devon Substation): Sediment has been swept from the roadway.

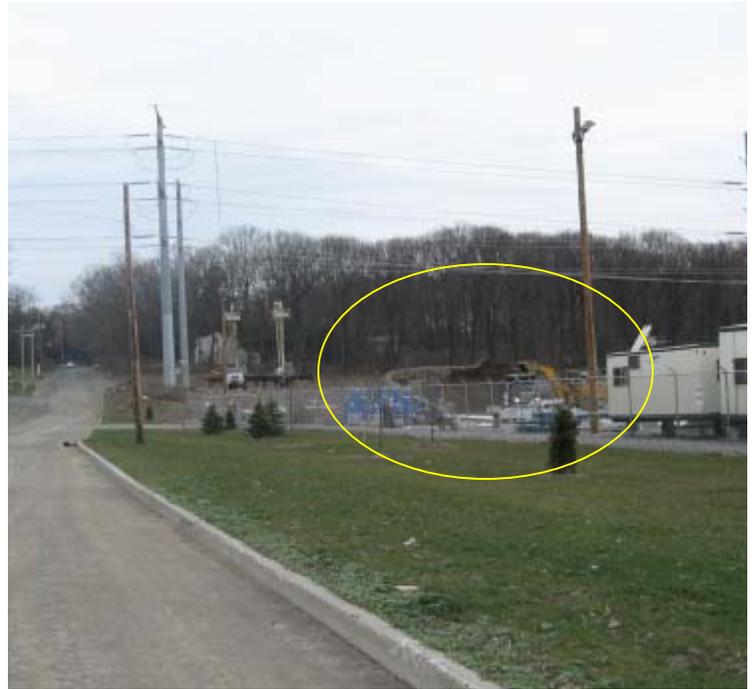
East Devon Substation (Milford): Spoils are being removed from the site.
