**Docket No. 272 – Development and Management Plan Inspection**

**East Devon Substation Inspection**

**Date:** May 9, 2008

**Location:** East Devon Substation

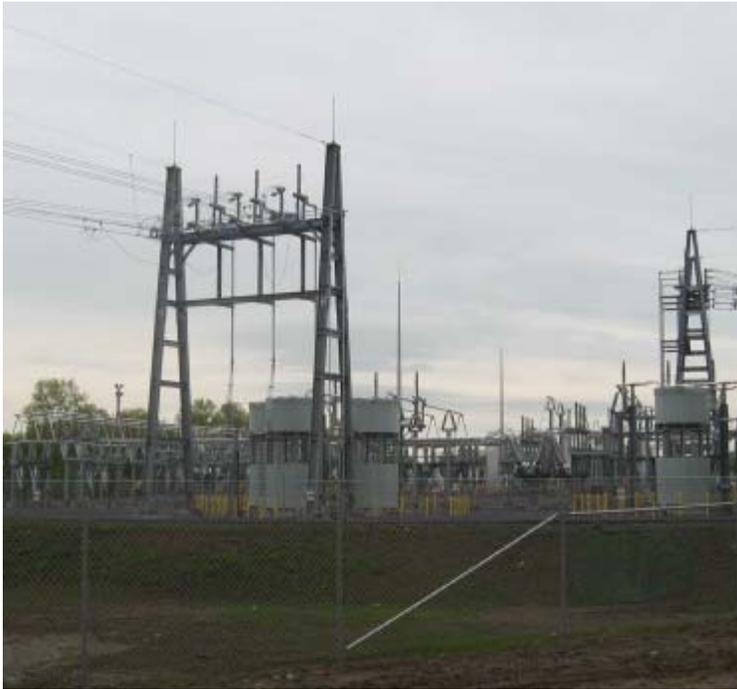
East Devon Substation (Milford): A general view of construction at the substation.

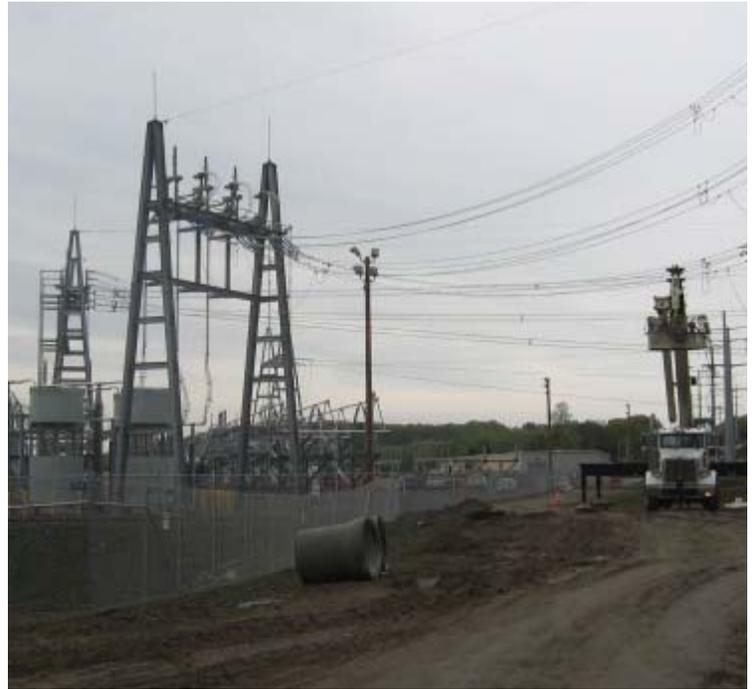
East Devon Substation: An additional view of construction at the substation.

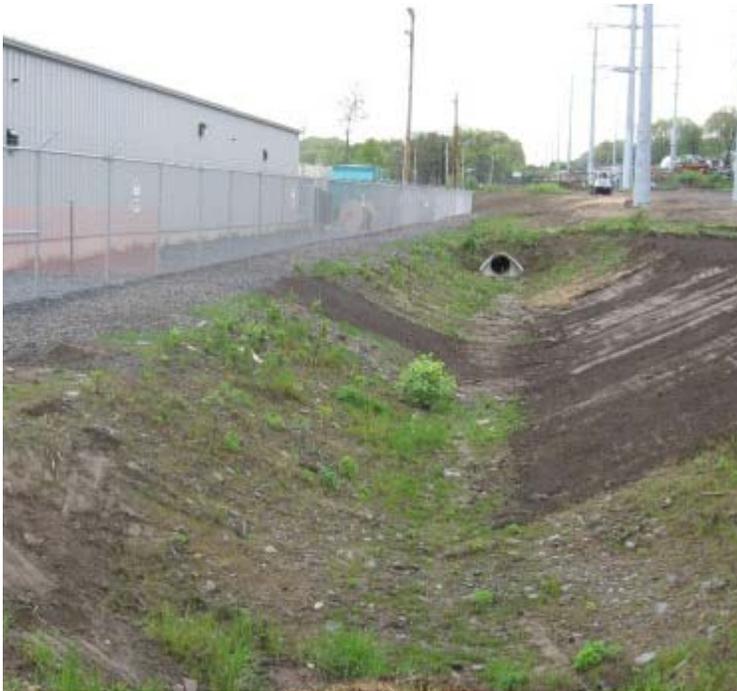
East Devon Substation: A view of the swale located along the eastern boundary of the substation site. Portions of the swale have been re-graded and grass growth was observed. The EC mat has been removed.

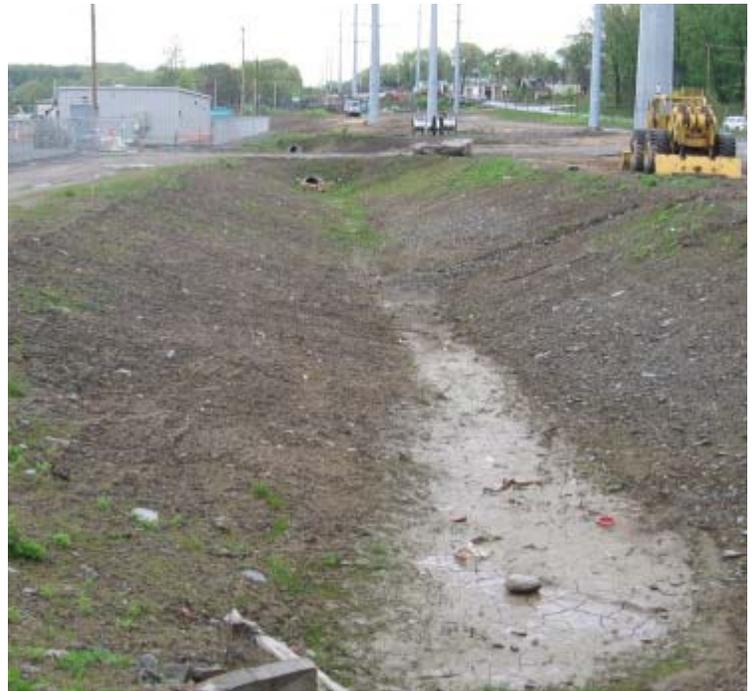
East Devon Substation: A view of the southern portion of the swale.
