Docket No. 272 – Development and Management Plan Inspection

East Devon Substation Inspection

Date: May 16, 2008

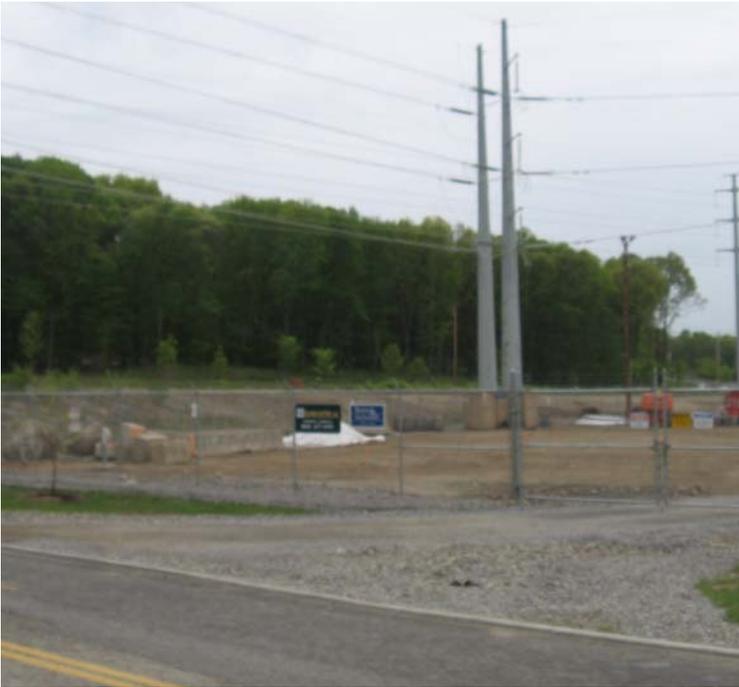
East Devon Substation (Milford): A view of a stone tracking pad at an entrance to the substation off Plains Rd. The spoil pile has been removed from the northeast corner of the substation.

Areas of Inspection	Observation	Recommended Action	Corrected Action
Access Roads and Adjacent Roadways	No sediment tracking/accumulation was noted on Plains Rd this week. 5/16/08	Continue to monitor for sediment tracking, sweep roadways as necessary, and maintain stone access pads at the entrances to reduce tracking. 5/16/08	Not Applicable (NA)
	“Silt Saks” remain intact within the Plains Rd catch basins. Curb inlet protection has not been provided in this area. 5/16/08	Continue to monitor for sediment tracking and clean/replace “Silt saks” when necessary. Provide curb inlet protection and continue to sweep the roadway regularly. See EC Section. 5/16/08	NA
	“Silt saks” remain intact within the Shelland Street catch basins. 5/16/08	Continue to monitor. 5/16/08	NA
Foundation and site construction	Foundation work appears to be complete, but construction continues on site. 5/16/08	None at this time. 5/16/08	NA

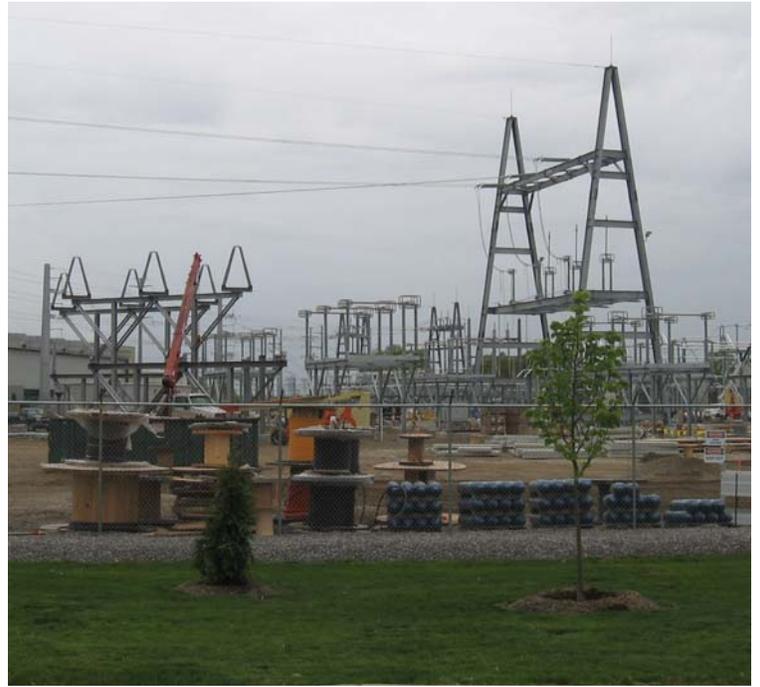
East Devon Substation: A general view of construction at the substation.

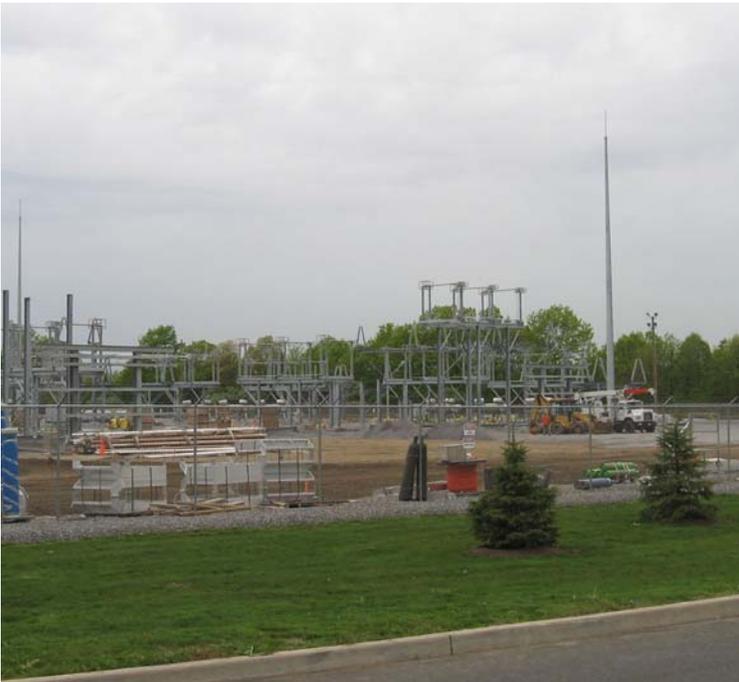
East Devon Substation: An additional view of construction at the substation.

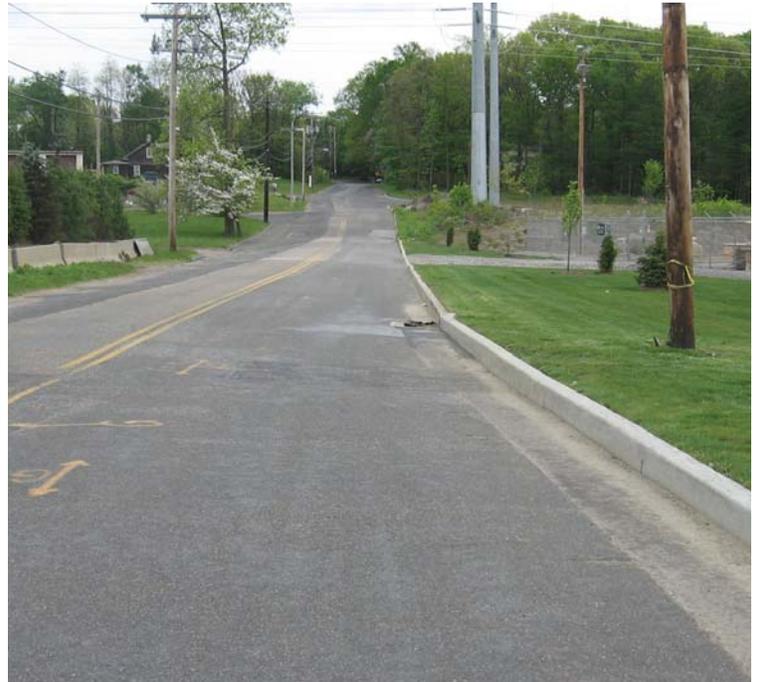
East Devon Substation: A view of Plains Rd. This roadway is swept regularly, "Silt saks" remain within catch basins, but no inlet protection has been provided here.

Erosion and Sediment Controls	The retaining wall continues to contain soils and prevent off site sedimentation. 5/16/08	Continue to monitor and improve controls as necessary. 5/16/08	NA at this time
	“Silt saks” remain intact within the catch basins	Continue to monitor and add controls as necessary.	NA

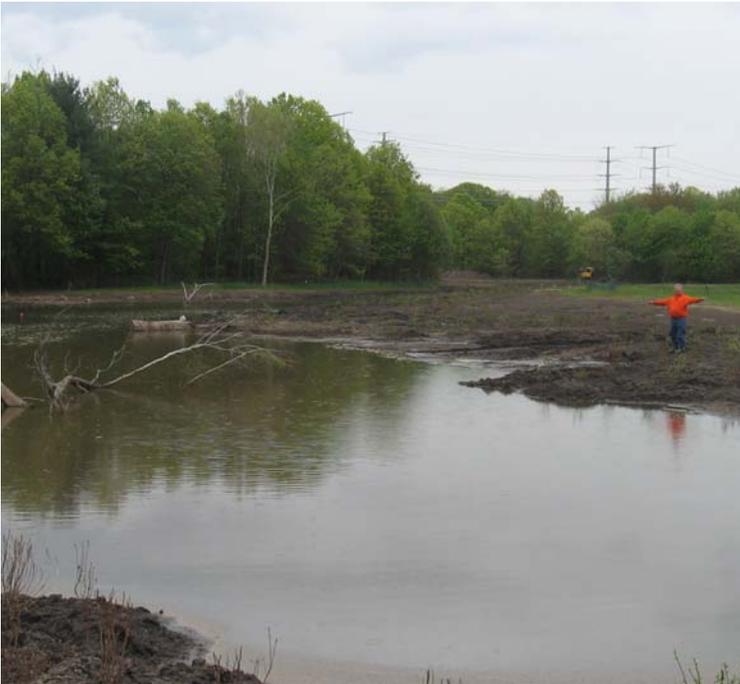
Wetland Mitigation Site (Milford): A view of the southern end of the mitigation site.

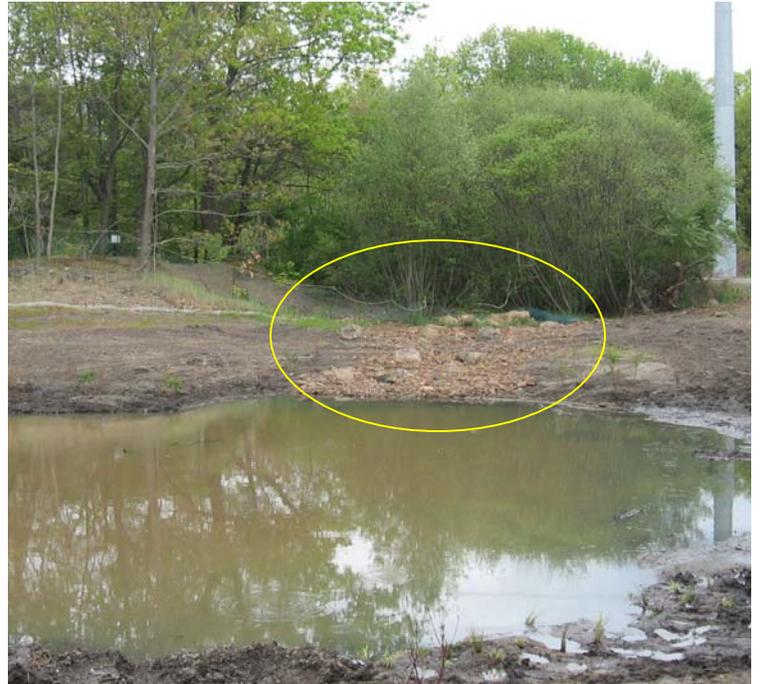
Wetland Mitigation Site: A view of the northern end of the mitigation site. The bank of the mitigation site has been graded and stabilized with stone.

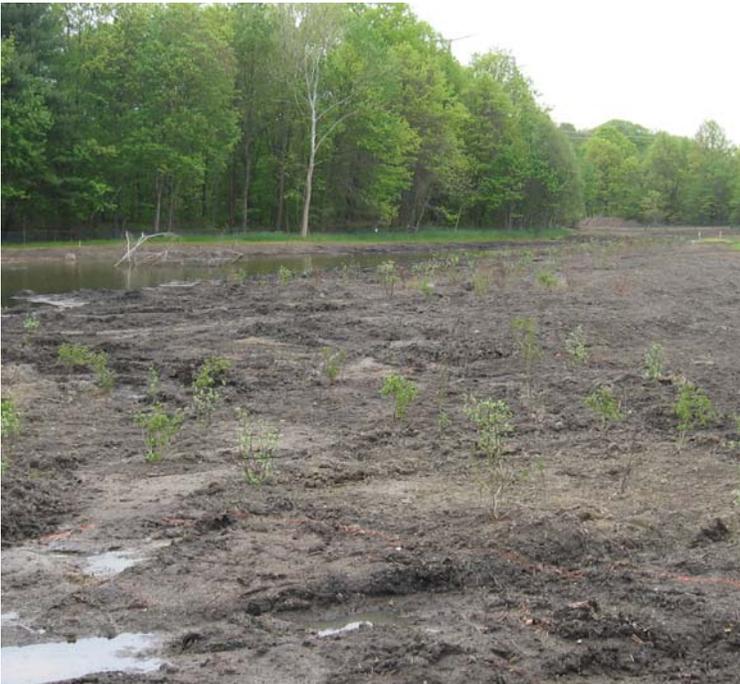
Wetland Mitigation Site: Wetland shrubs and trees have been planted throughout the site.

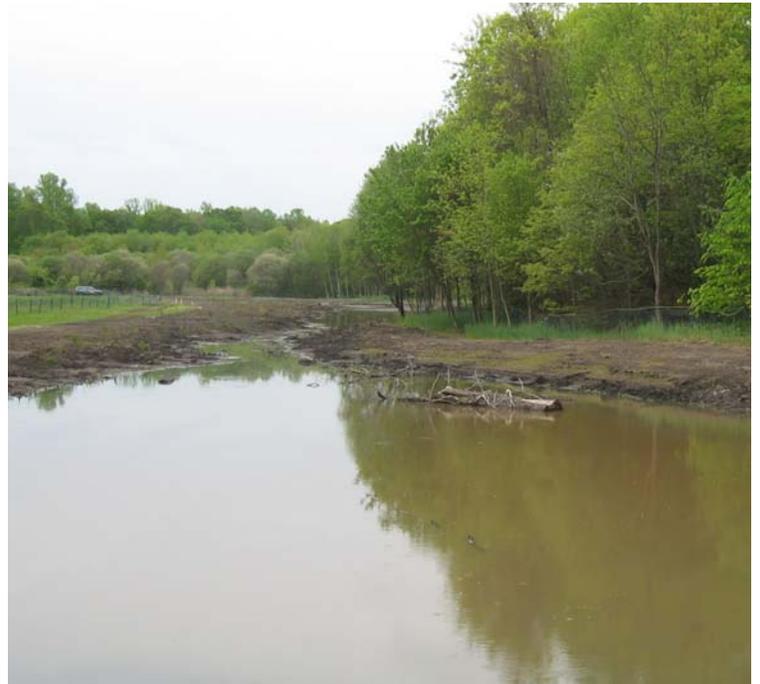
Wetland Mitigation Site: A view of the northern end of the mitigation site.

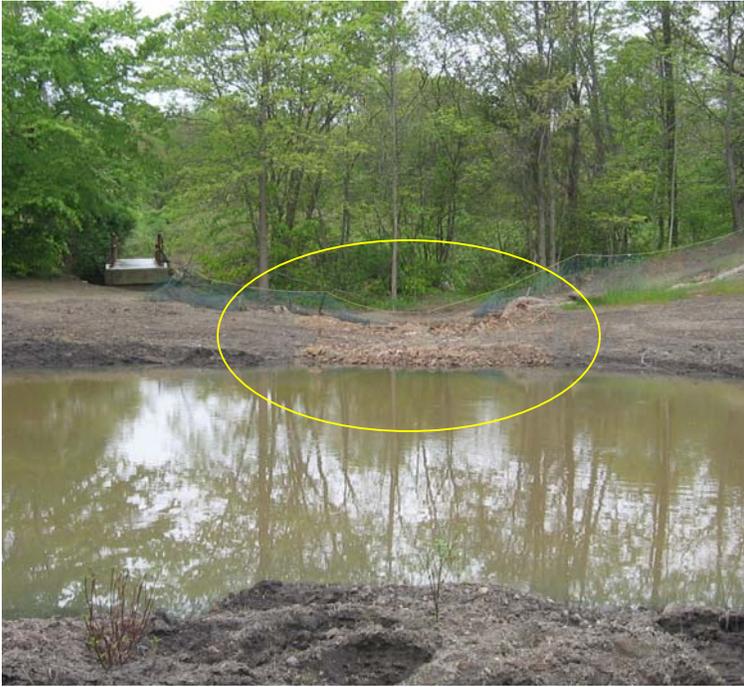
Wetland Mitigation Site: Dry overflow channels have been constructed.

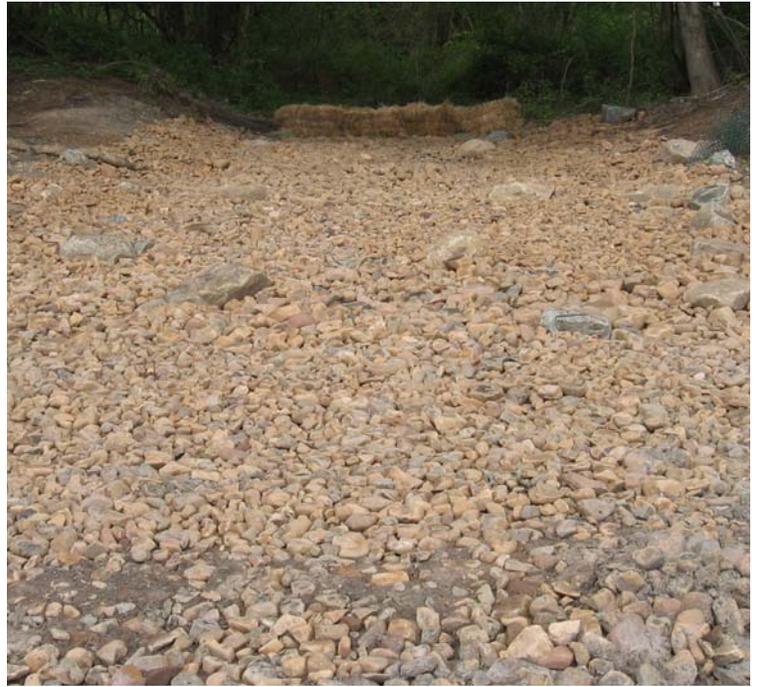
Wetland Mitigation Site: An additional view of the overflow channel.

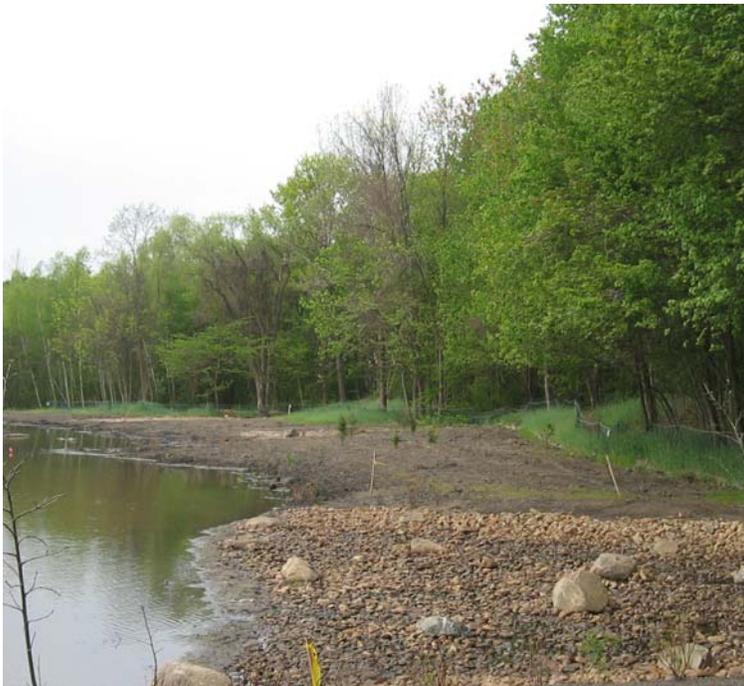
Wetland Mitigation Site: A view of the overflow channel and plantings along the western edge of the mitigation site.

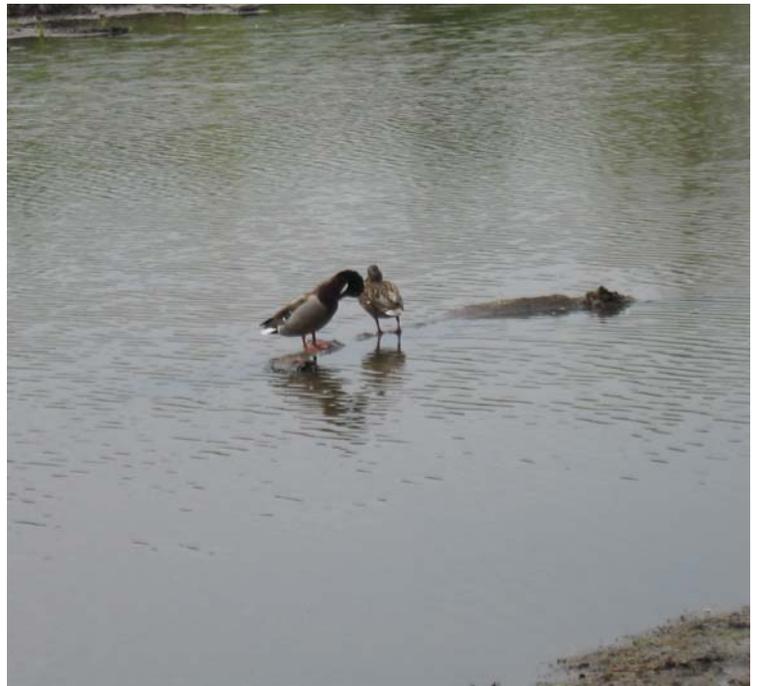
Wetland Mitigation Site: Mallards paired on the mitigation site.
