**Docket No. 272 – Development and Management Plan Inspection**

**East Devon Substation Inspection**

**Date:** June 12, 2008

**Location:** East Devon Substation

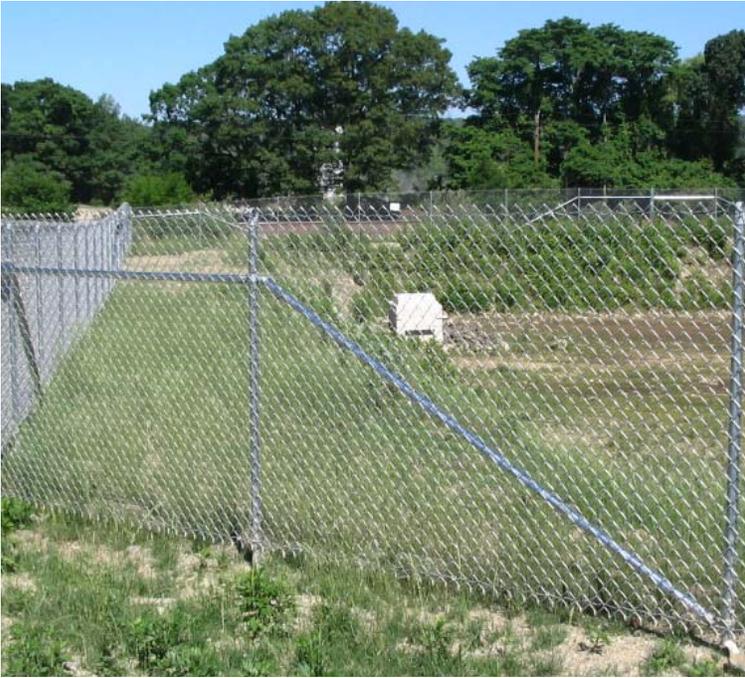
East Devon Substation (Milford): A view of the stormwater detention basin located along the southern boundary of the substation site.

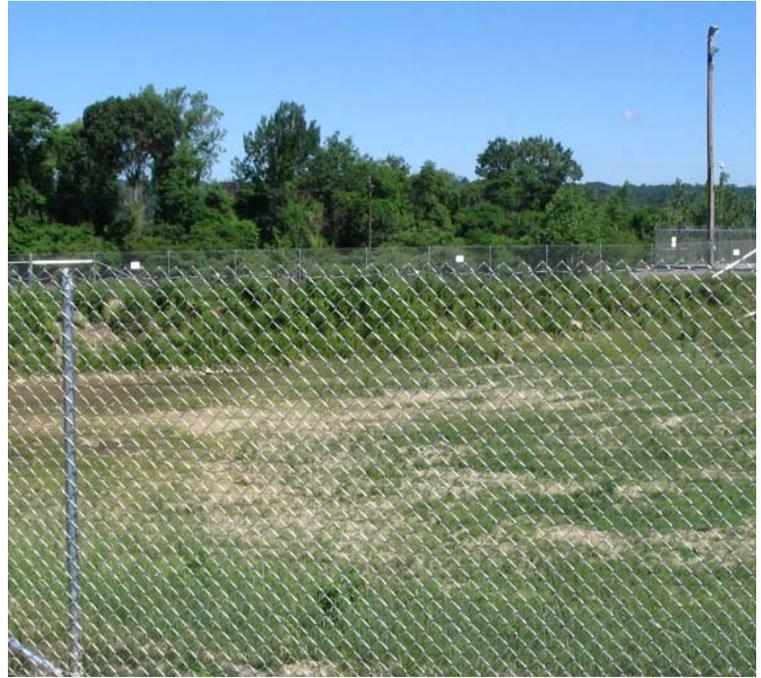
East Devon Substation: An additional view of the detention basin. Vegetation covers approximately 35-40% of the area at this time.

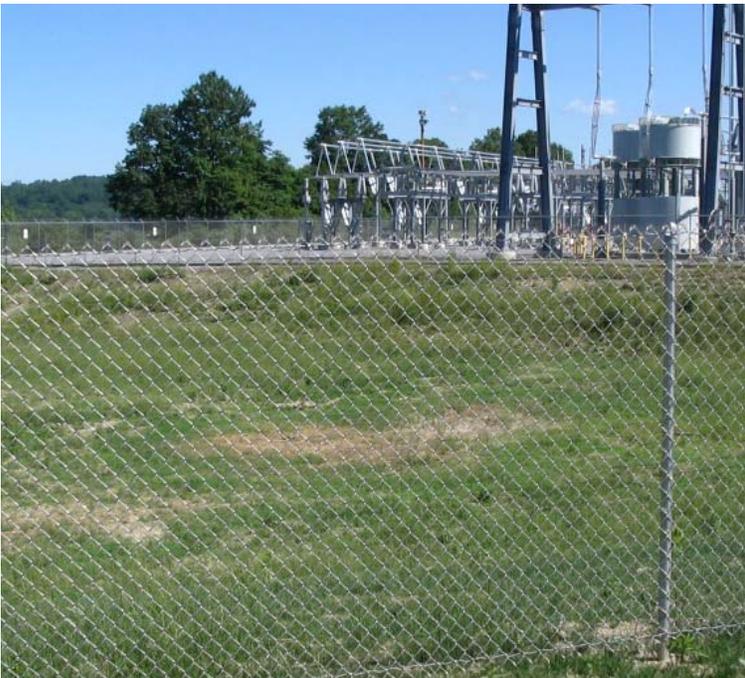
East Devon Substation: An additional view of the detention basin.

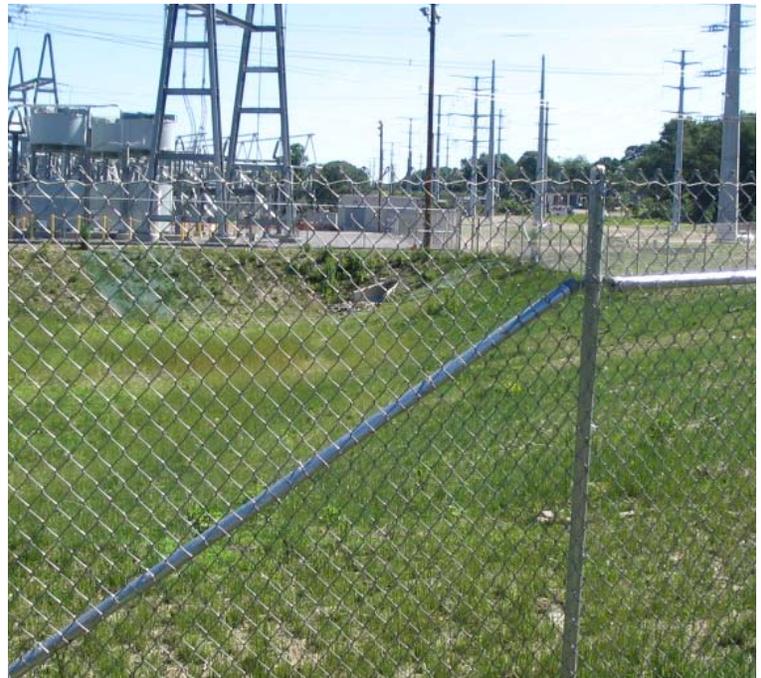
East Devon Substation: An additional view of the detention basin. All slopes appear to be stable at this time.

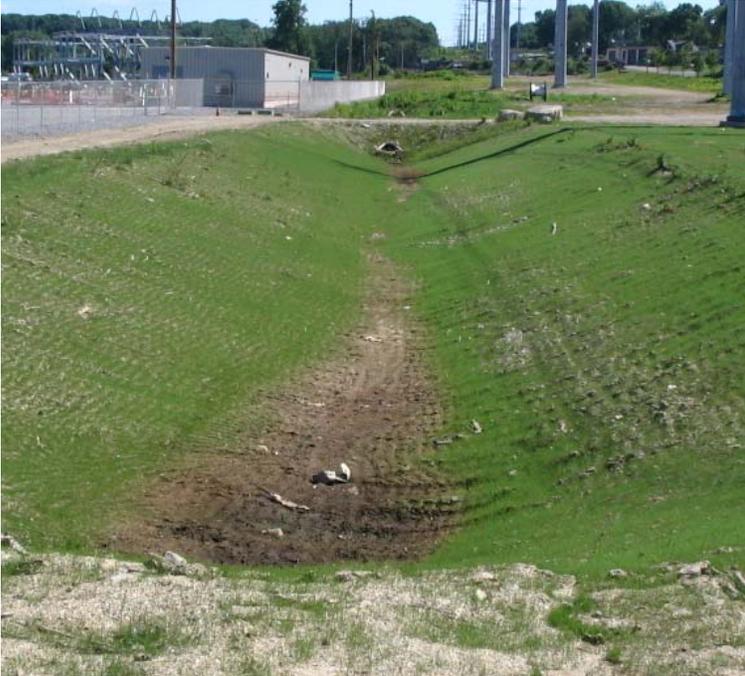
East Devon Substation: A view of the southern portion of the vegetated swale looking north toward Plains Road. Grass growth continues.

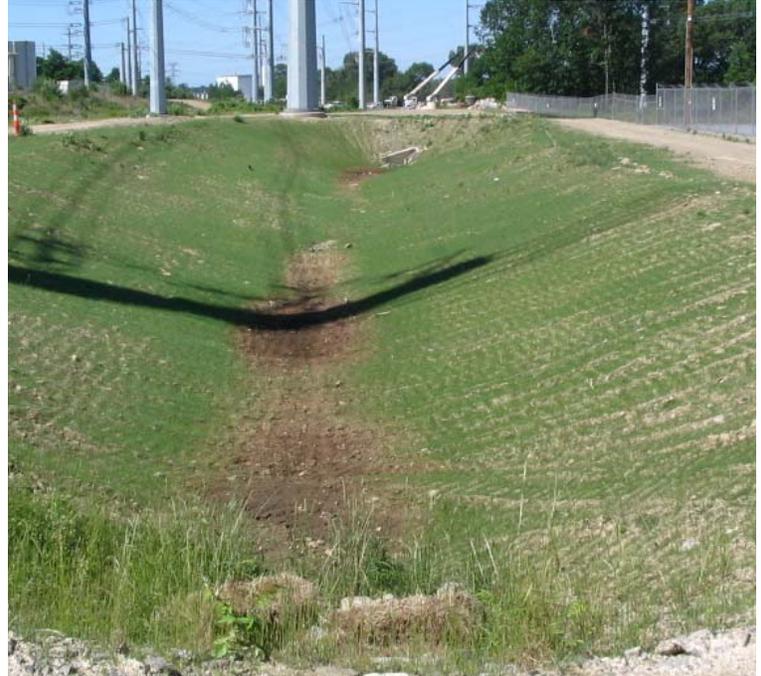
East Devon Substation: A view of the southern portion of the vegetated swale looking south. Vegetation covers approximately 25-30% of this area at this time.

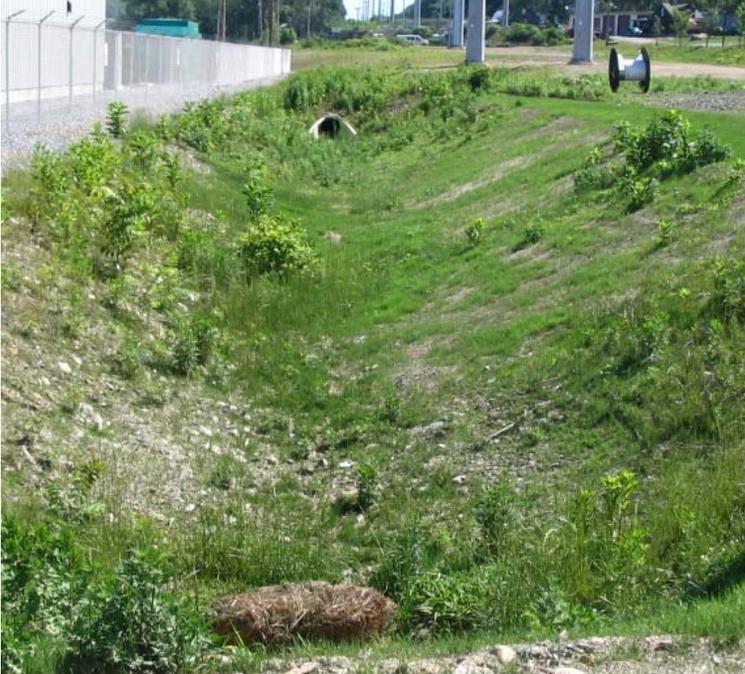
East Devon Substation: A view of the central section of the vegetated swale. Vegetation covers approximately 40-45% of this area at this time.

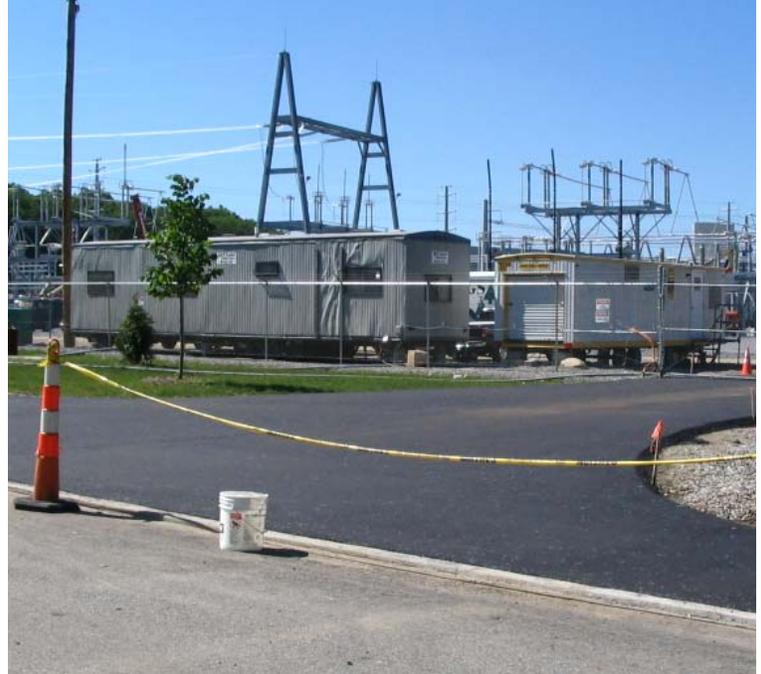
East Devon Substation: The westerly substation access point has been paved with asphalt.
