Docket No. 272 – Development and Management Plan Inspection

East Devon Substation Inspection

Date: June 19, 2008

Location: East Devon Substation

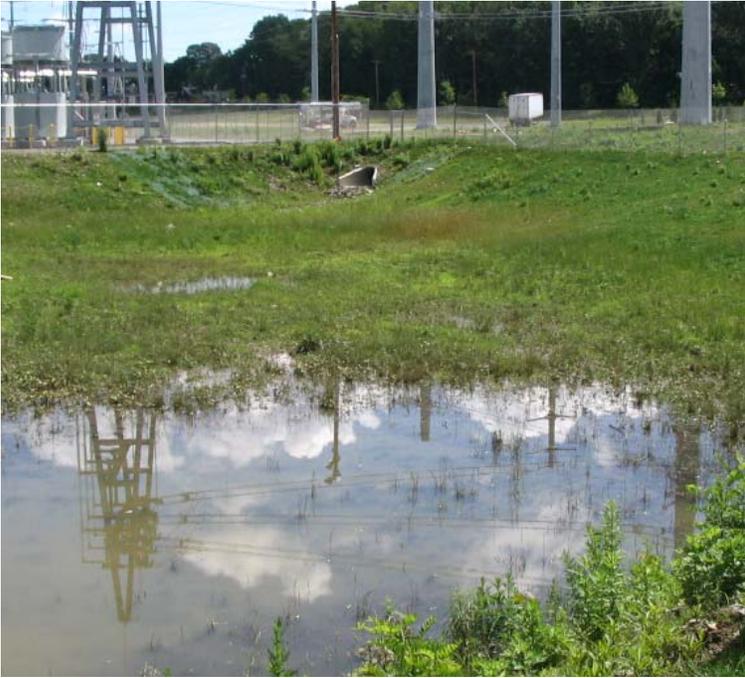
East Devon Substation (Milford): A view of the stormwater detention basin located along the southern boundary of the substation site. Vegetation covers approximately 70-75% of the basin.

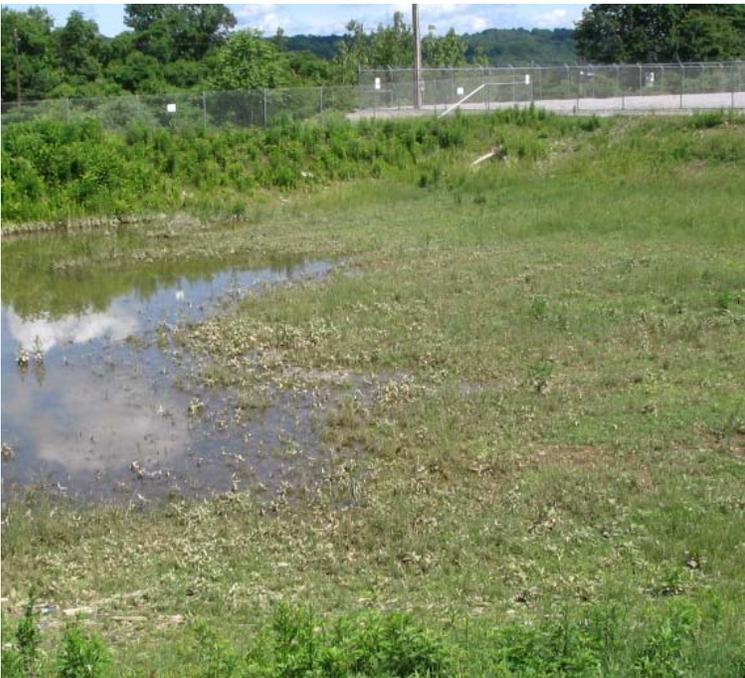
East Devon Substation: A view of the northwestern corner of the detention basin.

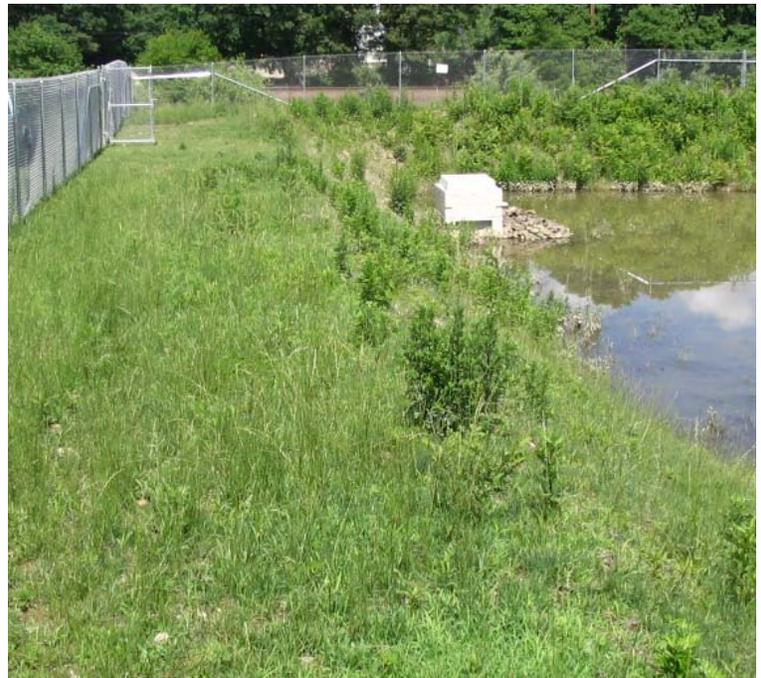
East Devon Substation: A view of the southern slope of the detention basin.

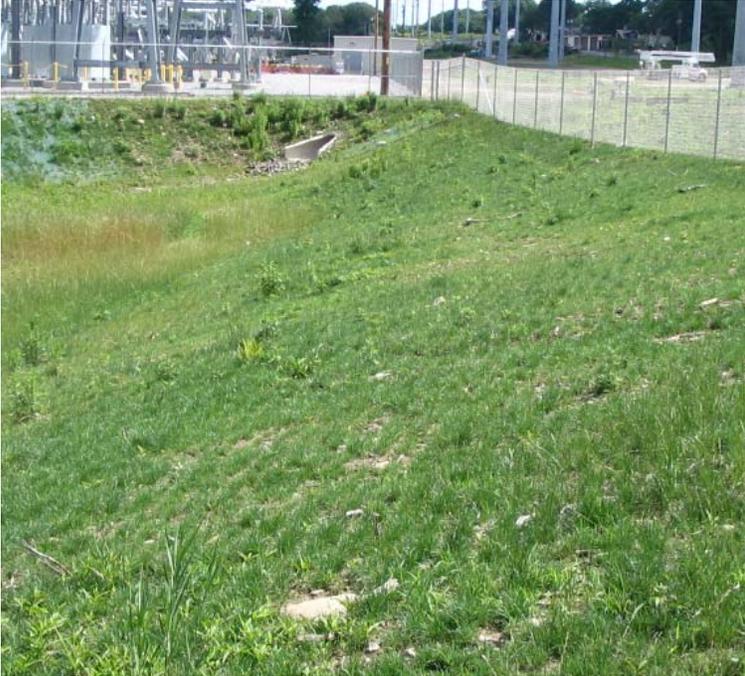
East Devon Substation: A view of the eastern slope of the detention basin.

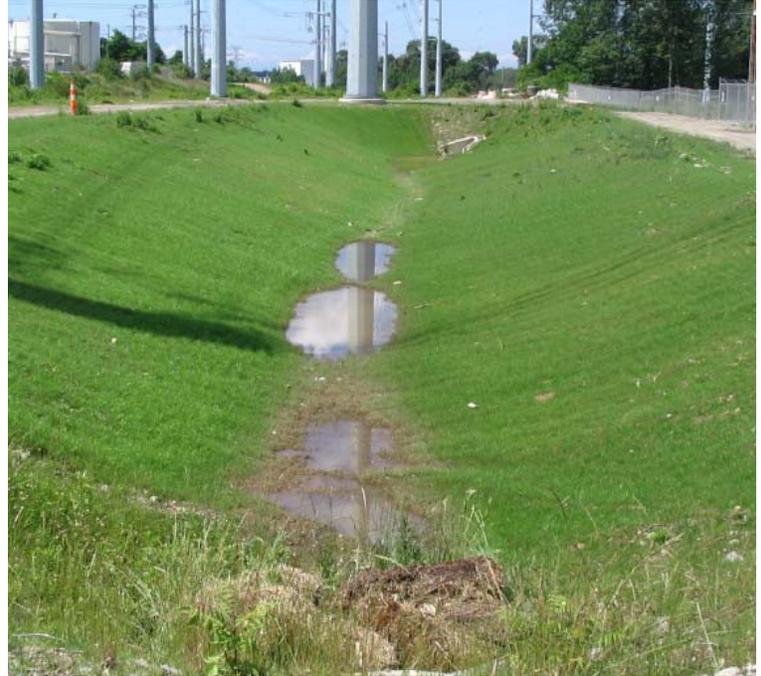
East Devon Substation: A view of the southern portion of the vegetated swale looking south. Vegetation covers approximately 60-65% of this area at this time.

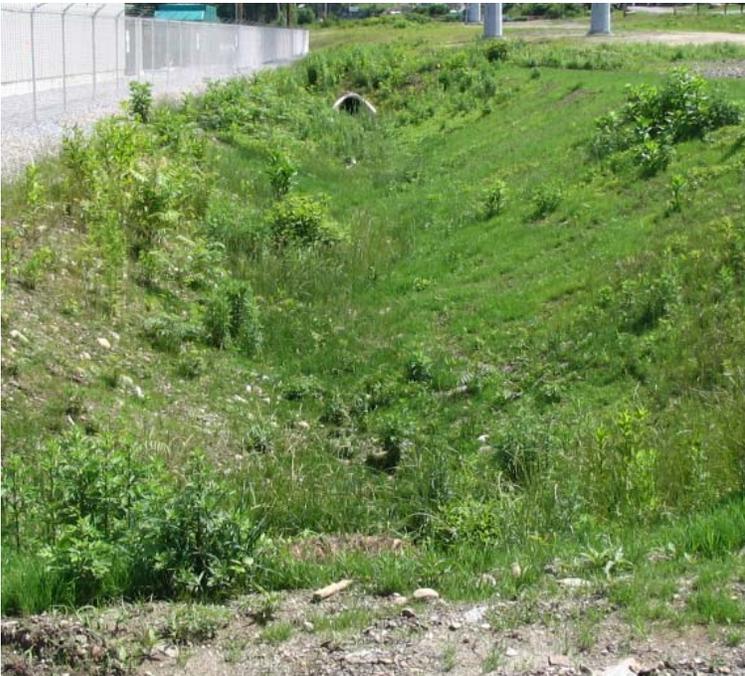
East Devon Substation: A view of the middle portion of the vegetated swale looking north. Vegetation covers approximately 65-70% of this area at this time.

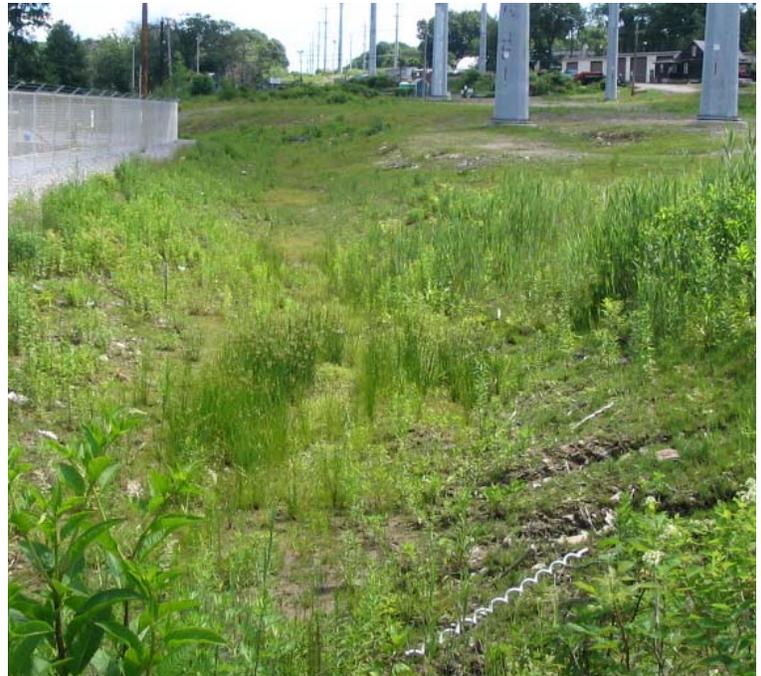
East Devon Substation: A view of the northern portion of the vegetated swale looking north. Vegetation covers approximately 60-65% of this area at this time.
