Docket No. 272 – Development and Management Plan Inspection

East Devon Substation Inspection

Date: July 11, 2008

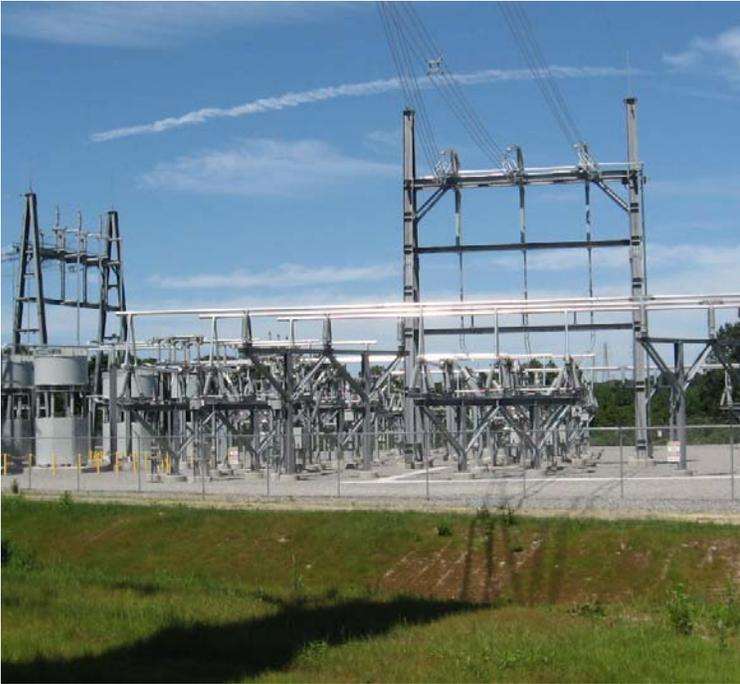
East Devon Substation (Milford): A view of the southern section of the substation. Construction is complete.

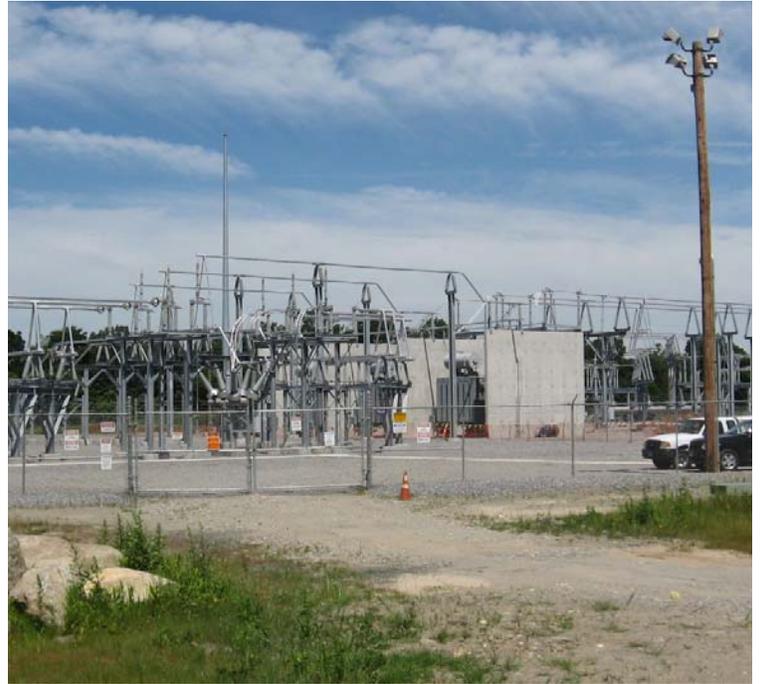
East Devon Substation: A general view of the substation.

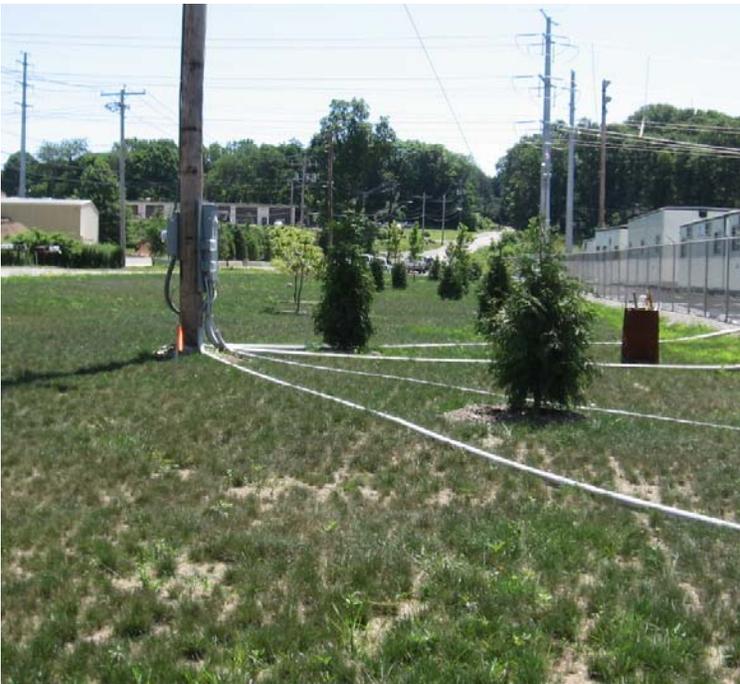
East Devon Substation: A view of the plantings along Plains Road.

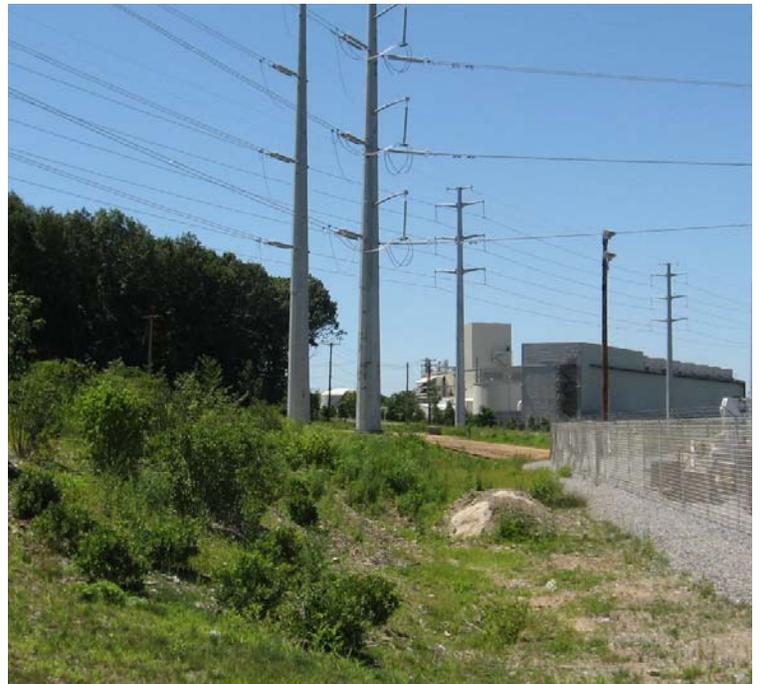
East Devon Substation: A view of the northern portion of the vegetated swale.
