Docket No. 272 – Development and Management Plan Inspection

Norwalk Substation

Date: May 8, 2008

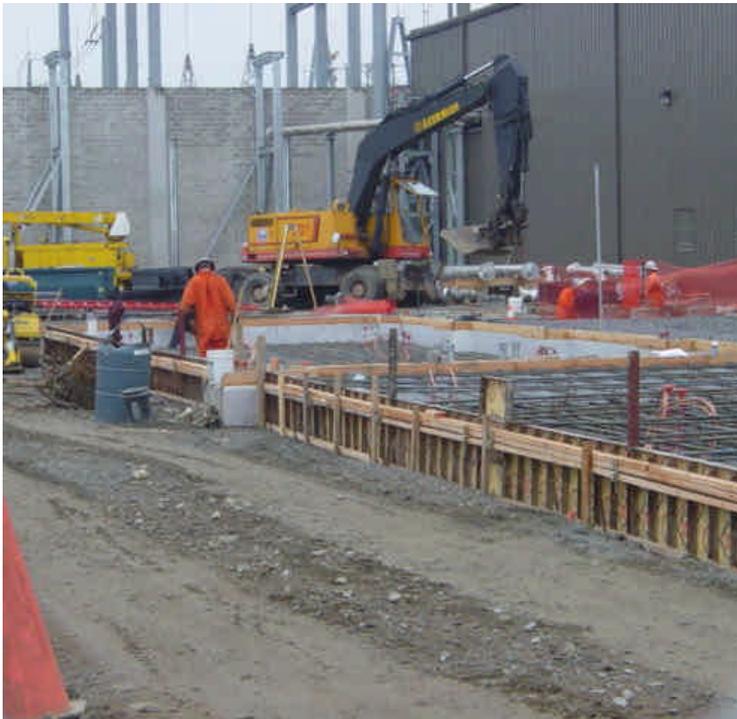
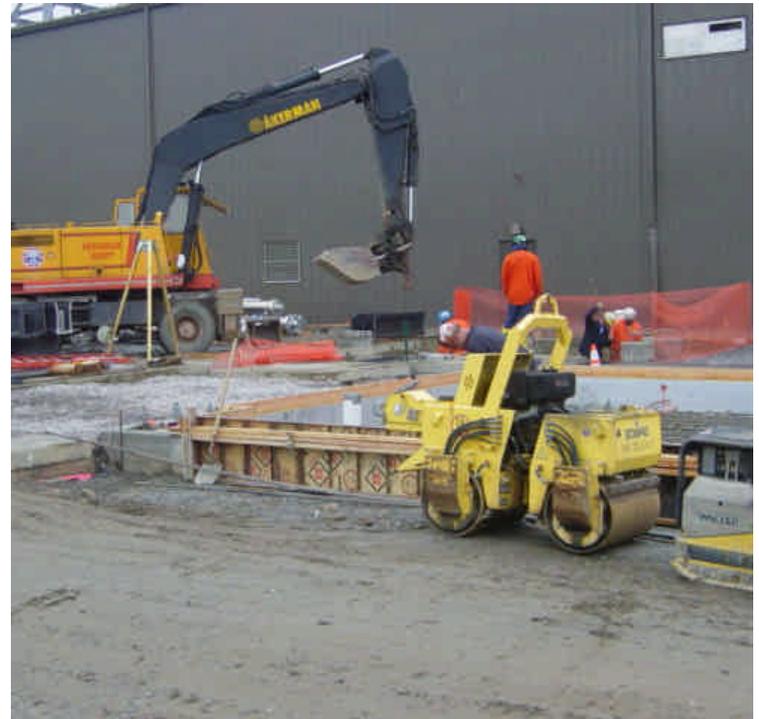
Formwork has been installed within the Norwalk Substation yard and crews were placing and tying rebar at the time of the inspection.

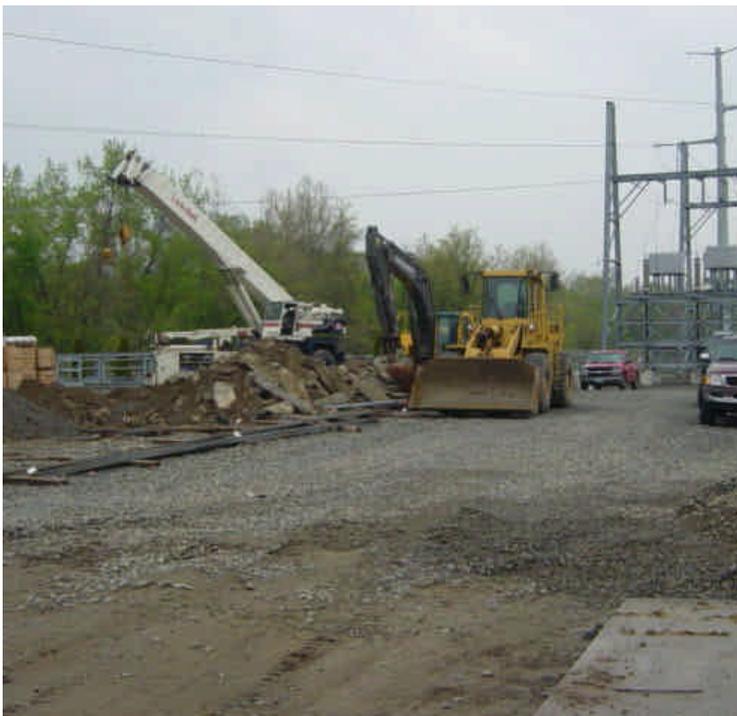
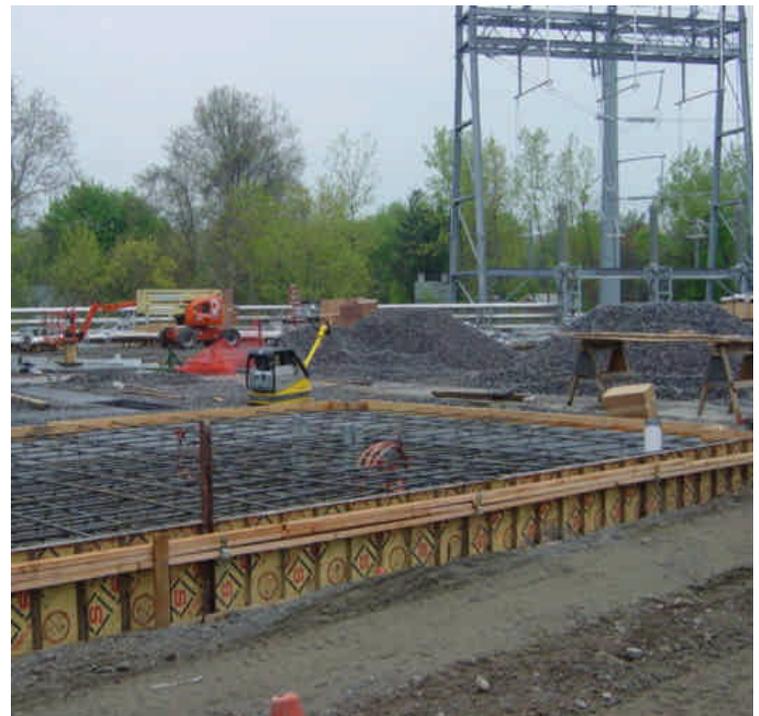
Areas of Inspection	Observation	Recommended Action	Corrected Action
Spills and Material Storage	<p>Equipment appeared to be appropriately stored. 5/8/08</p> <p>Several stockpiles of material were observed without appropriate containment immediately at their base but they were located within the yard and surrounded with trap rock. 5/8/08</p>	<p>In general, provide regular equipment checks and repair any drips or leaks as soon as they are observed. 5/8/08</p> <p>Provide adequate containment around temporary soil stockpiles. 5/8/08</p>	<p>NA</p> <p>Needs evaluation.</p>
Additional Observations	None. 5/8/08	None. 5/8/08	NA

Several material stockpiles were observed within the Norwalk Substation without proper containment immediately at their base. Crushed rock remains over most surfaces of the yard and there did not appear to be any sediment issues related to the stockpiles.
