**Docket No. 272 – Development and Management Plan Inspection**

**Norwalk Substation**

**Date:** May 29, 2008

**Location:** Norwalk Substation - 50 New Canaan Avenue, Norwalk, CT

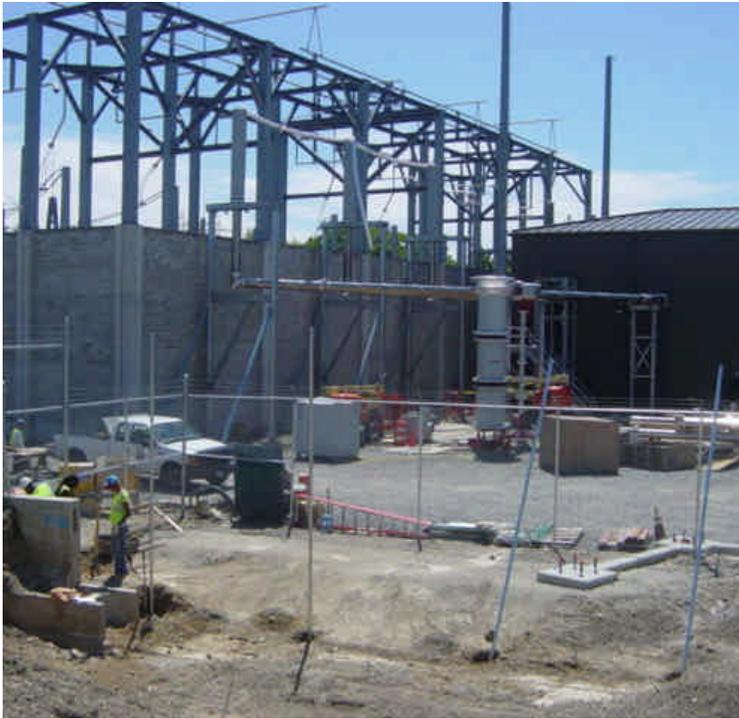
**Electrical connection and tie-in work continues inside the substation.**

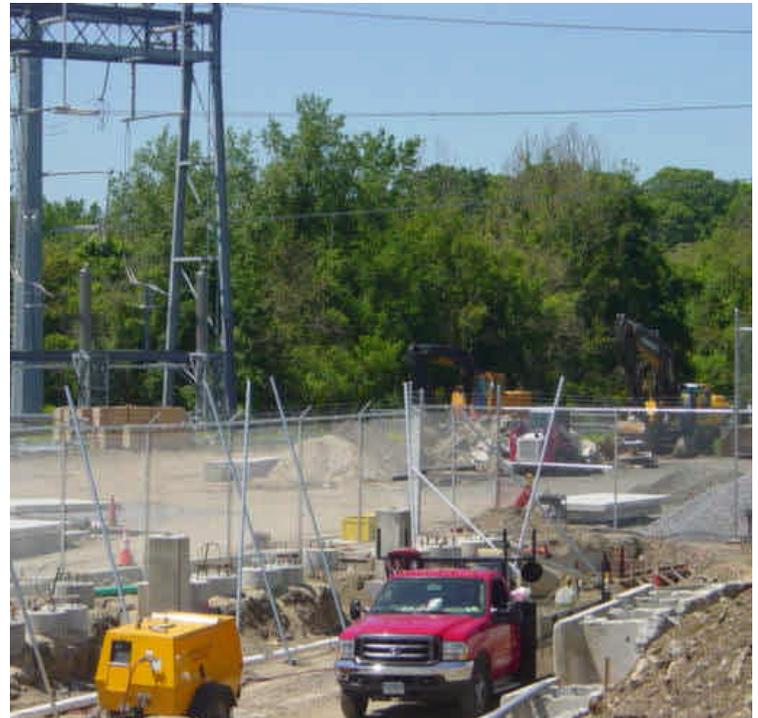
**Stockpiles remain adjacent to the work area but there were no observed erosion issues. Watch any adjacent catch basins within the yard as they outlet to the river.**

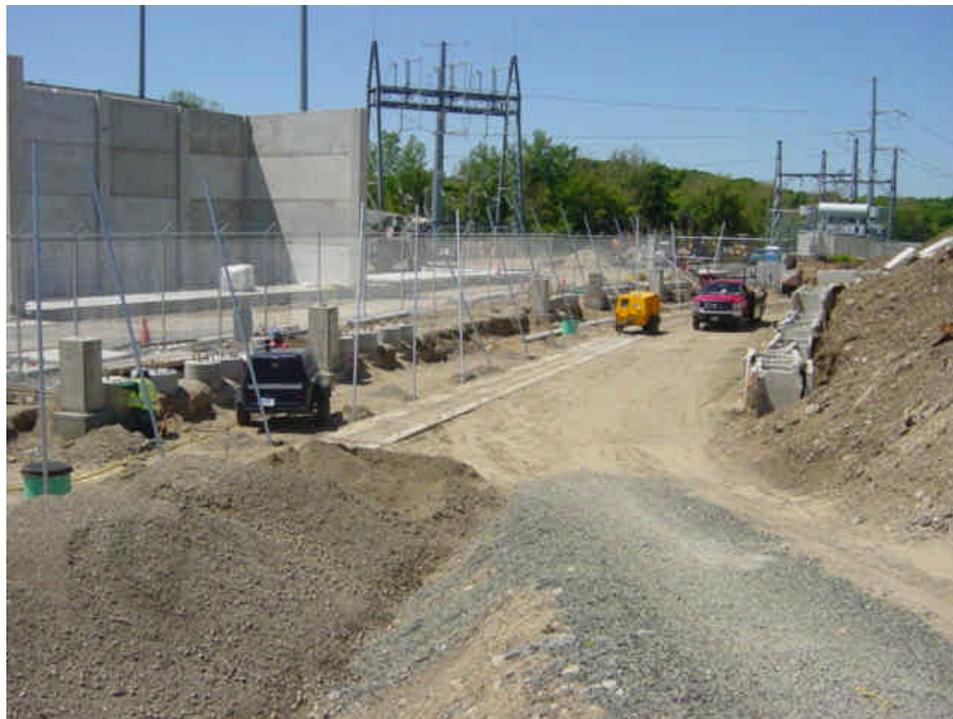
**Seg 4C work: The conduits have been tied in to the termination structures and the trench has been backfilled. Crews were relocating the perimeter fence surrounding the substation to encompass the newly placed foundations.**
