Docket No. 272 – Development and Management Plan Inspection

Norwalk Substation

Date: June 6, 2008

Location: Norwalk Substation - 50 New Canaan Avenue, Norwalk, CT

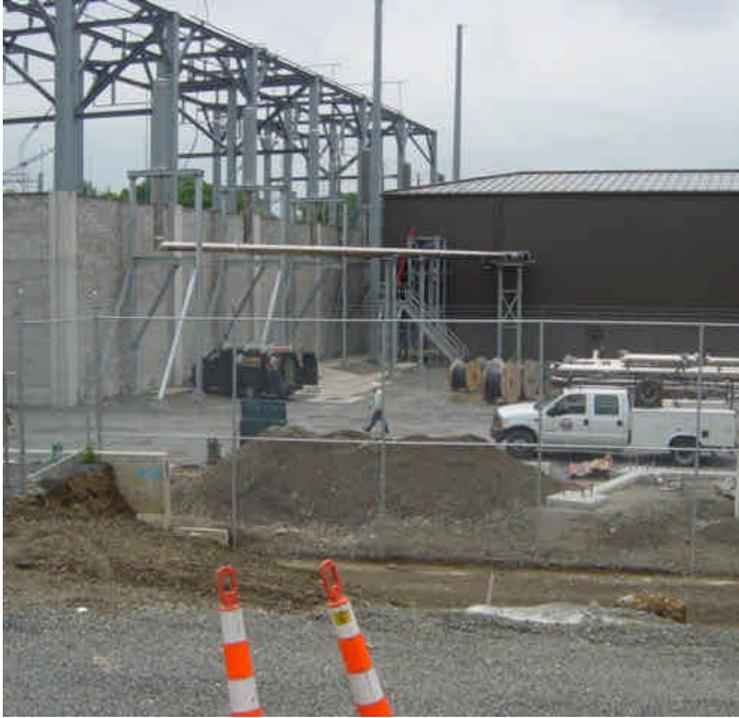
| Areas of Inspection | Observation | Recommended Action | Corrected Action |
|---|--|---|---|
| Active Construction | Electrical connection and tie-in work was on going as well as some minor excavation. The perimeter fence has been relocated to encompass the terminal foundation structures. 6/6/08 | None. 6/6/08 | Not Applicable (NA) |

Electrical connection and tie-in work continues inside the substation yard.

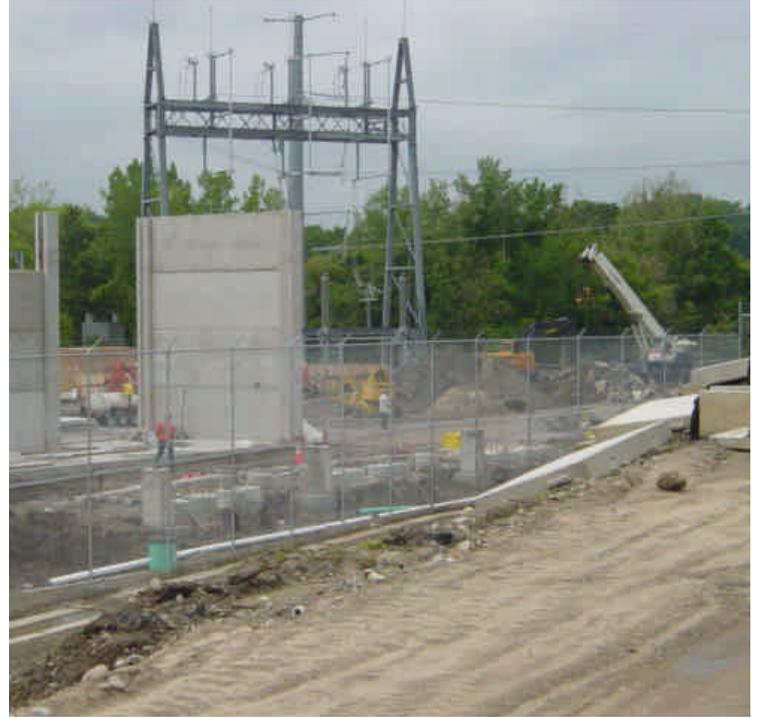
| Areas of Inspection | Observation | Recommended Action | Corrected Action |
|---|--|---|--|
| Spills and Material Storage | <p>Equipment appeared to be appropriately stored. 6/6/08</p> <p>Several stockpiles of material were observed without appropriate containment immediately at their base but they were located within the yard and surrounded with trap rock. 5/8-6/6/08 However, catch basins/inlets that drain to the River are present in the yard and need to be monitored. 6/6/08</p> | <p>In general, provide regular equipment checks and repair any drips or leaks as soon as they are observed. 6/6/08</p> <p>Provide adequate containment around temporary material stockpiles or cover the material with tarps. 5/8-6/6/08</p> <p>Consider controls in the inlets if controls are not used at the base of stockpiles. 6/6/08</p> | <p>NA</p> <p>Needs evaluation.</p> |

Stockpiles remain adjacent to the work area but there were no observed erosion issues. Watch any adjacent catch basins within the yard as they outlet to the river.

| Areas of Inspection | Observation | Recommended Action | Corrected Action |
|--|---|---|---|
| | <p>resource areas. Some soil is exposed during minor excavation. 6/6/08</p> <p>Catch basin/inlets are present in the yard that outlet to the Norwalk River. Watch placement of stockpiles or exposed soil. 6/6/08</p> | <p>the majority of civil –site work but has since been removed. 6/6/08</p> <p>Protect inlets with controls or place controls at base of stockpiles if necessary. 6/6/08</p> | Needs evaluation. |

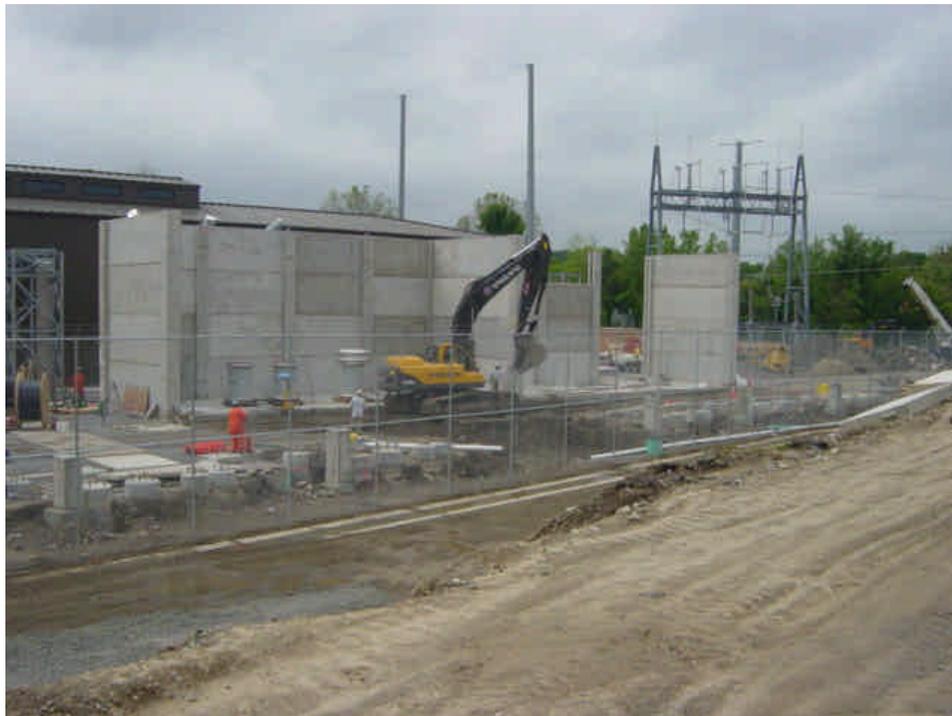
Minor excavation work was underway inside the substation. The perimeter fence surrounding the substation has been relocated to encompass the newly placed foundations.
