Docket No. 272 – Development and Management Plan Inspection

Norwalk Substation

Date: July 2, 2008

Location: Norwalk Substation - 50 New Canaan Avenue, Norwalk, CT

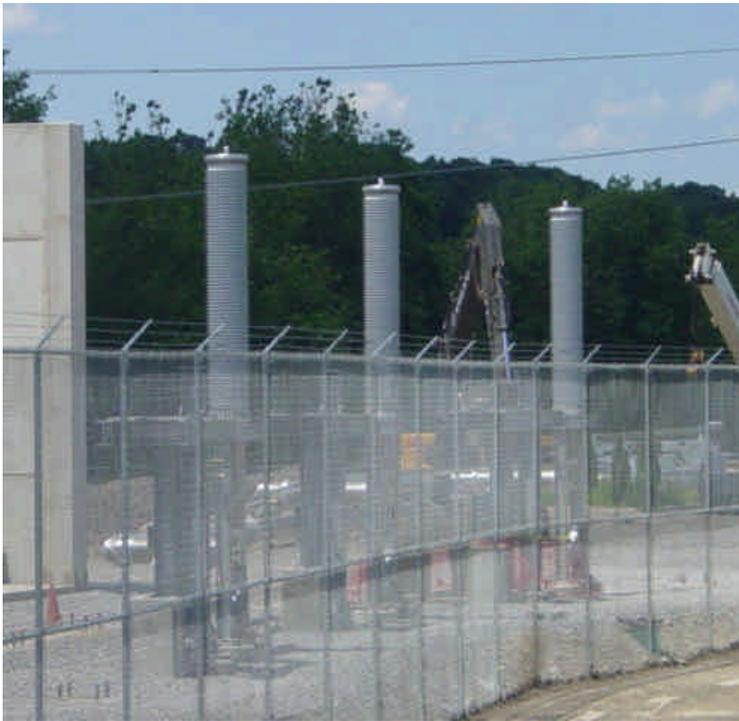
Work continues within the Norwalk substation. Crews were installing additional electrical equipment.

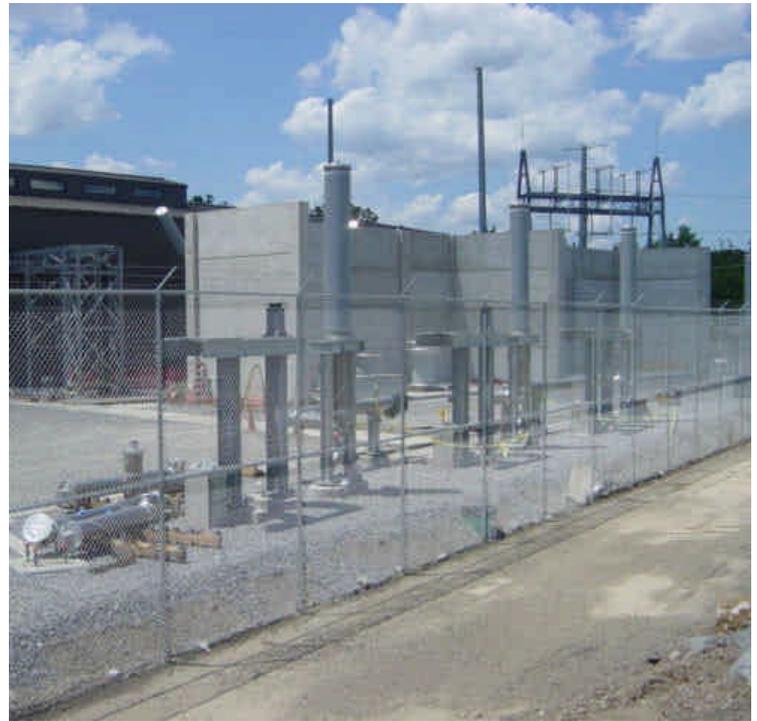
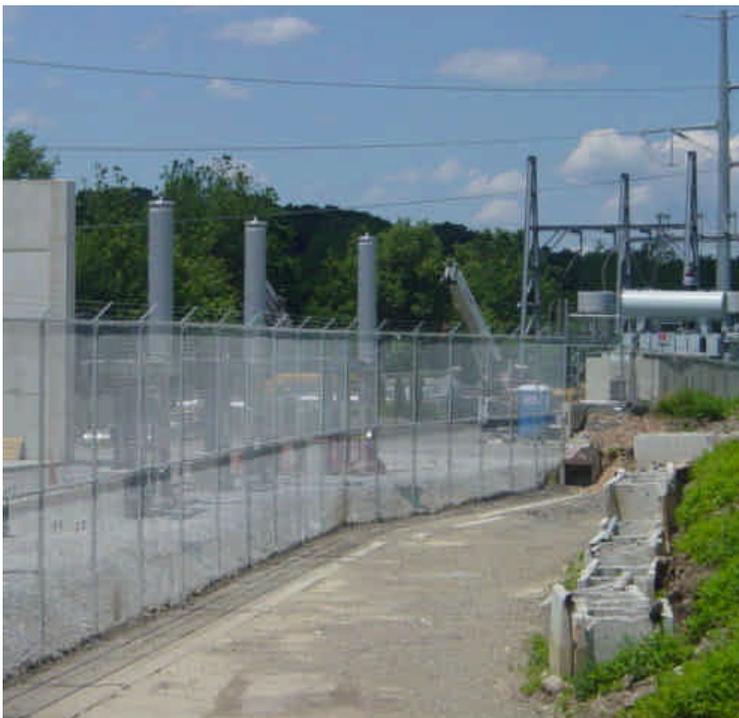
Tie-in work with 4C has been completed at the Norwalk substation. The pre-cast concrete wall needs to be restored.

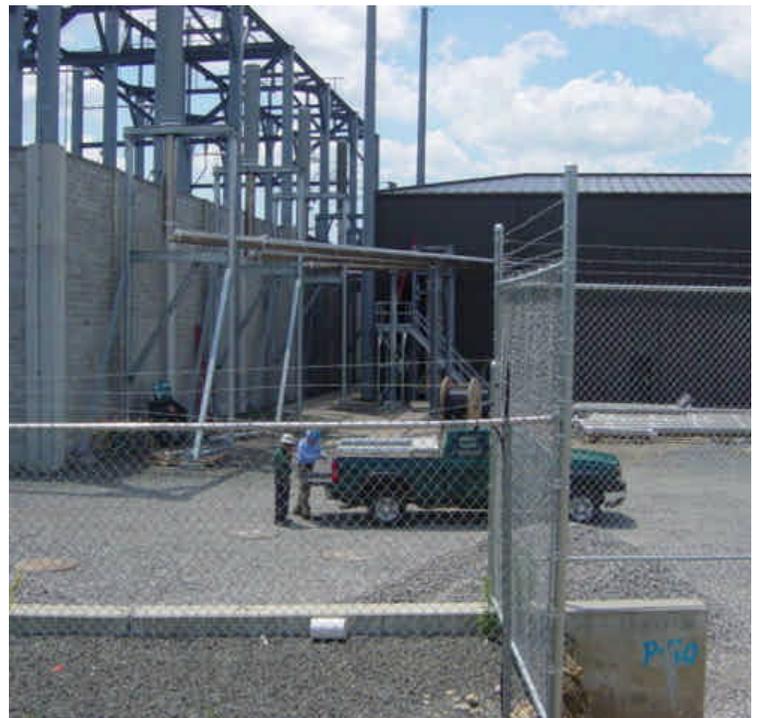
Electrical contractors continue to install conduits and pull wire.
