**Docket No. 272 – Development and Management Plan Inspection**

**Norwalk Substation**

**Date:** September 12, 2008

**Location:** Norwalk Substation - 50 New Canaan Avenue, Norwalk, CT

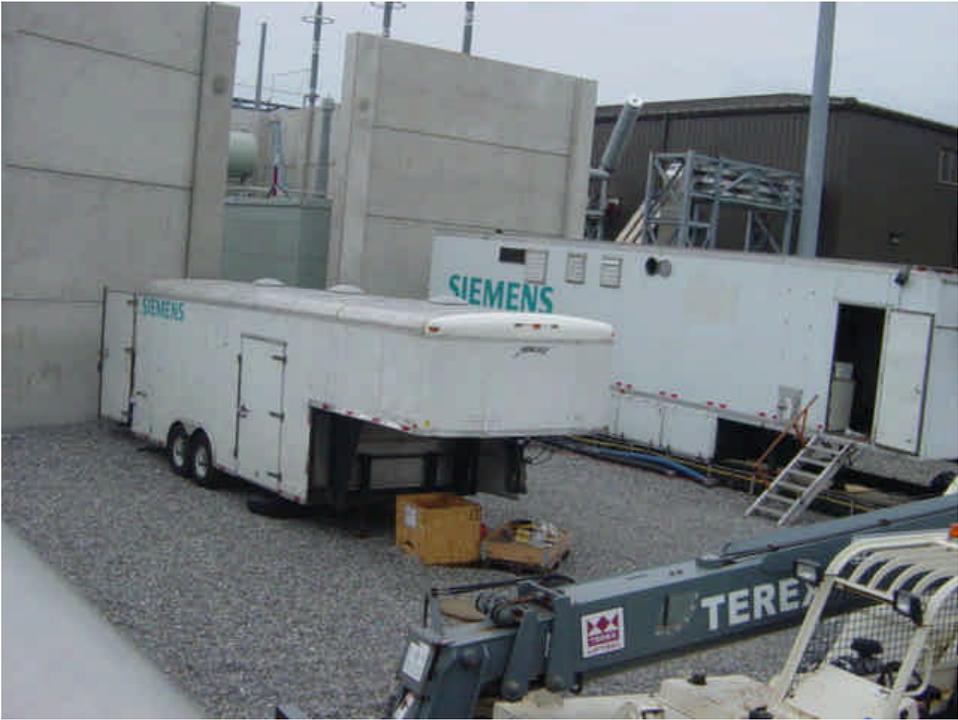
**Electrical work continues inside the substation.**

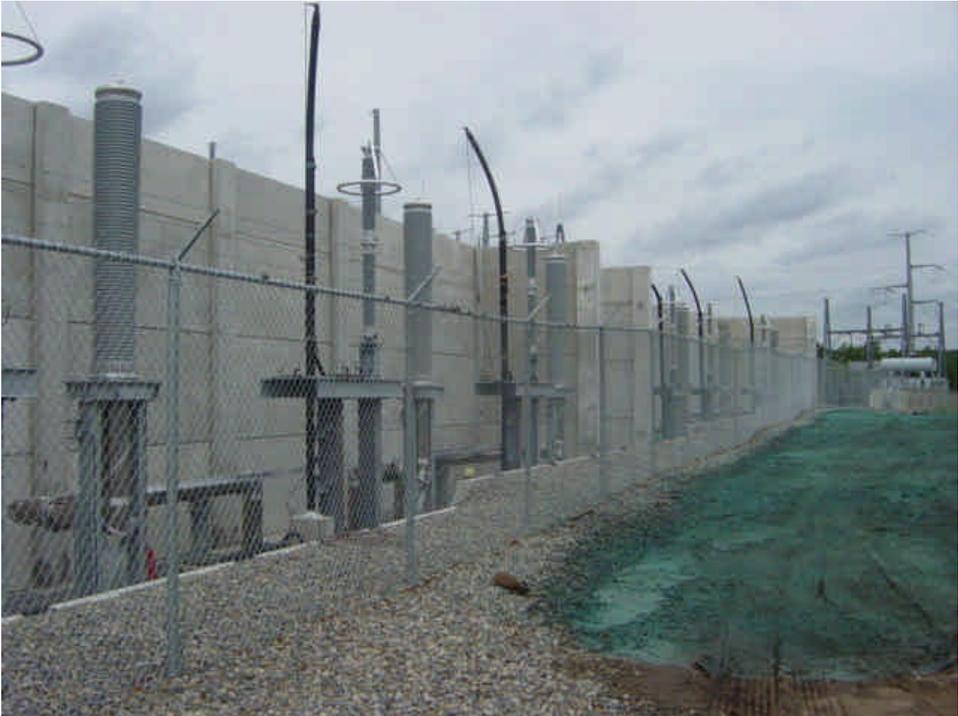
**Electrical connection and tie-in work continues inside the substation.**
