**Docket No. 272 – Development and Management Plan Inspection**

**Norwalk Substation**

**Date:** October 10, 2008

**Location:** Norwalk Substation - 50 New Canaan Avenue, Norwalk, CT

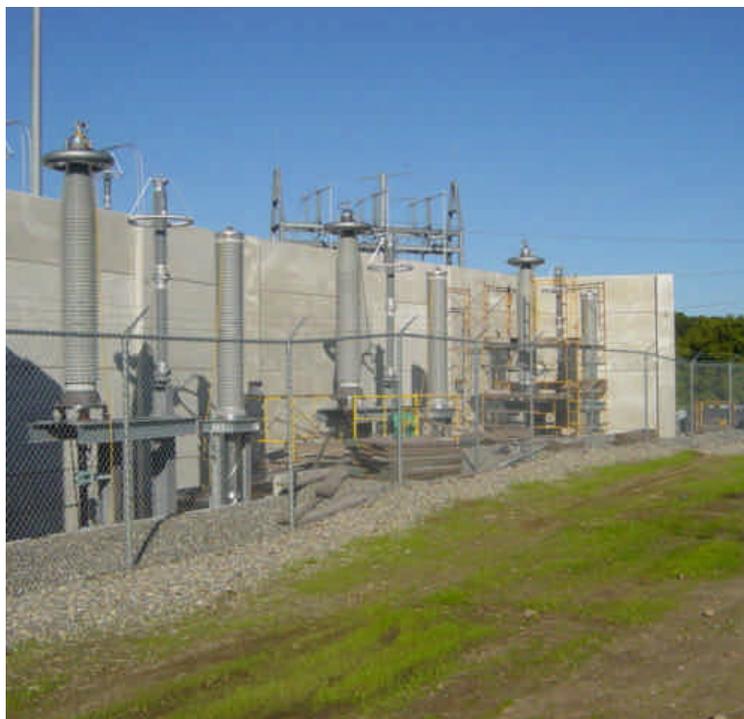
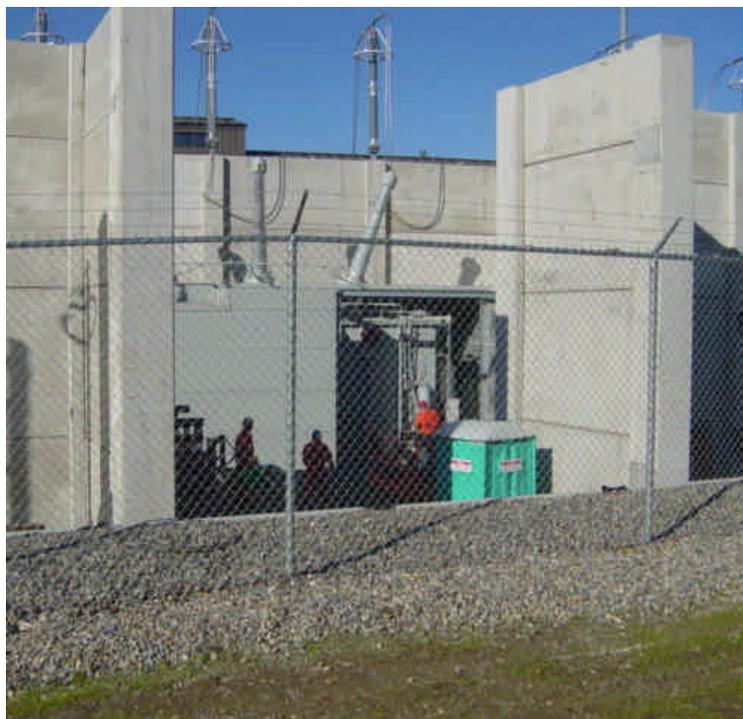
**Tie-in work continues inside Norwalk substation.**

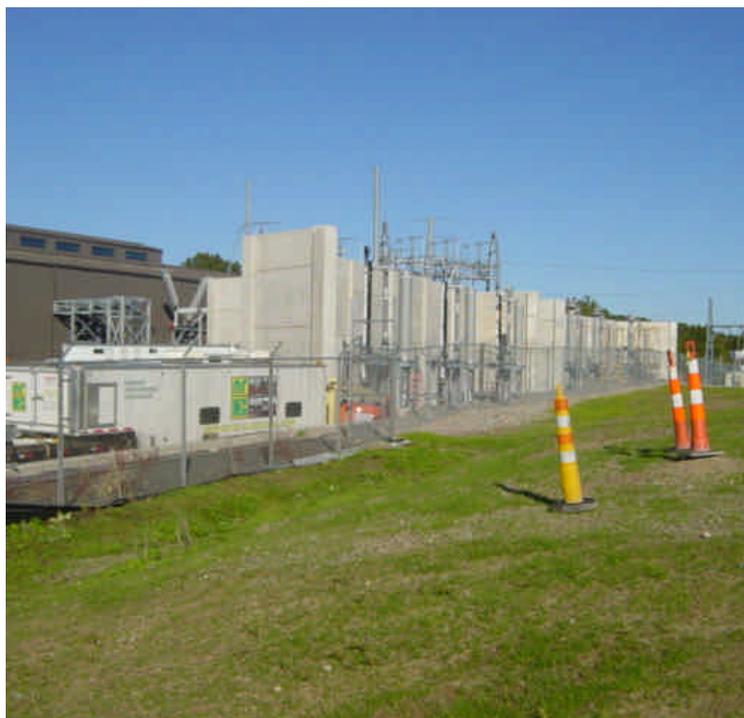
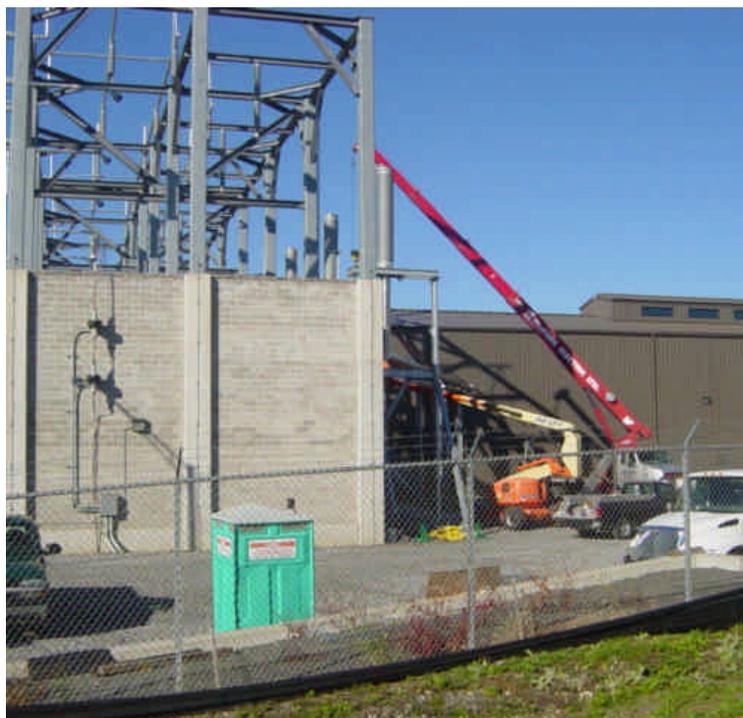
**Tie-in work continues inside Norwalk substation. New River Electric was on-site performing work.**
