Docket No. 272 – Development and Management Plan Inspection

Segment 1a Inspection

Date: January 7, 2008

Location: Segment 1a – Scovill Rock Switching Station to Chestnut Junction, Oxbow Junction to Beseck Switching Station (excluding Royal Oak Bypass), and Black Pond Junction to Beseck Switching Station

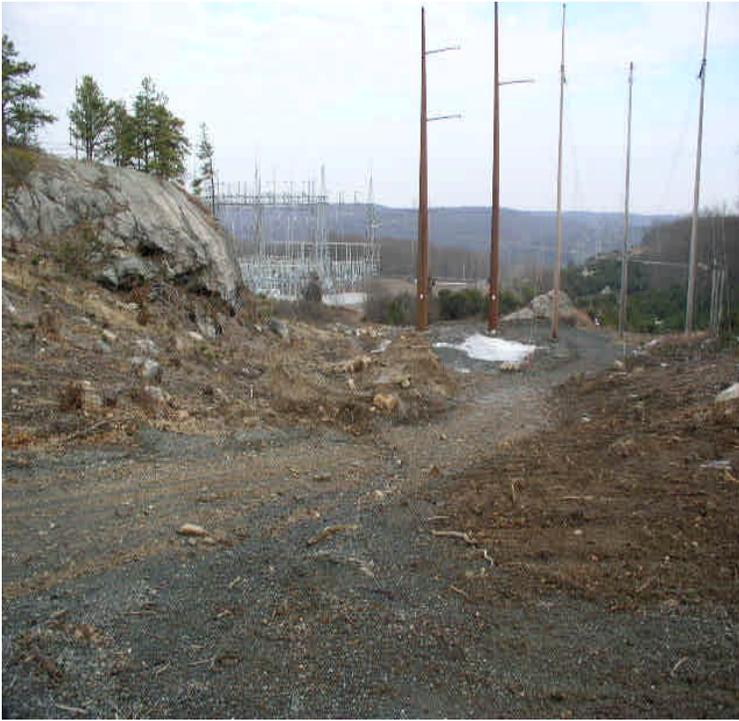
West of Scovill SS: Drainage ditch installed within the access road. Small stockpiles noted in this area.

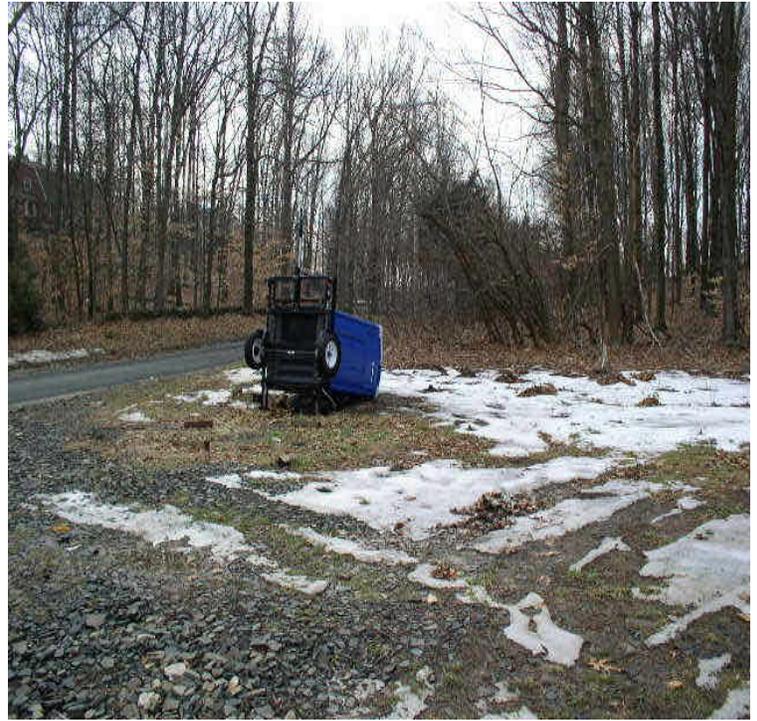
Areas of Inspection	Observation	Recommended Action	Corrected Action
Oxbow Junction to Beseck SS Arbutus St.	Sanitary facility has tipped over at the ROW entrance in this location. 12/17-1/7/08	containment near wetlands. Remove the material once work is complete. 1/7/08 Secure the facility and clean the spill appropriately. 12/17-1/7/08	Needs attention.
Contractor Receiving Yard and Staging Area	Materials are being stored and structures staged in this area. Fuel tanks are not present. 1/7/08	Continue to locate hazardous materials and equipment away from wetland inlets such as culverts and CBs. 1/7/08	NA
Little Lane	Stockpiles from other sites were being stored here. 11/26-1/7/08	Add controls if soil is to remain here. 11/26-1/7/08	Needs attention if soil remains.
Black Pond Junction to Beseck SS	Some equipment and supplies are being stored here. A large spill kit is stored onsite. 1/7/08	Always store equipment and supplies away from sensitive areas. Monitor and maintain equipment as needed and provide housekeeping on a regular basis. 1/7/08	NA at this time

Arbutus St: Sanitary facility has tipped over. Secure the facility and clean up any affected soil appropriately.

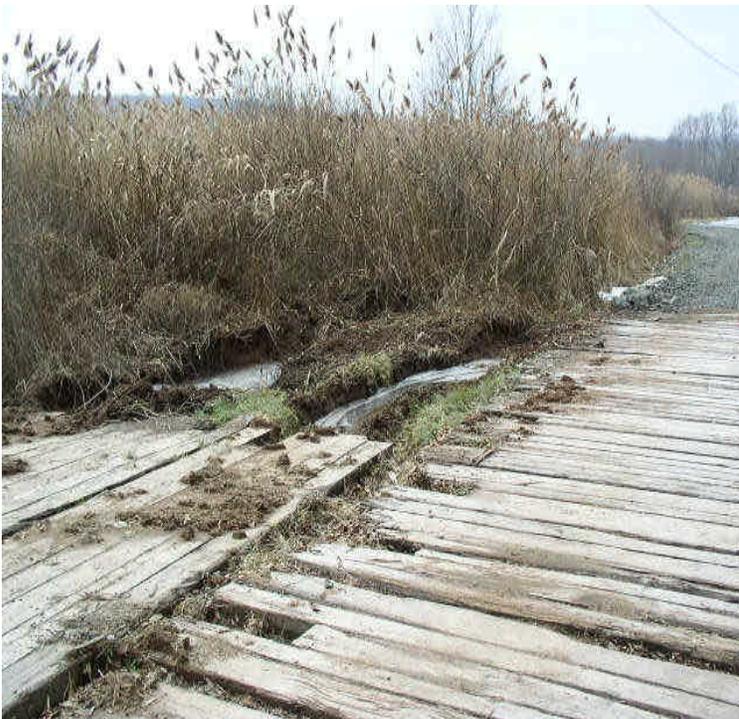
<p>Heavy ruts were noted at the end of timber mats in the golf course. 12/3-1/7/08 When the area is active, turbid water is noted at the wetland crossing to structure #24520 and timber mats are compressing into the mud 11/26-1/7/08</p>	<p>Repair ruts and stabilize and consider adding additional mats. Add controls as needed during construction. Add controls along the edge of the mats within the wetlands to prevent turbid water. 11/26-1/7/08. Work in this area is almost complete. 12/10-. 1/7/08</p>	<p>Needs attention.</p>
East of Beseck SS	<p>A stone pad remains in place at the original ROW access off Carpenter Ln. in order to prevent sediment tracking. Stone from the access road has migrated onto the roadway and BSS entrance. 1/7/08</p>	<p>Carpenter Lane should be swept on a regular basis. Remove stone from the roadway and BSS entrance. 1/7/08</p>	<p>Needs regular attention</p>
	<p>Turbid run-off from the access road has been previously observed in</p>	<p>Add controls as needed to the access road adjacent to the sediment trap.</p>	<p>Needs evaluation.</p>

Durham Rd: View of the ruts created off the edge of the timber mats graded and stabilized. in the wetlands. This occurred several weeks ago when equipment was anchoring lines. This should be carefully regraded and repaired.

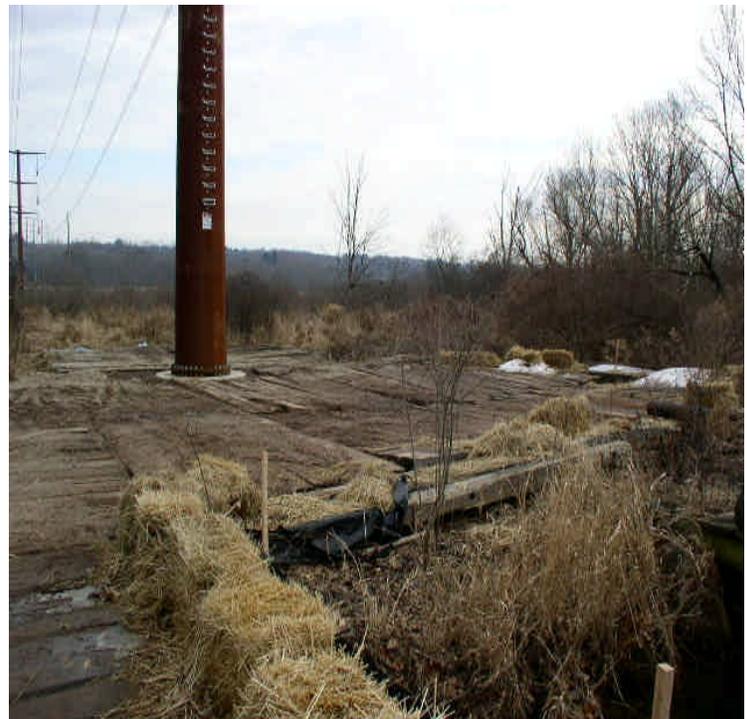
Durham Rd: Monitor sediment on the timber mat pad and add controls as needed.

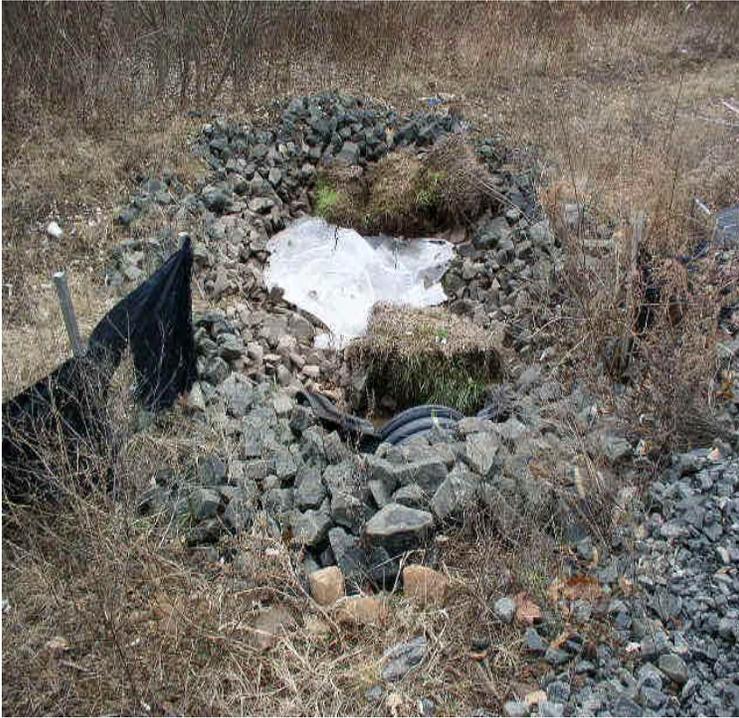
Carpenter Ln: Turbid water has settled out of the sediment trap. During rain events, run-off is still an issue at the wetlands to the East of Beseck.

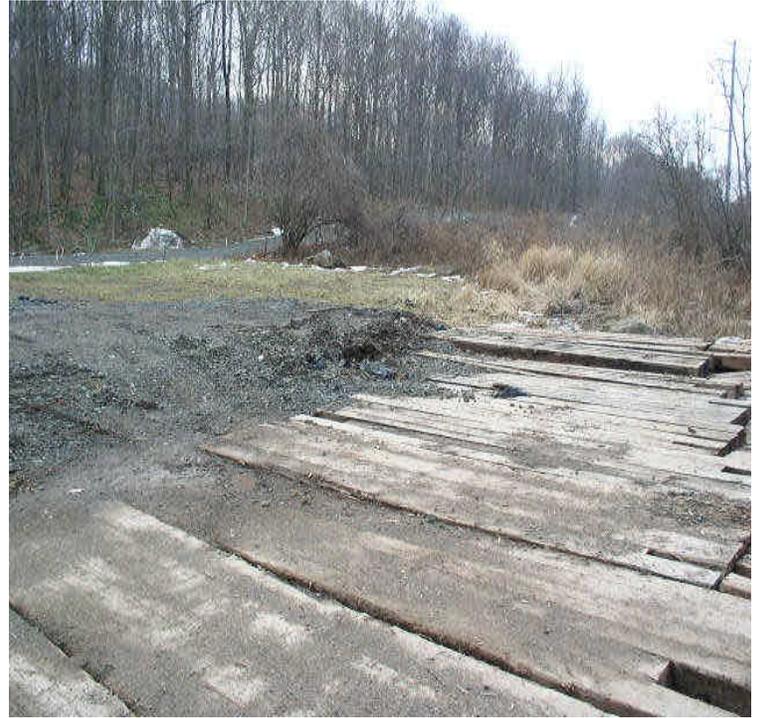
High Hill Rd: Provide controls in order to reduce sediment tracking on the timber mats.

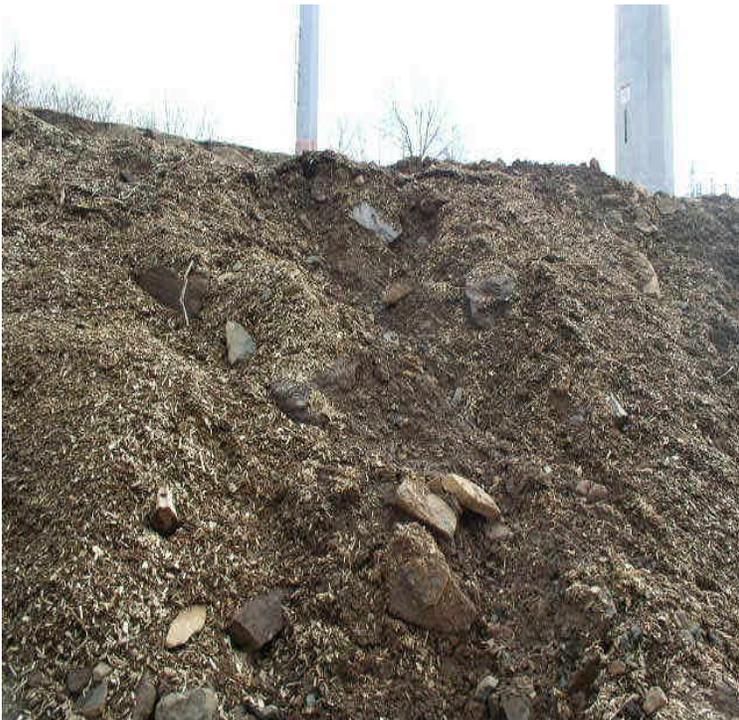
E. Meriden SS: Erosion channel beginning to form on a steep pad slope which was previously mulched.

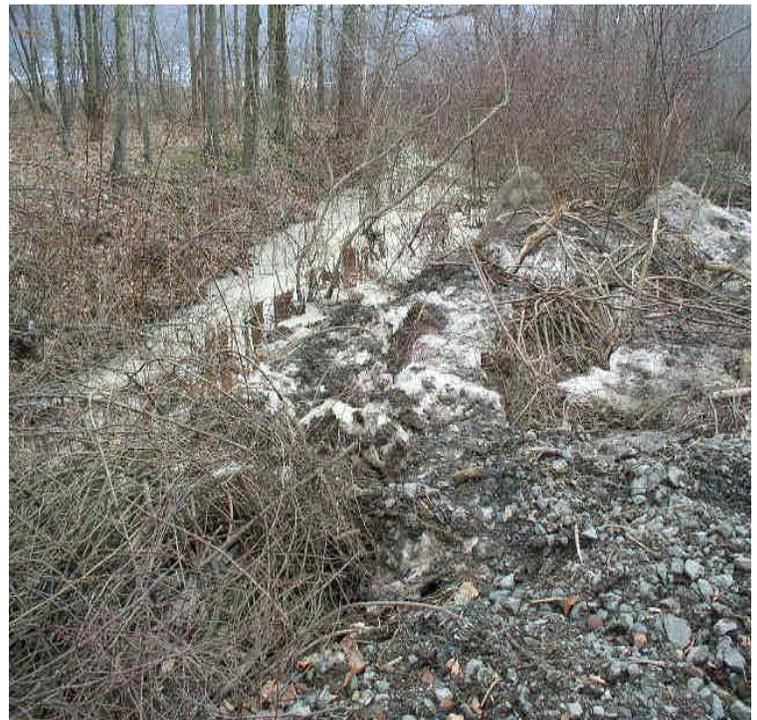
<p>Controls are still needed at large disturbed areas adjacent to wetlands to the south of East Main St. 11/5-1/7/08</p>	<p>Add controls around the disturbed area and provide temporary stabilization in the approved timelines. 11/12-1/7/08</p>	<p>Needs attention. Restoration needed per approved timelines</p>
	<p>Snowplows have also pushed snow (containing sediment/stone) from the pad site into the wetlands. 12/26-1/7/08</p>	<p>Snow should not be plowed into wetlands as it deposits sediment/stone. Pull the existing snow back and repair controls. 12/26-1/7/08</p>	<p>Needs attention.</p>

South of East Main Street: Snow and associated sediment has been plowed into wetlands and needs to be carefully removed as soon as possible.
