**Docket No. 272 – Development and Management Plan Inspection**

**Segment 1a Inspection**

**Date:** January 22, 2008

**Location:** Segment 1a – Scovill Rock Switching Station to Chestnut Junction, Oxbow Junction to Beseck Switching Station (excluding Royal Oak Bypass), and Black Pond Junction to Beseck Switching Station

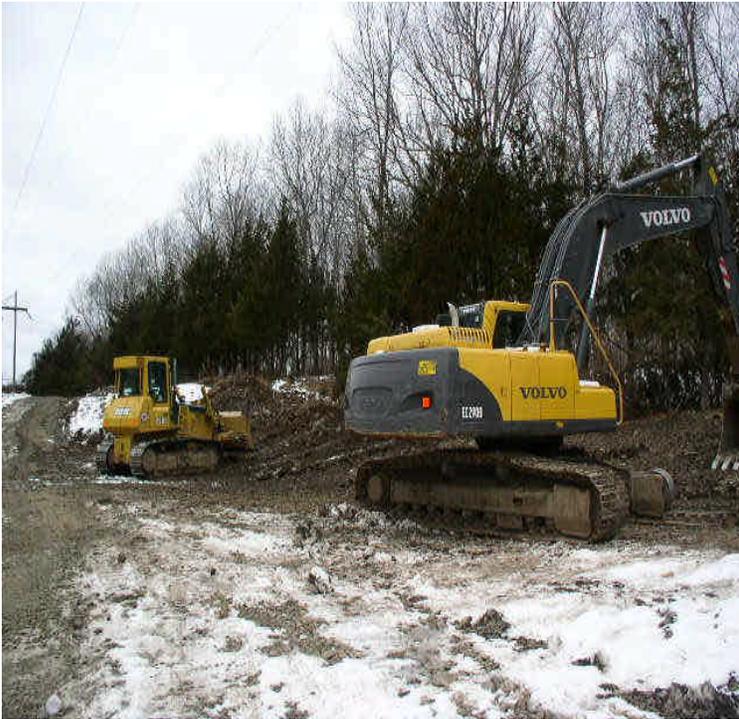
**Black Walnut Dr:** Crews were grading a stockpile and soils. Temporarily stabilize the area upon completion of activities.

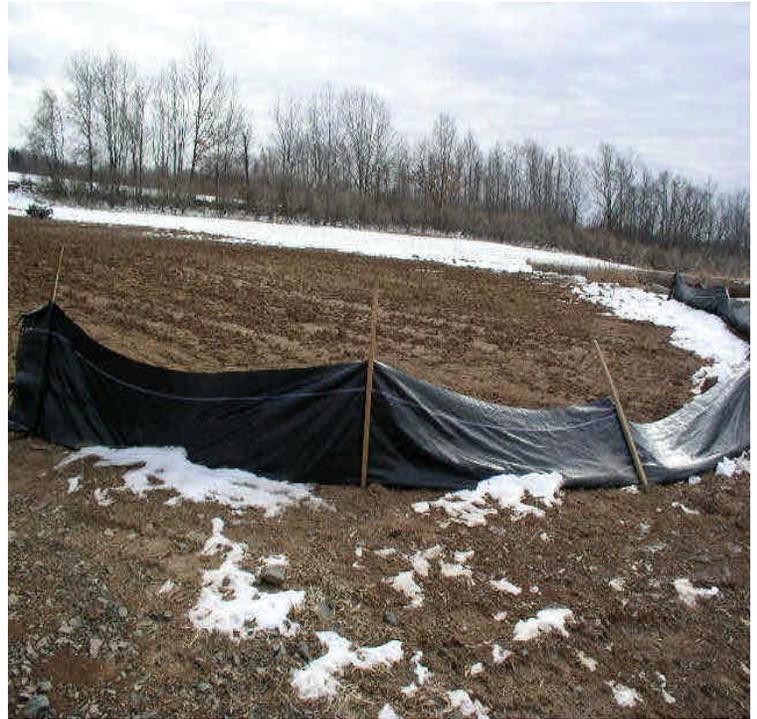
**Little Ln:** Controls remain downgradient of a disturbed area along a slope following stockpile removal.

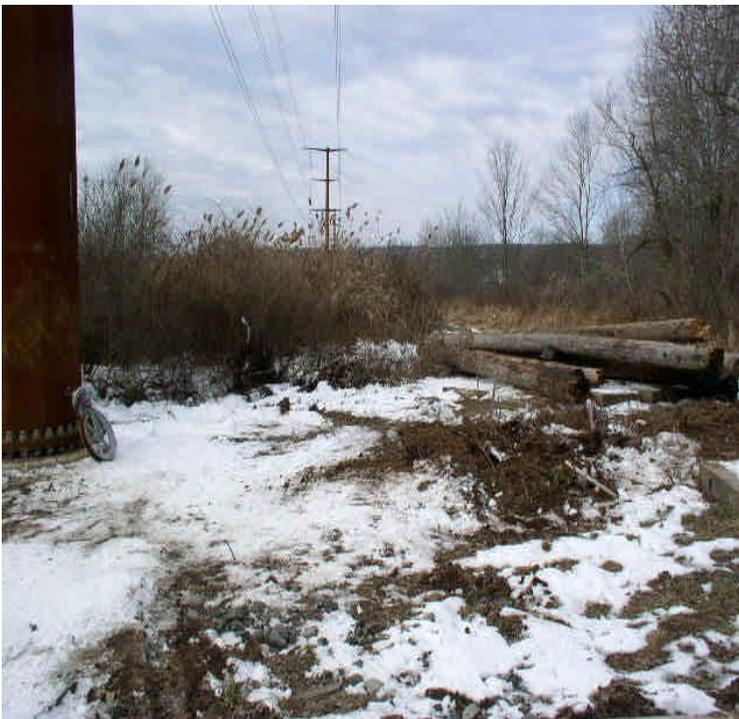
**Durham Rd:** Old wooden poles were placed in the previously rutted area. Remove structures and restore the contours in the area.

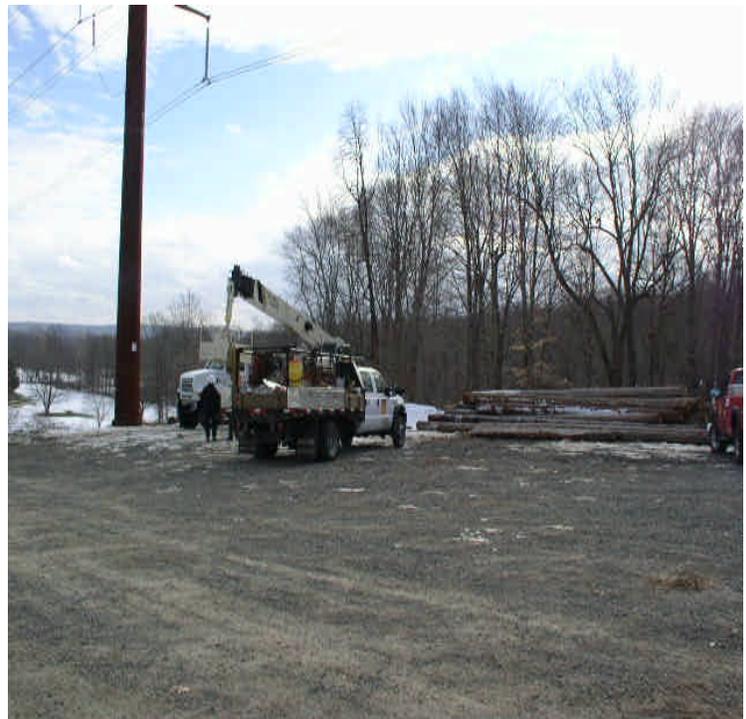
**Durham Rd:** Line work was underway. Crews were installing line spacers.

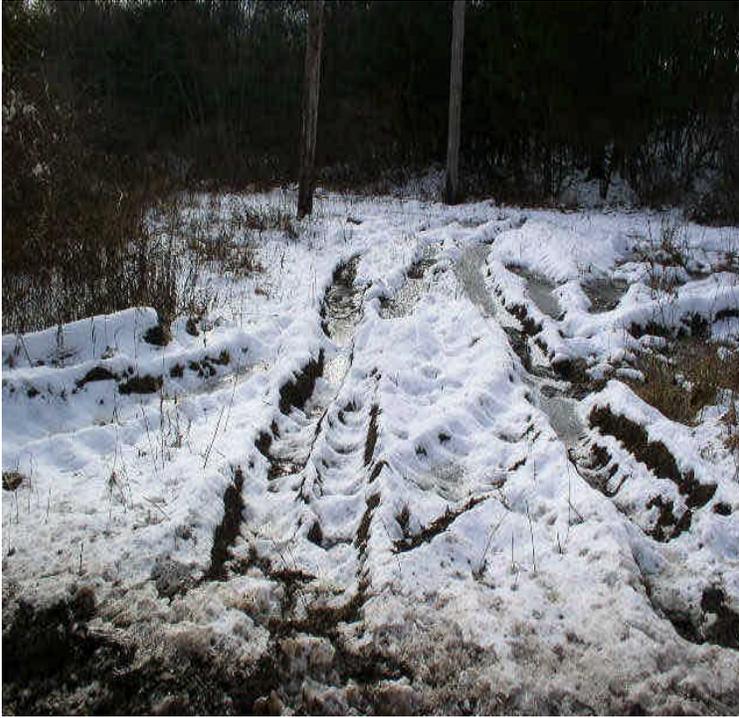
**Powder Hill Rd:** Controls had been disturbed by equipment accessing an old structure for removal. Ruts were noted within wetlands. Restore controls and provide appropriate access/mats. Ensure that removal crews are aware of wetland boundaries. Carefully repair the ruts in the wetland.

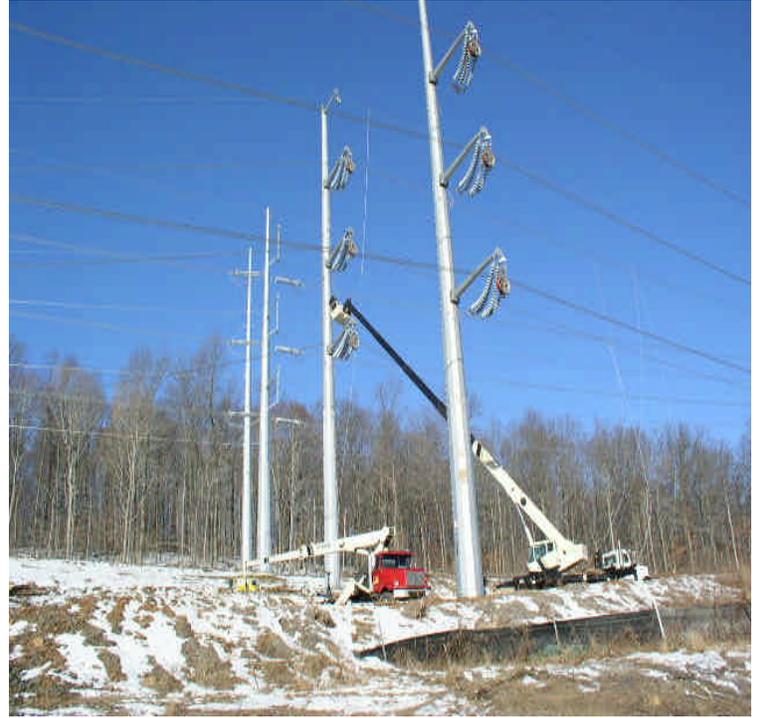
**North of Beseck SS:** Line work underway moving north from the switching station.

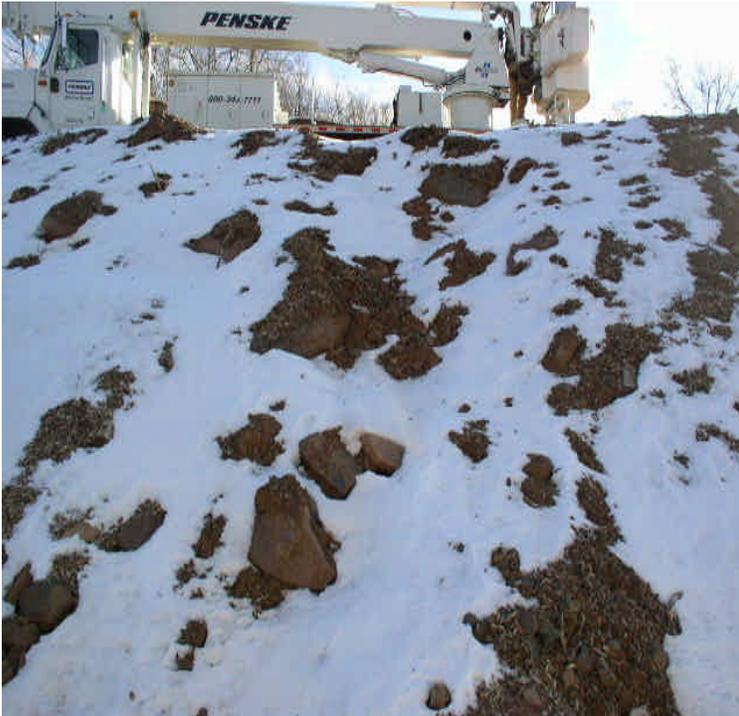
**E. Meriden SS:** Line work was underway. Small eroded, rill channels were forming along a pad slope. Run-off was contained to site but provide stabilization when conditions permit.

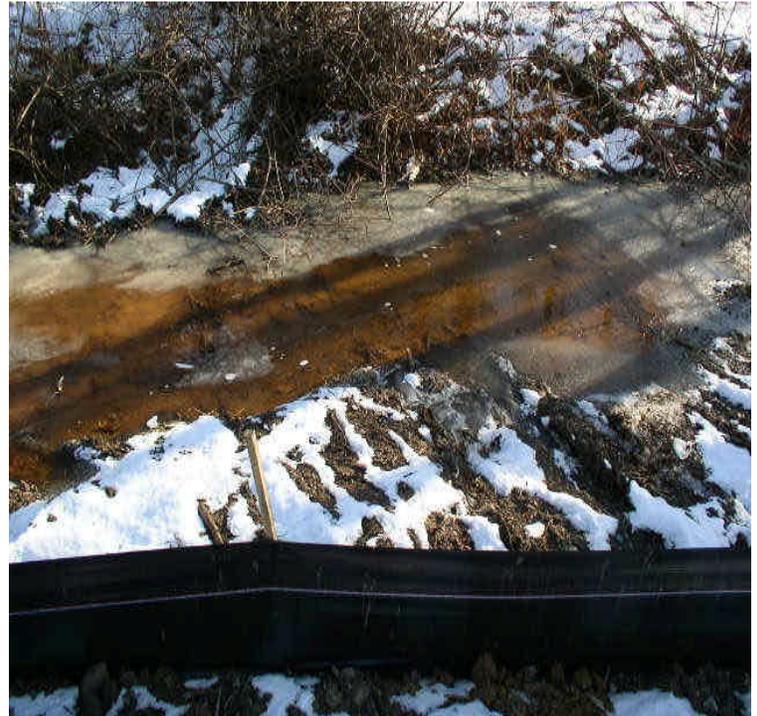
**South of East Main Street:** View of the wetlands and channel where the plowed snow has been removed. Controls remain in place. Soils still need stabilization when conditions permit.
