Docket No. 272 – Development and Management Plan Inspection

Segment 1a Inspection

Date: February 4, 2008

Location: Segment 1a – Scovill Rock Switching Station to Chestnut Junction, Oxbow Junction to Beseck Switching Station (excluding Royal Oak Bypass), and Black Pond Junction to Beseck Switching Station

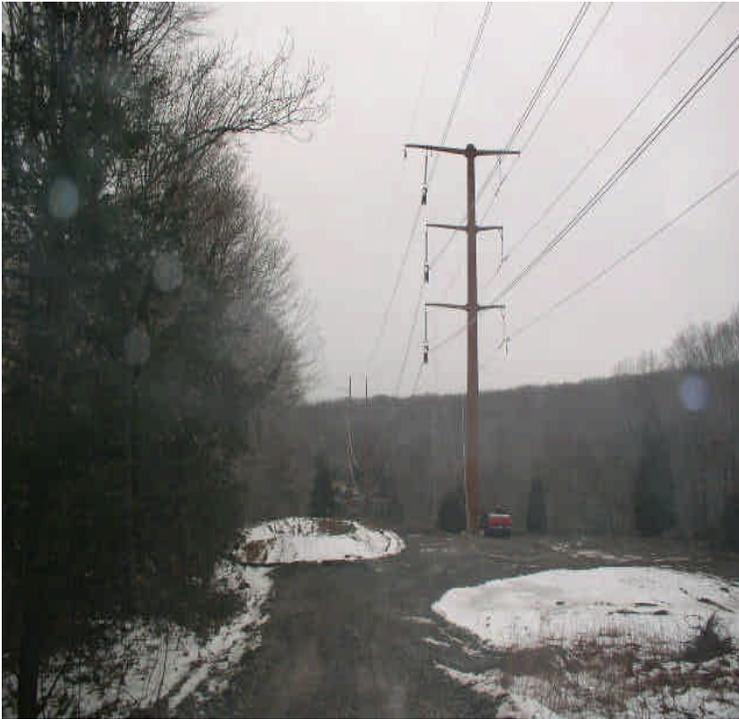
Arbutus Rd.: Line work was underway near the Ball Brook crossing.

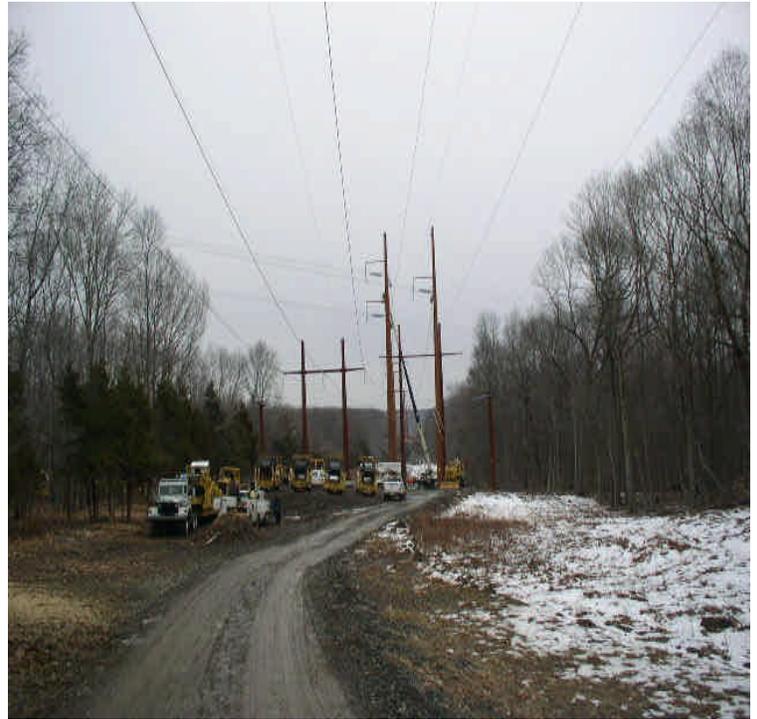
Black Walnut Dr: Line work was underway.

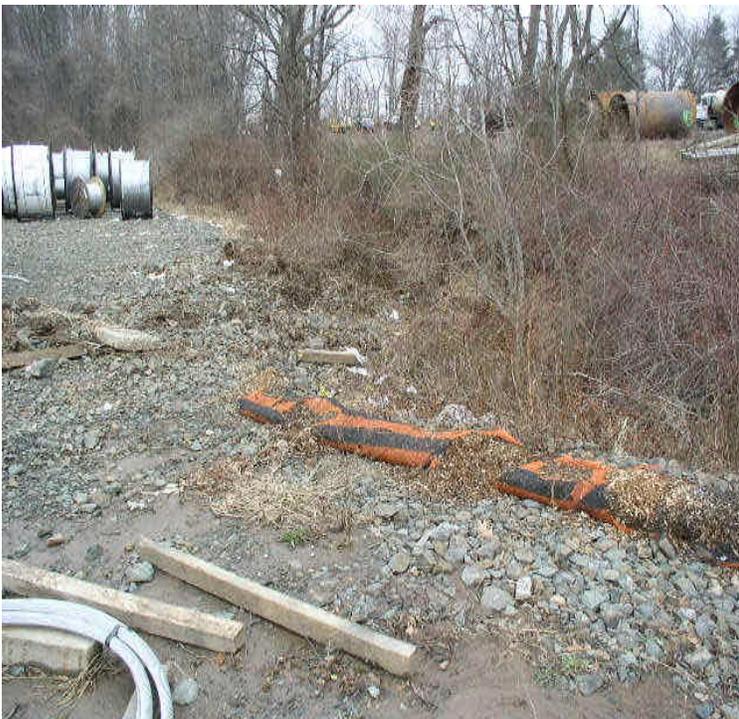
Receiving Yard: Deteriorating controls need to be extended and repaired to prevent run-off to receiving wetlands.

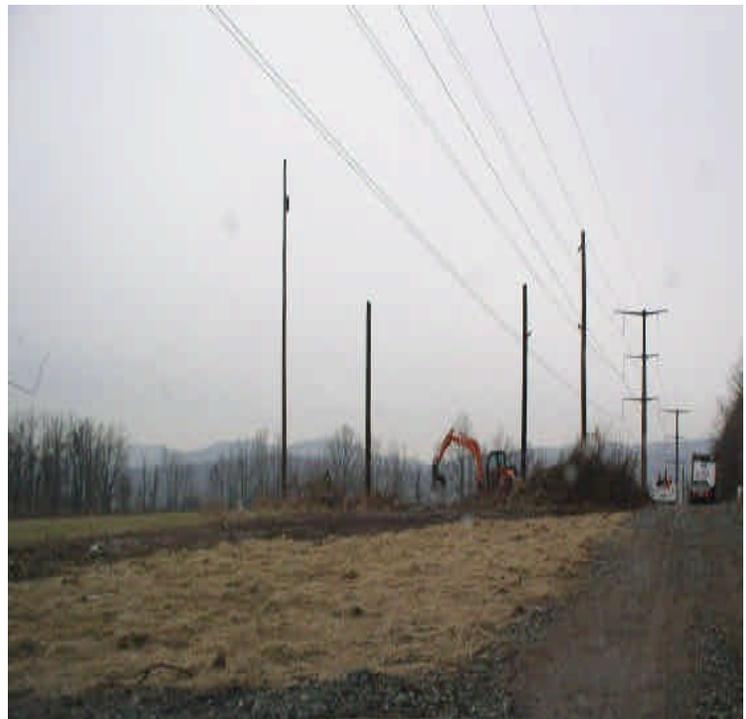
Little Ln: Crews were removing old wooden structures. Hay mulch and seed were used to stabilize exposed areas.

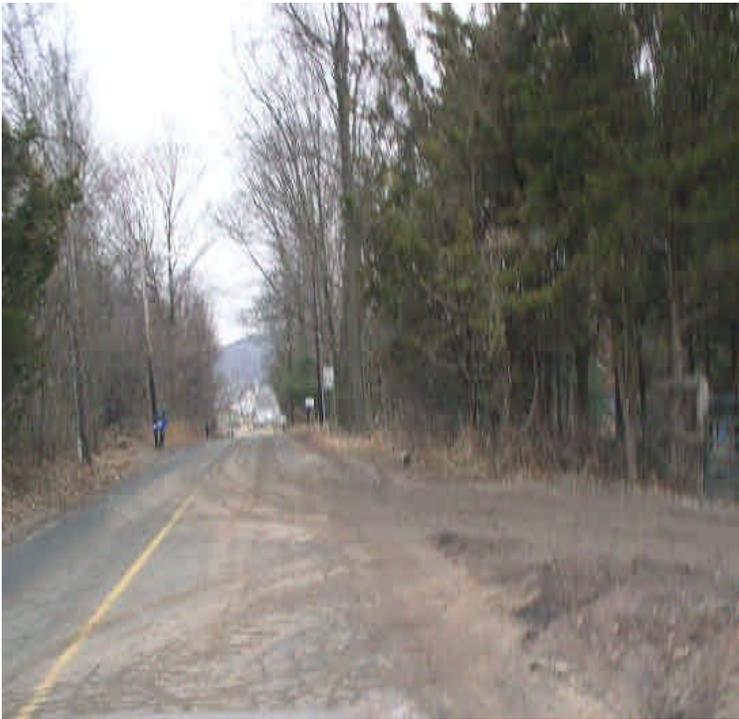
| Areas of Inspection | Observation | Recommended Action | Corrected Action |
|---|---|--|---|
| Powder Hill | Sediment tracking was noted on the roadway due to the activities west | Clean/sweep roadway and refresh the stone entrance pad. 2/4/08 | Needs attention. |

Powder Hill Rd: Sediment tracking was noted to the roadway. Sweep on a regular basis and refresh the stone entrance pad.

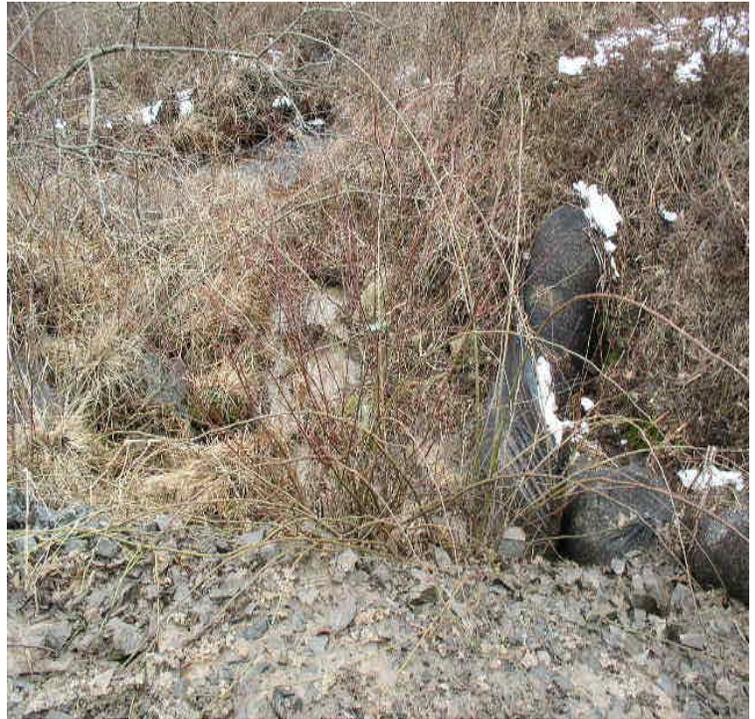
| Areas of Inspection | Observation | Recommended Action | Corrected Action |
|--|---|---|--|
| <p>Powder Hill Rd.</p> | <p>Numerous controls remain in place along the access road. Filter socks and haybales remain upgradient of the stream and pond (both sides) at the base of slope. Sediment accumulation has occurred at the controls (since 8/20) and turbid water was now noted flowing into the wetlands from the access</p> | <p>Remove sediment accumulated around the controls and vegetation. Stream crossings/culverts are temporary and will be removed at the end of the work. Turbid run-off was noted during a storm this week while the site was active. Additional controls are needed. 2/4/08</p> | <p>Turbid run-off needs attention.</p> |

Powder Hill: Turbid water from the access road crossing was observed flowing into adjacent wetlands.

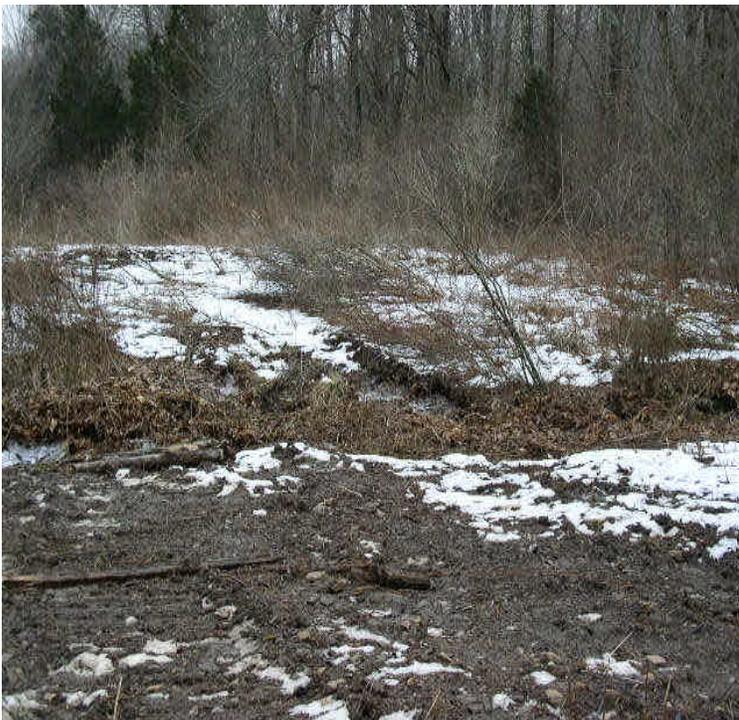
| Areas of Inspection | Observation | Recommended Action | Corrected Action |
|--|--|--|---|
| | <p>wetlands from the access road. 2/4/08</p> <p>Ruts were noted at the base of Beseck Mtn where equipment accessed an old wood structure. Controls in this area were damaged by equipment and appropriate access measures (timber mats) were not used. (Since 1/22) Ruts were also noted across a small stream in the middle of the mountain slope. 2/4/08</p> | <p>Controls need to be repaired and ruts within wetlands need to be carefully graded out. Add appropriate access (mats) if more work is to be done. Stabilize the area as soon as possible. Ensure removal crews observe wetland boundaries. 1/22-2/4/08</p> | <p>Needs attention.</p> |

Powder Hill: Ruts from equipment noted through a stream channel. Ruts should be carefully graded out and stabilized. Obvious controls should be used to identify the wetland boundary.

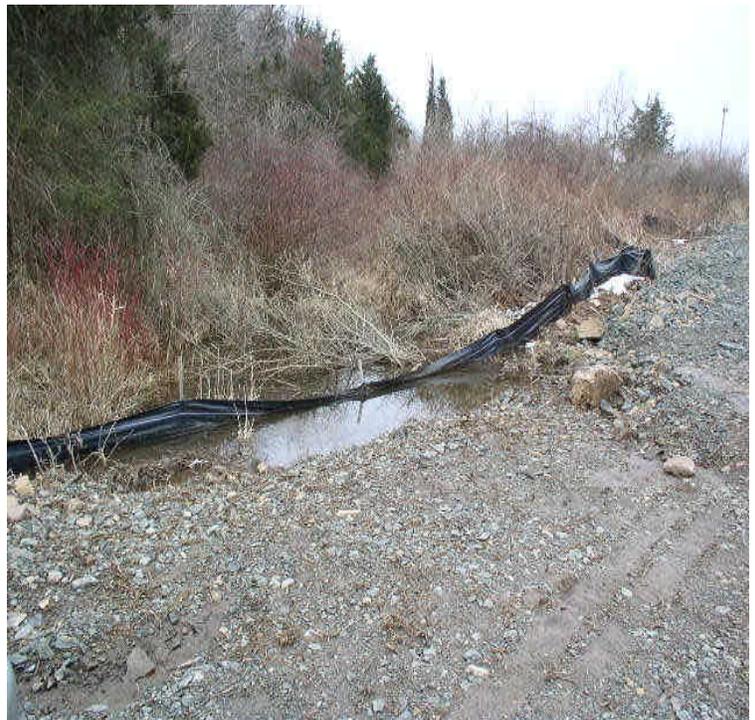
| Areas of Inspection | Observation | Recommended Action | Corrected Action |
|--|--|--|---|
| <p>East of Beseck SS</p> | <p>Silt fence was added near the riprap trap (11/19) but was not able to keep turbid water out of the trap and overflowing into the wetland. (11/19, 12/3, & 2/5). 2/4/08</p> | <p>Consider adding stone to the portion of access road adjacent to wetlands. 11/12-2/4/08 Turbid water noted entering in multiple areas along the access road. (2/5)</p> | <p>Needs attention.</p> |

East of Beseck SS: Wetland flooding was overwhelming the controls. Turbid water was noted in the wetland during heavy rain events.
