**Docket No. 272 – Development and Management Plan Inspection**

**Segment 1a Inspection**

**Date:** February 19, 2008

**Location:** Segment 1a – Scovill Rock Switching Station to Chestnut Junction, Oxbow Junction to Beseck Switching Station (excluding Royal Oak Bypass), and Black Pond Junction to Beseck Switching Station

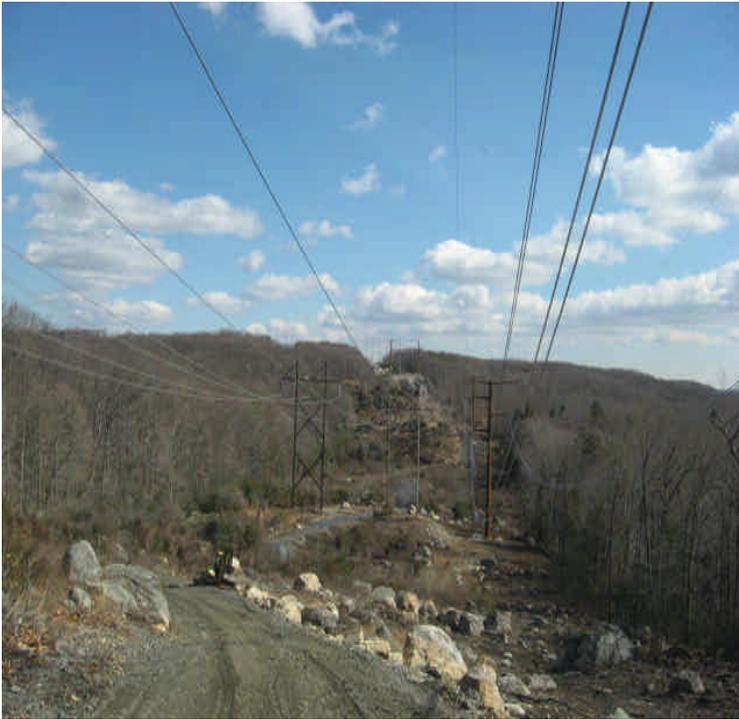
**West of Scovill SS: New lines have been installed and crews were repairing drainage ditches in this section.**

<p><b>Foundation and site construction Scovill SS to Chestnut Jct.</b></p>	<p><b>Line work and drainage/ water bar improvements were underway from Scovill Rd to Shunpike.</b></p>	<p><b>Monitor and maintain controls now that the area is active. 2/19/08</b></p>	<p><b>Crews were improving controls.</b></p>

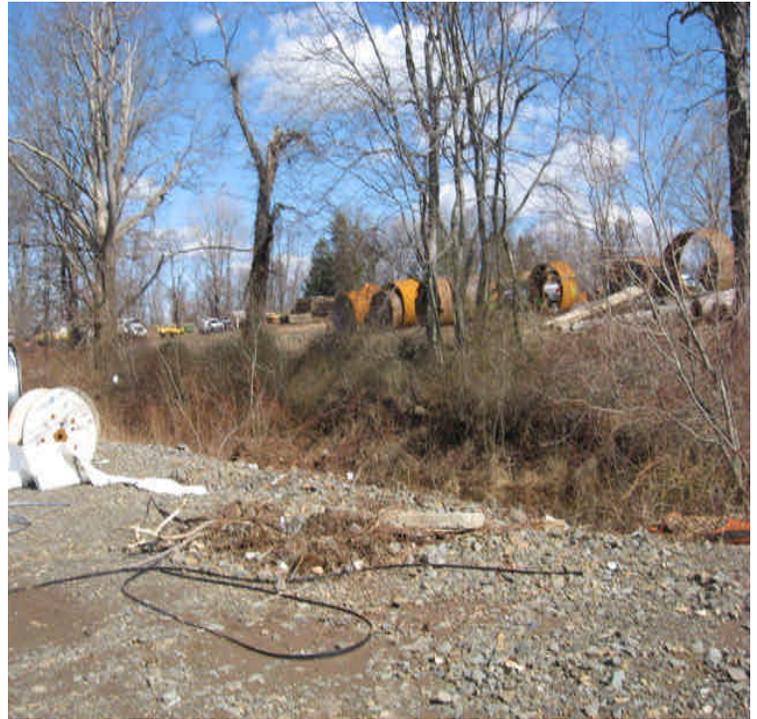
**PAR Receiving Yard: New controls installed at culverted crossing. Controls should be extended as turbid run-off is flowing around the controls and into the drainage ditch.**

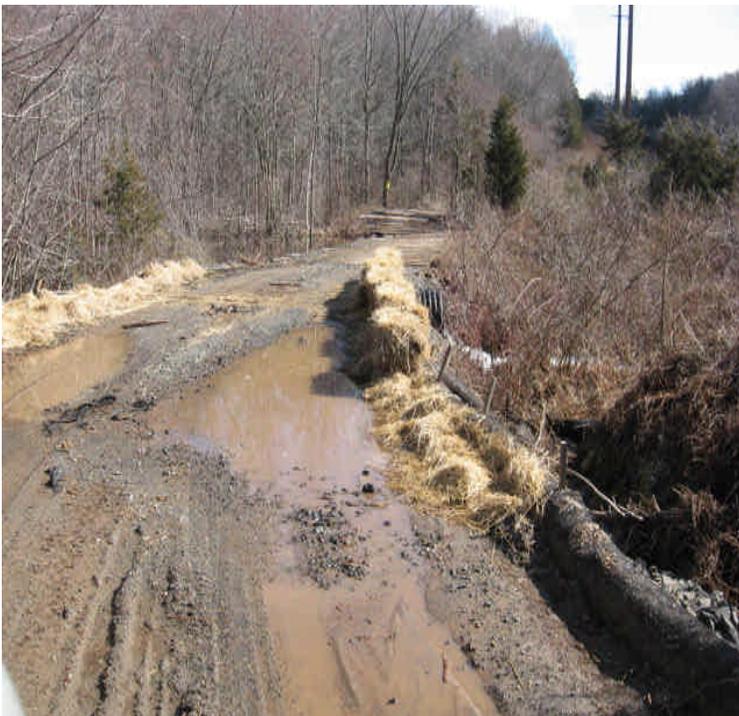
**Powder Hill Rd: Additional controls were installed at the wetland crossing to reduce turbidity.**

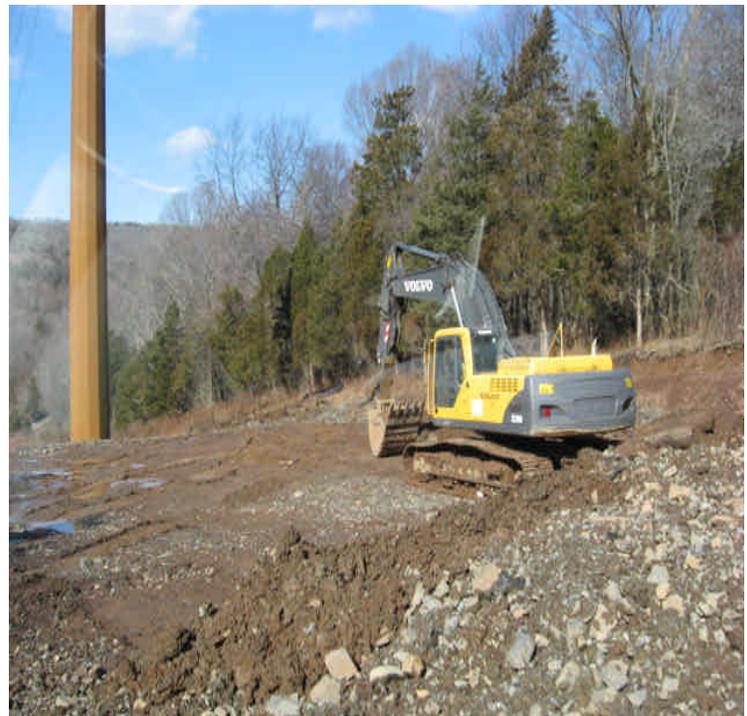
**Powder Hill Rd: Reclamation and final grading were underway at pad sites.**

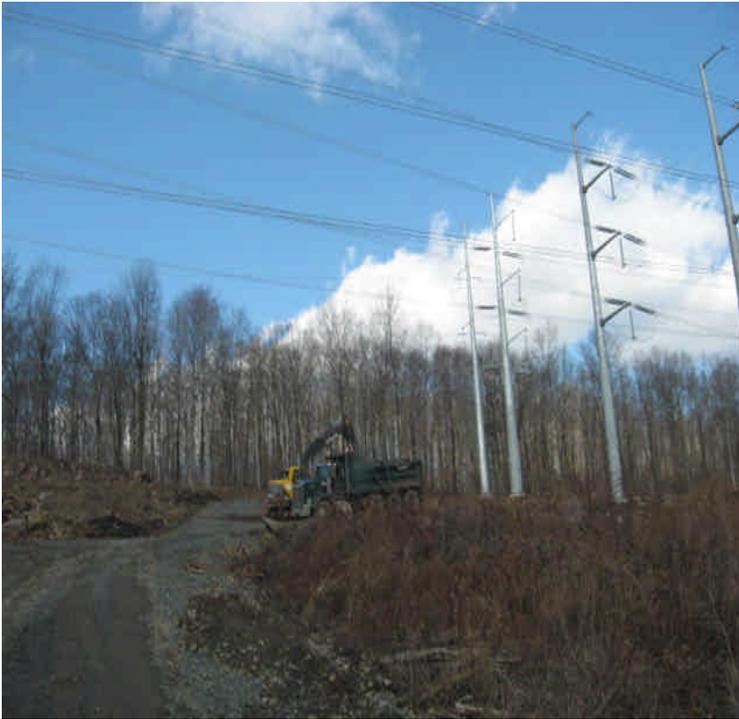
**North of Beseck: Reclamation and final grading were underway.**

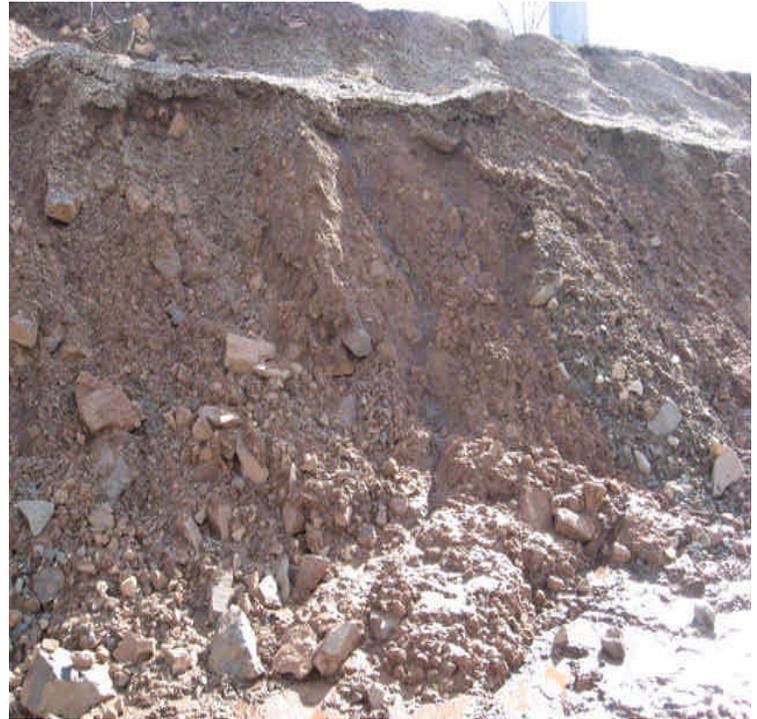
**East Meriden SS: Erosion noted on the steep slopes at structure #24462. Run-off has created gullies/channels and sediment is overwhelming controls adjacent to the pond.**

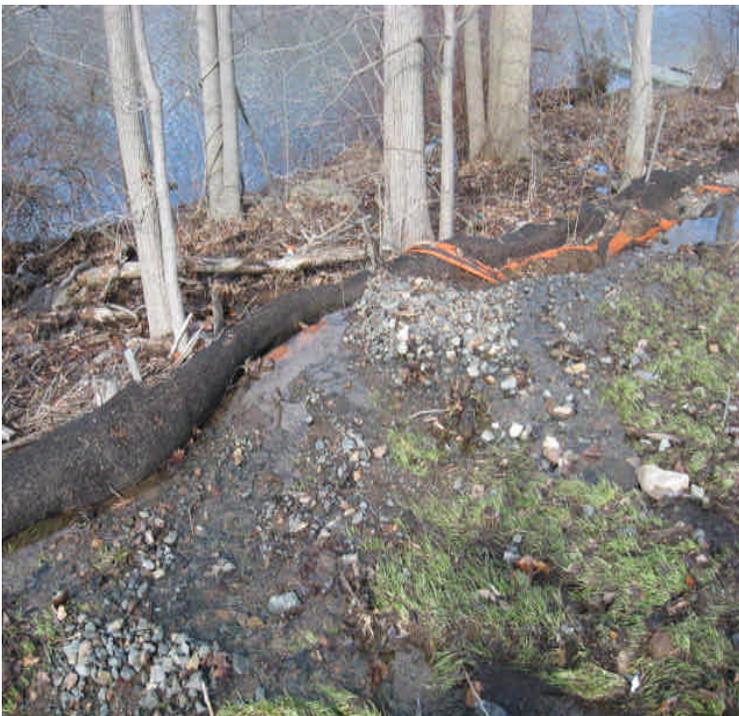
**East Meriden SS: Sheet flow and sediment/gravel were overwhelming controls upgradient from the pond.**

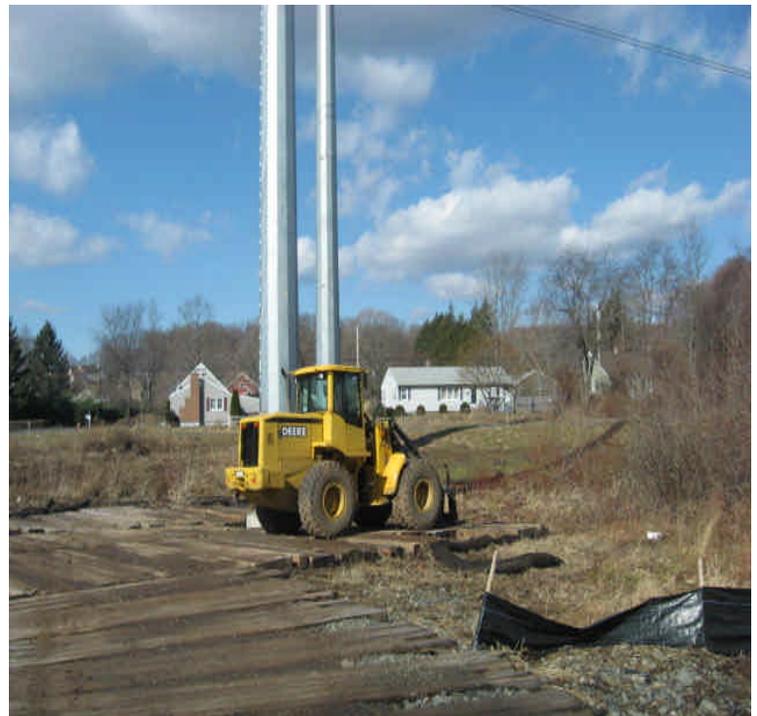
**North of High Hill: One of the two pieces of equipment that were observed parked on mats in the wetlands. Equipment should be stored greater than 100 feet from resource areas.**

<b>Areas of Inspection</b>	<b>Observation</b>	<b>Recommended Action</b>	<b>Corrected Action</b>
<b>North of High Hill Rd.</b>	<b>Equipment is being stored on timber mats within the wetland. 2/19/08</b>	<b>Remove equipment and relocated over 100 feet from wetlands. 2/19/08</b>	<b>Needs attention.</b>
<b>Additional Observations</b>	<b>None. 2/19/08</b>	<b>None. 2/19/08</b>	<b>NA</b>
