**Docket No. 272 – Development and Management Plan Inspection**

**Segment 1a Inspection**

**Date:** February 25, 2008

**Inspector:** Matthew Creighton

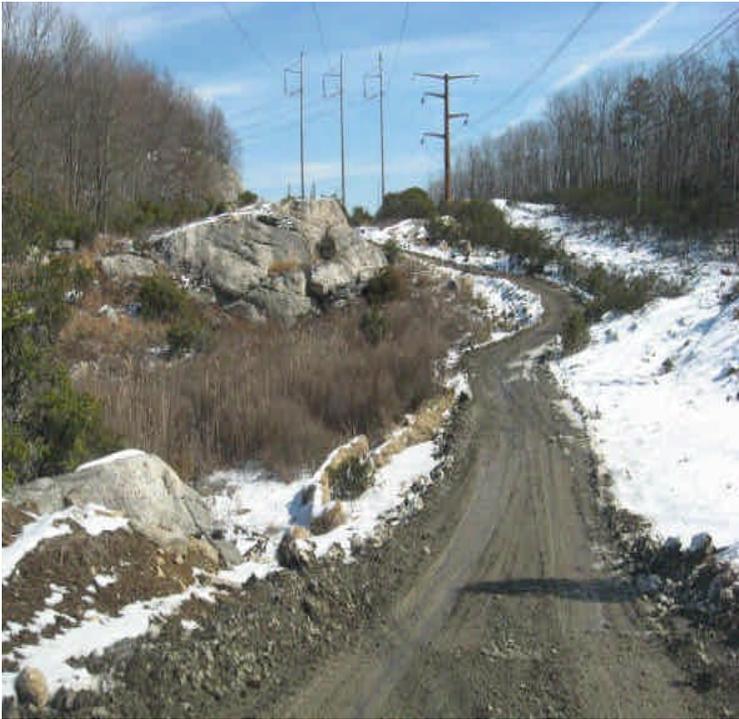
**West of Scovill SS: Wetland #5 crossing is in good shape. Line work was underway.**

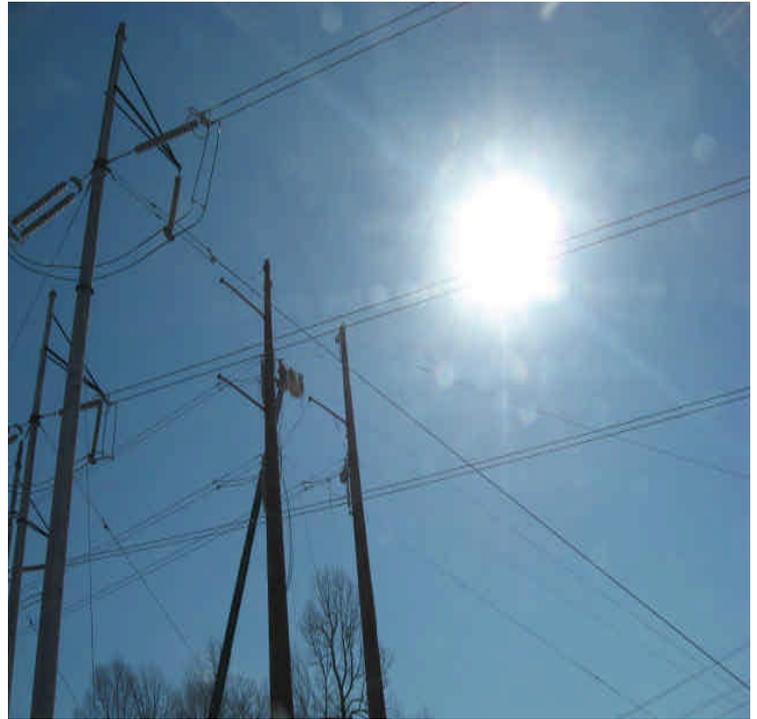
**East Mount Rd.: Line work was underway.**

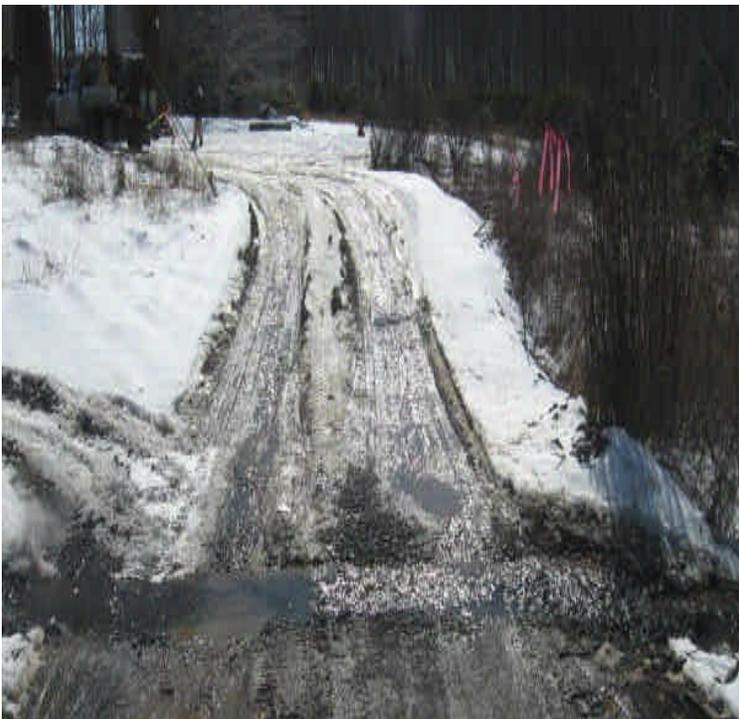
<b>Water was noted flowing over the access road and becoming slightly turbid, at the E. Mount Rd entrance. 2/25/08</b>	<b>A culvert, stone, or timber mat should be considered to prevent equipment from creating turbid run-off. 2/25/08</b>	<b>Needs attention/evaluation.</b>
<b>Oxbow Junction to Beseck SS</b>	<b>Timber mats are in place along the access roads at wetland crossings.</b>	<b>Continue to add controls where needed, i.e. mulch, check dams, silt fence, to control sediment and prevent erosion. Sweep</b>	<b>NA</b>
<b>Haddam Quarter Rd. (Oxbow Junction); Johnson Ln; Foot Hills</b>	<b>Controls remain in place at all wetlands and no</b>

**East Mount Rd: Water was flowing across the access road and becoming slightly turbid. Consider adding controls at the crossing to filter out sediment.**

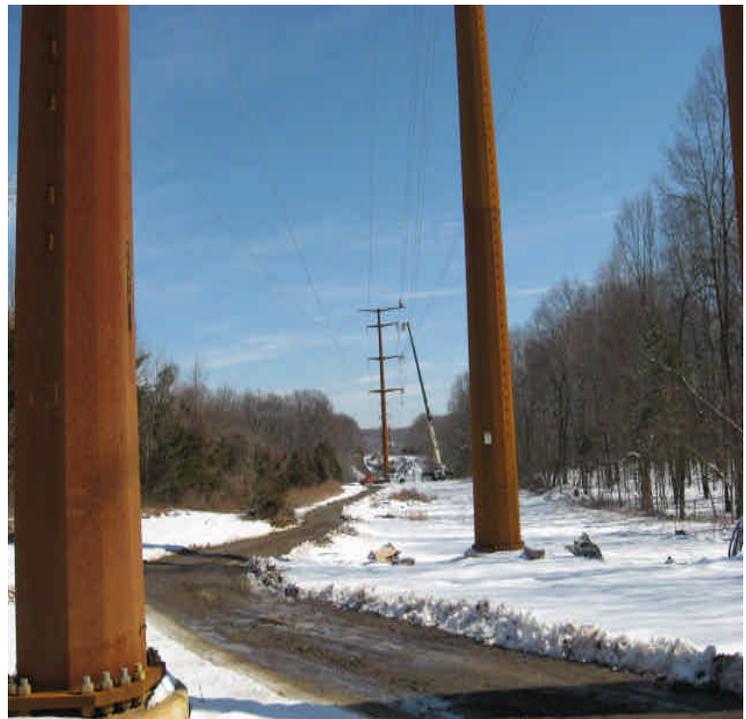
**Black Walnut Dr.: Line work underway.**

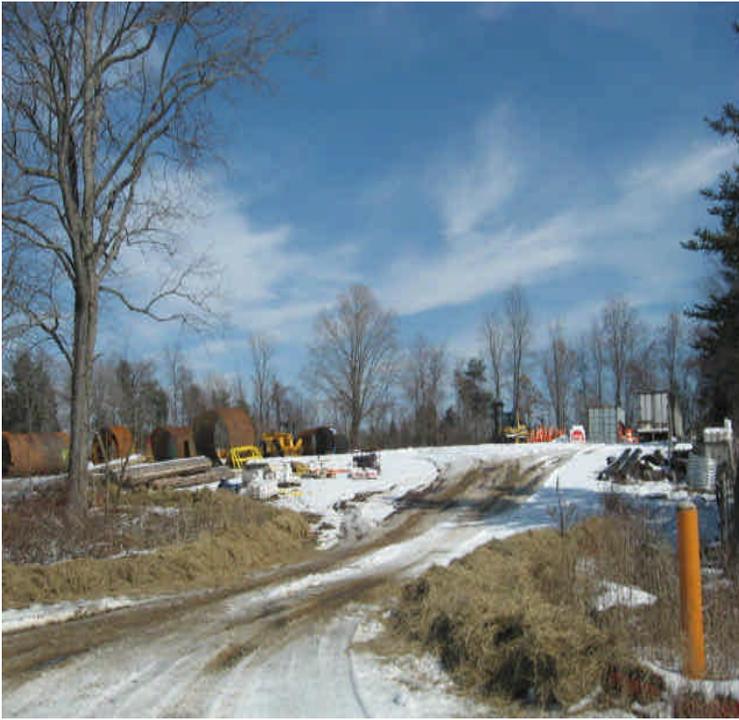
**PAR Receiving Yard: Additional controls were installed at the culverted crossing**

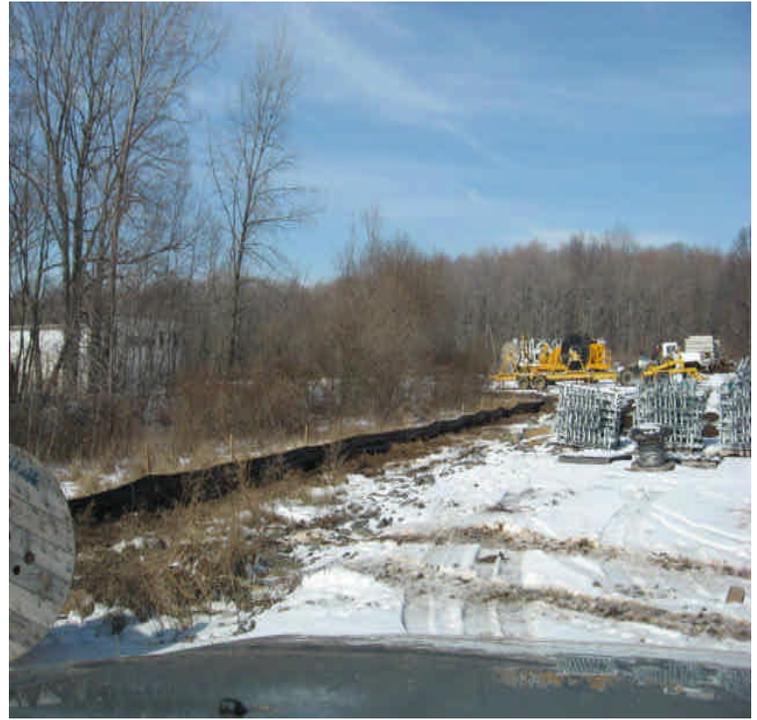
**PAR Receiving Yard: Erosion controls have now been installed up-gradient from the pond.**

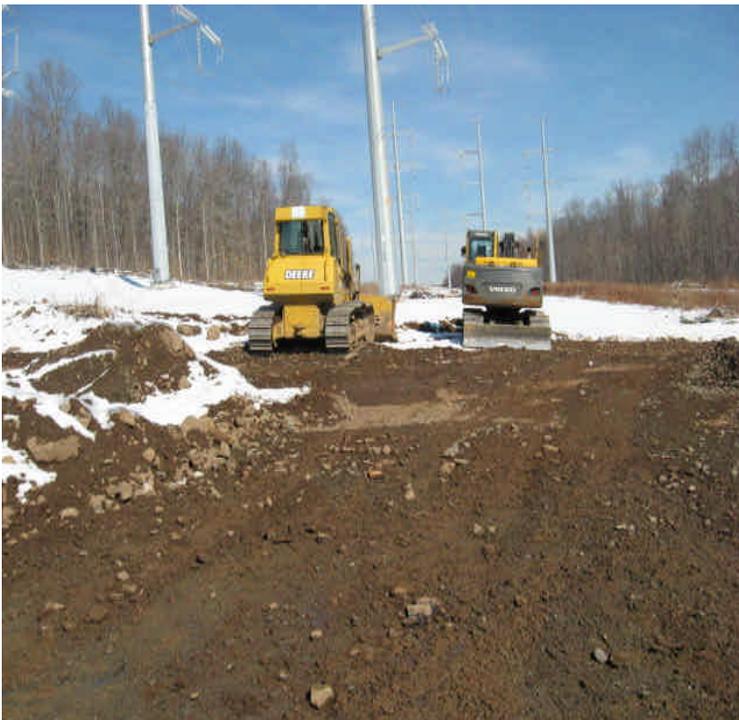
**North of Beseck: Crews were reclaiming pad sites and removing stone.**

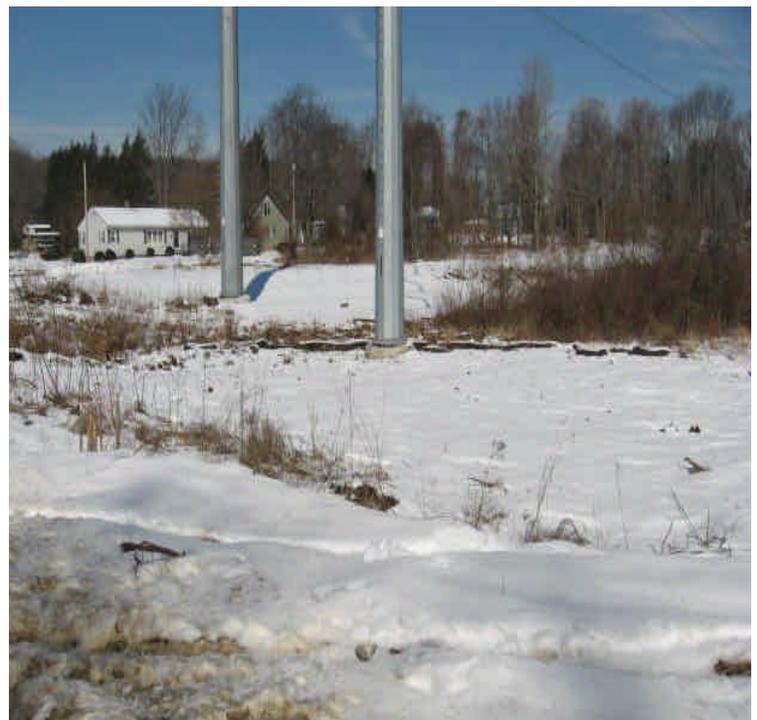
**North of High Hill: Timber mats and equipment were removed from the wetland prior to snow cover. Continue to provide full restoration.**
