Docket No. 272 – Development and Management Plan Inspection

Segment 1a Inspection

Date: March 10, 2008

Location: Segment 1a – Scovill Rock Switching Station to Chestnut Junction, Oxbow Junction to Beseck Switching Station (excluding Royal Oak Bypass), and Black Pond Junction to Beseck Switching Station

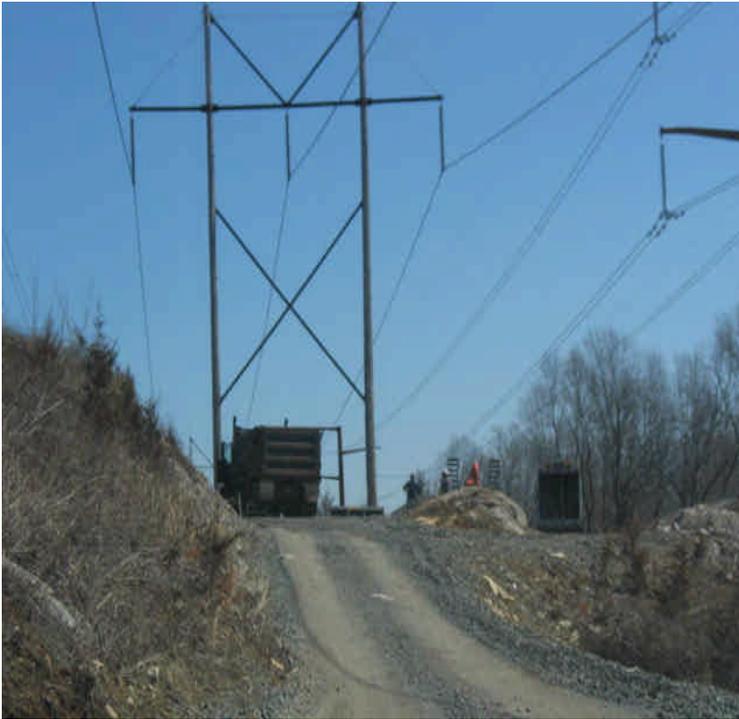
West of Scovill SS: Line work is underway. Hay mulch and seeding equipment were on site.

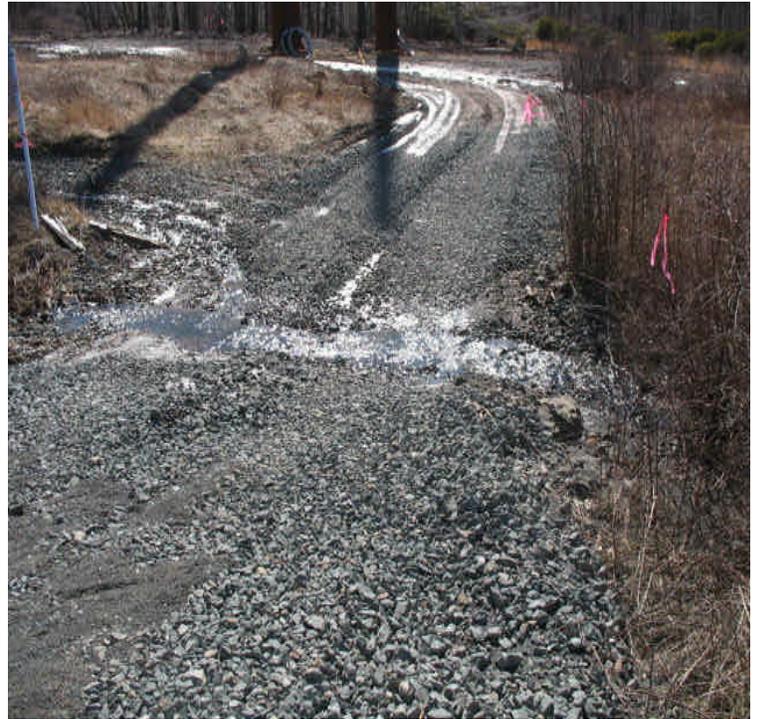
East Mount Rd: Stone was added to the access road at the entrance where flow was noted at the saturated crossing. Very slight turbidity was noted in the water and the area was not active.

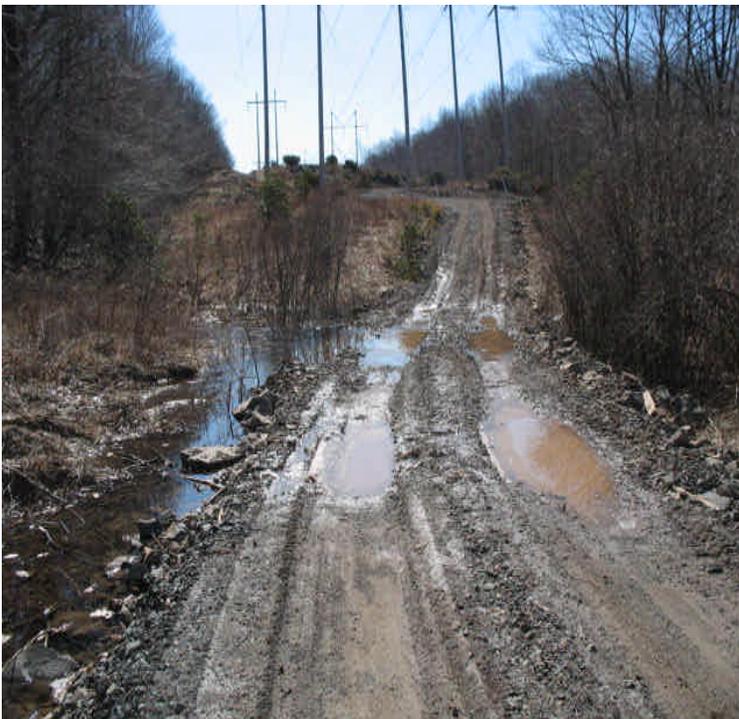
East Mount Rd: The new section of access road noted south of East Mount Rd. extends through a saturated crossing and dams the over-land flow, forcing the water to re-route down the access road. This is creating gullies and resulting in turbid run-off.

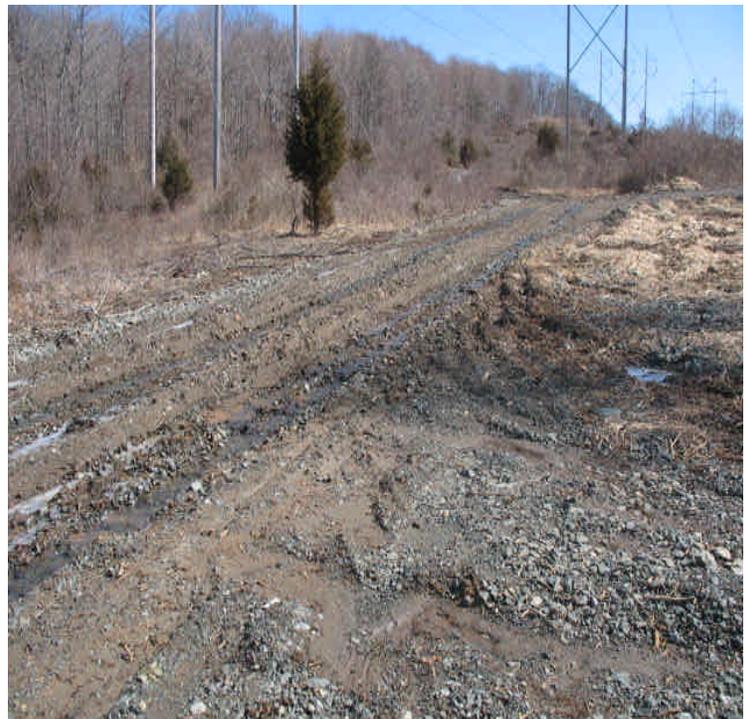
East Mount Rd.: View of a section of access road where water is flowing along the ruts due to the dammed crossing upgradient.

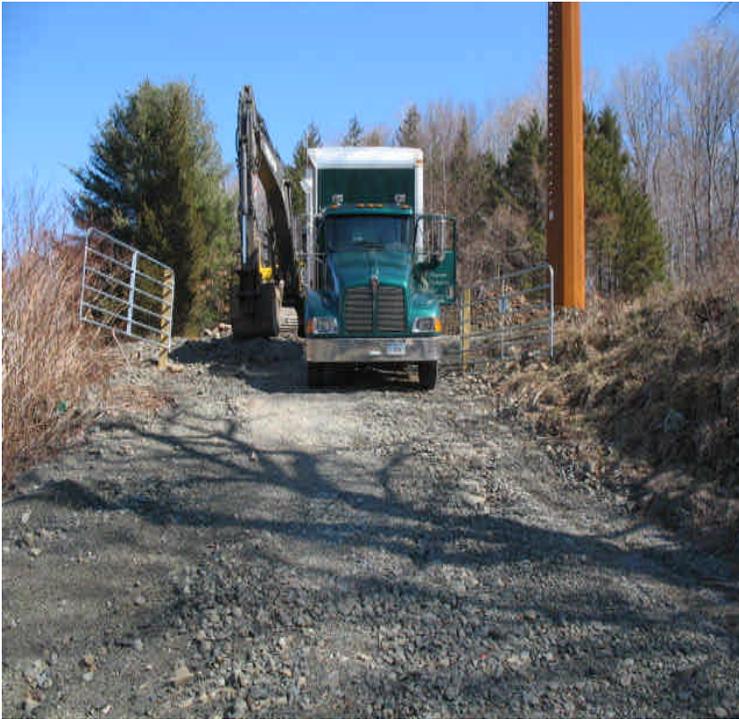
Foot Hills Rd: Pad work underway. Stabilize exposed soils upon the completion of work.

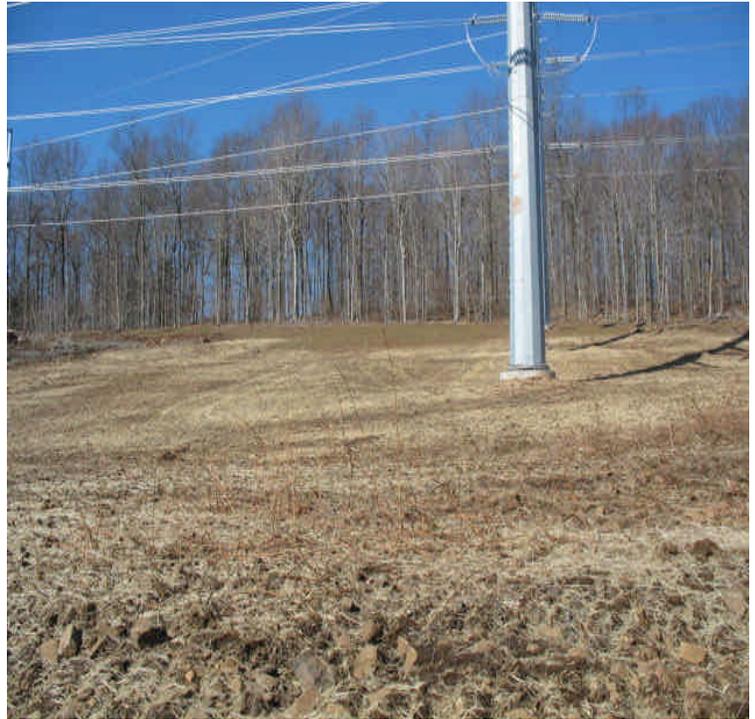
North of Beseck SS: Slopes, pads, and some access roads have been final graded and hay/seed has been applied for stabilization. Monitor for run-off and provide additional controls as needed.

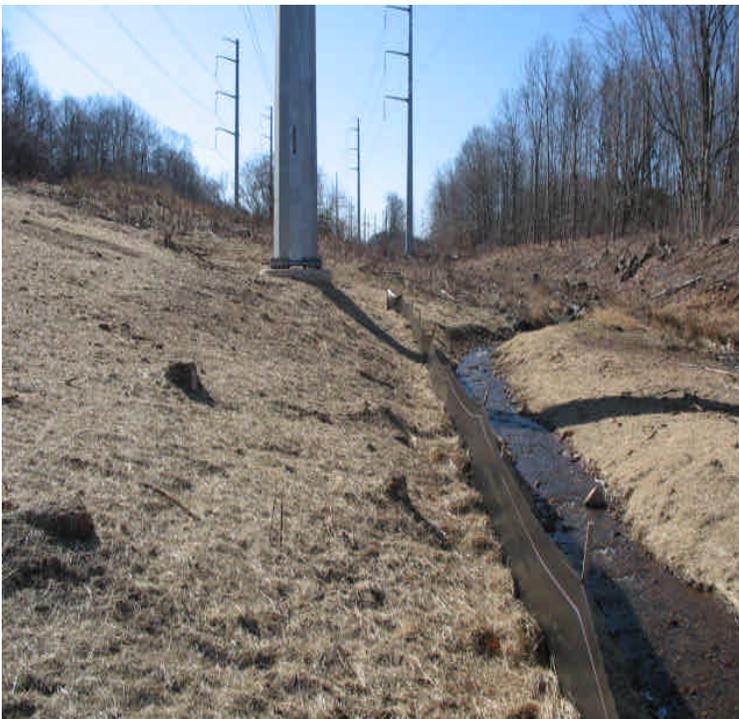
North of E. Meriden SS: Timber mats, stone, and fill have been removed from above the stream. Silt fence was installed and hay mulch and seed were applied to protect the stream and stabilize the soils. Continue to watch for erosion and vegetative cover in the growing season but the area was restored well.

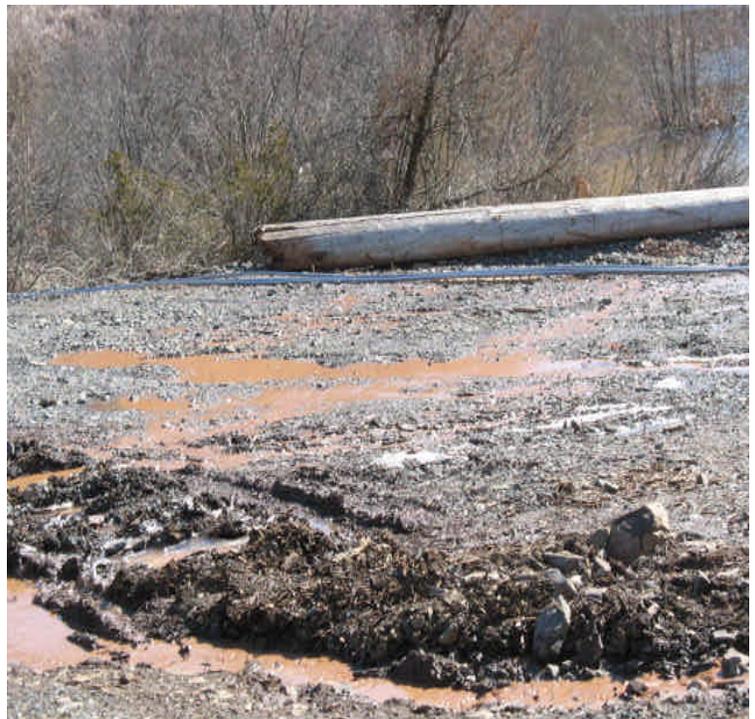
Black Pond Jct: Turbid water flowing from the access road, through controls, and into the wetland. Site is very active and ruts were noted on the access roads. Improve/reinforce controls and provide stormwater diversion if needed.
