**Docket No. 272 – Development and Management Plan Inspection**

**Segment 1a Inspection**

**Date:** March 24, 2008

**Location:** Segment 1a – Scovill Rock Switching Station to Chestnut Junction, Oxbow Junction to Beseck Switching Station (excluding Royal Oak Bypass), and Black Pond Junction to Beseck Switching Station

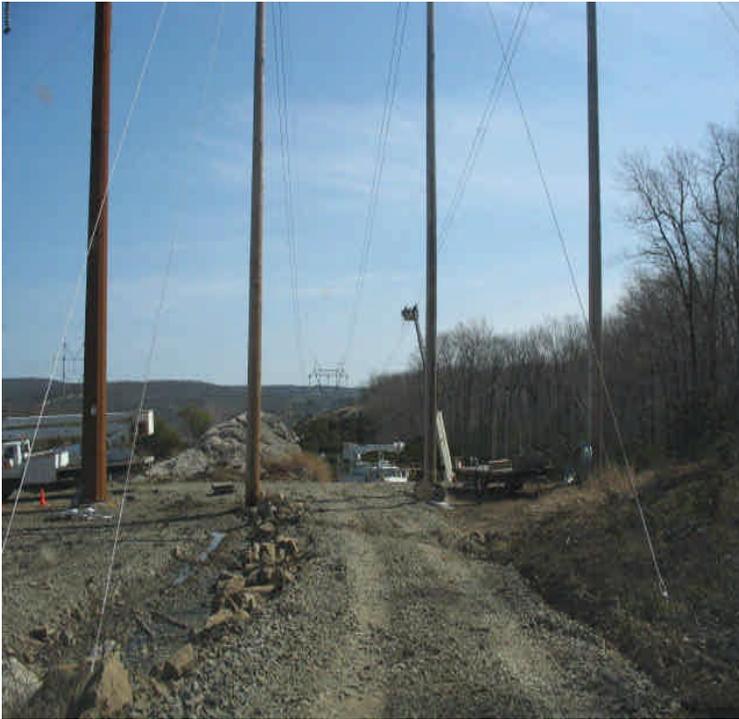
**West of Scovill SS: Line work is underway adjacent to and within the SS.**

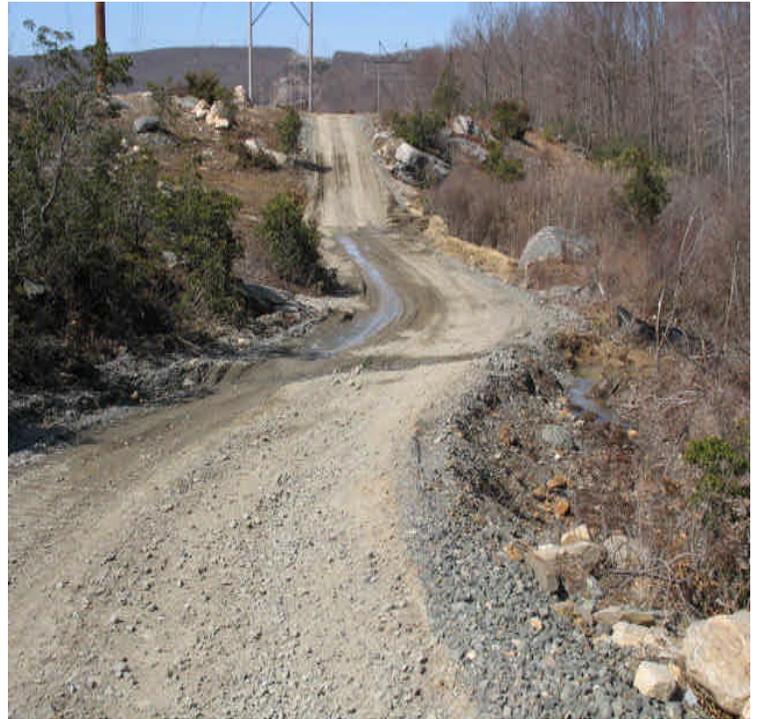
**West of Scovill SS: Saturated crossing at wetland #5 with new control. Controls appear to filter turbid water before it enters the wetlands.**

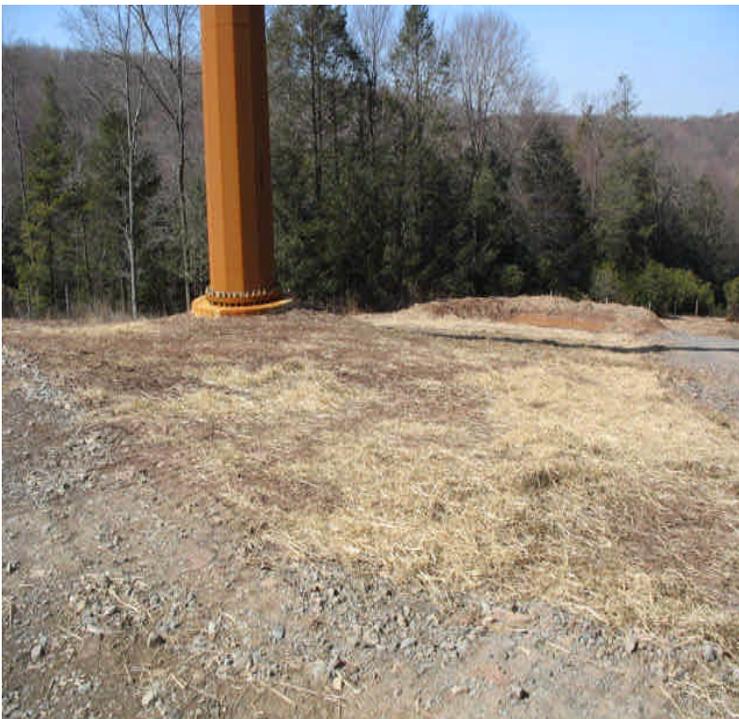
**Foot Hills Rd: Final reclamation complete east/west of roadway. Monitor slopes for erosion until final stabilization is complete.**

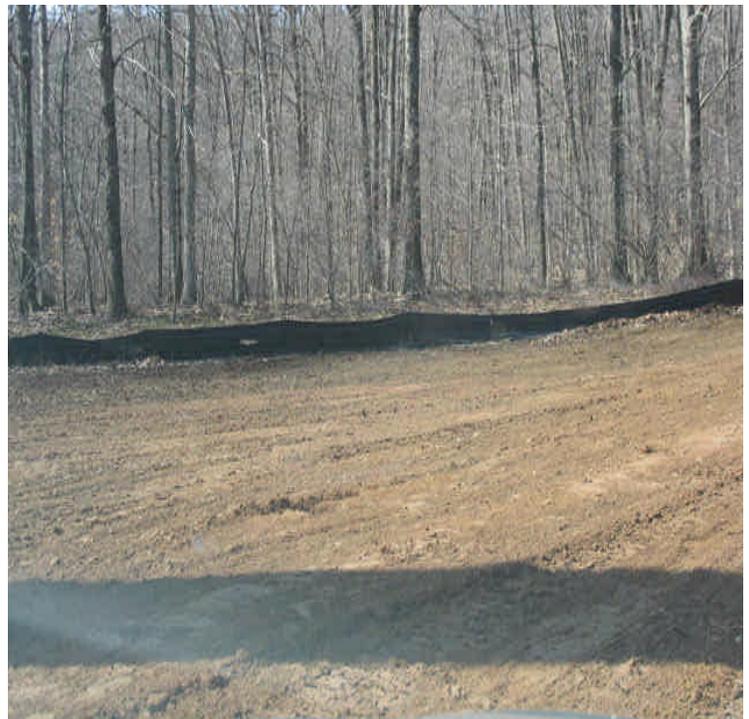
**Johnson Ln: Pad reclamation and soil stabilization were underway.**

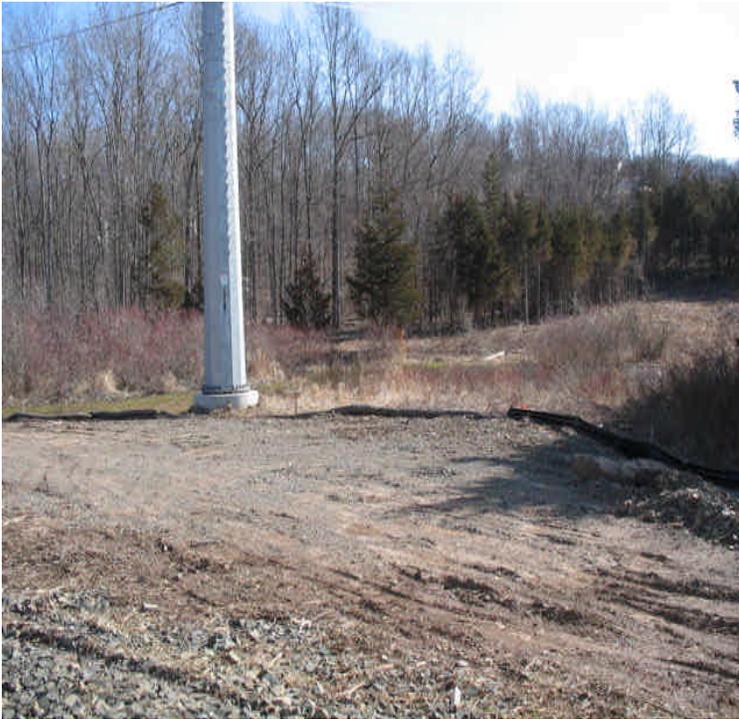
**East of BSS: Contractors plan to remove the remaining stone from the wetland soil here by using a shaker attachment. Care should be taken when reclaiming the area as amphibian breeding has already been observed in the pond.**

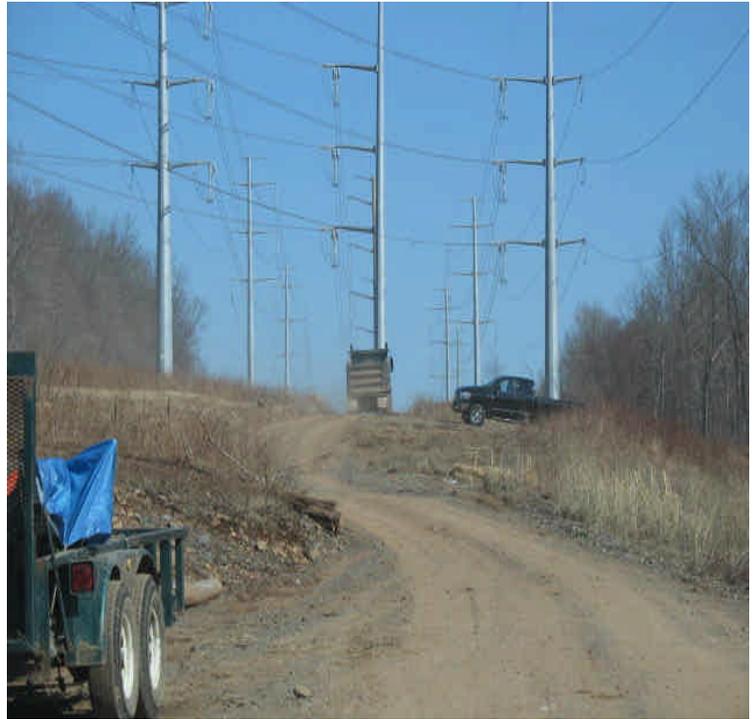
**North of BSS: Reclamation continues along the pads and roads moving north from BSS.**

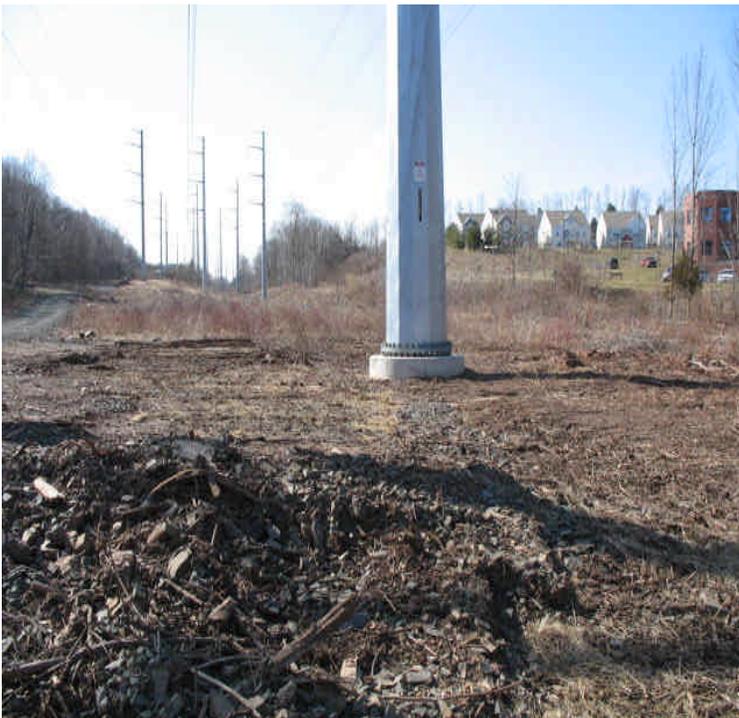
**South of High Hill Rd: Reclamation and final grading is still needed in some areas. Final restoration will continue from BSS north.**

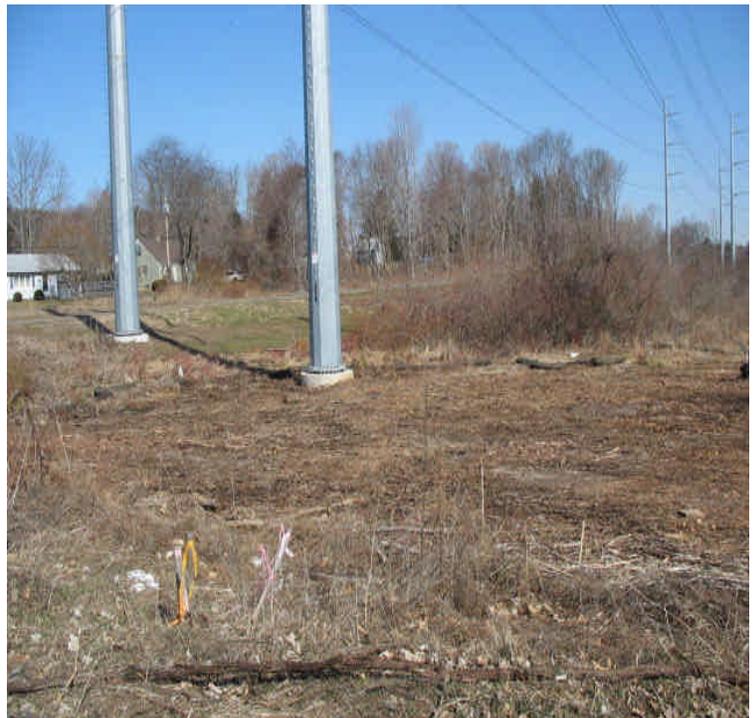
**North of High Hill Rd: Final stabilization is needed as timber mats have been removed. Some controls are in place around the exposed area.**
