Docket No. 272 – Development and Management Plan Inspection

Segment 1a Inspection

Date: April 7, 2008

Location: Segment 1a – Scovill Rock Switching Station to Chestnut Junction, Oxbow Junction to Beseck Switching Station (excluding Royal Oak Bypass), and Black Pond Junction to Beseck Switching Station

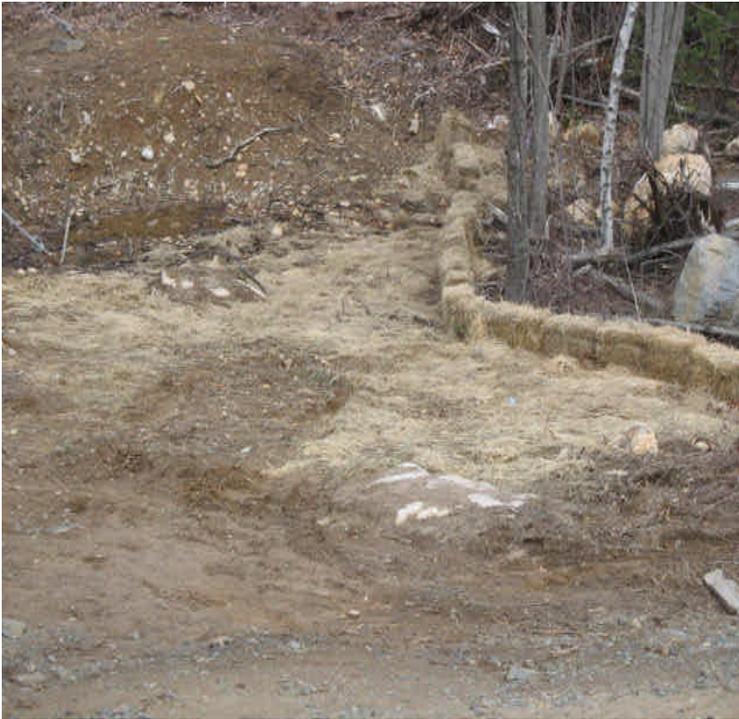
West of Scovill SS: New haybales installed and hay/seed applied upgradient from wetlands adjacent to Scovill SS.

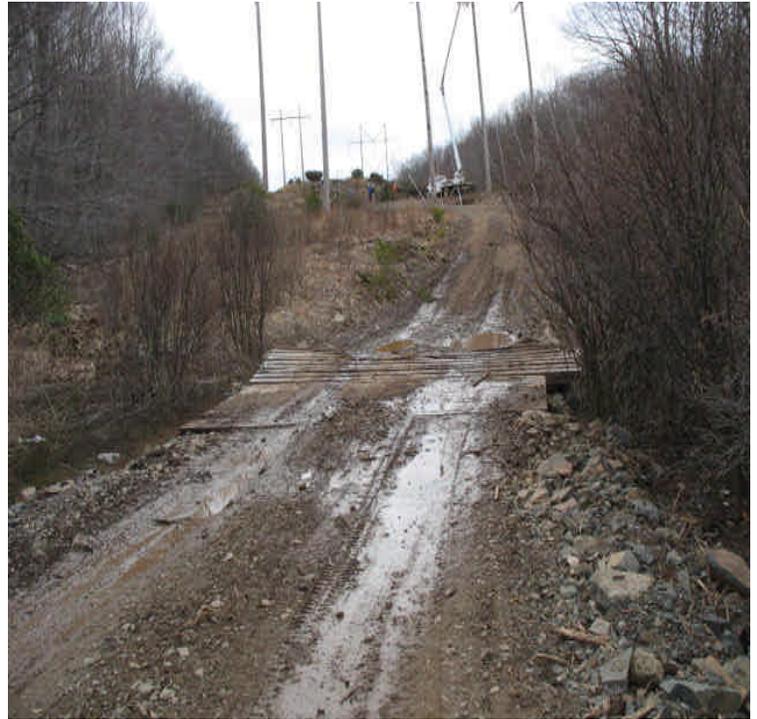
E. Mount Rd: View of wetland crossing and line work at access road leading to Oxbow Jct.

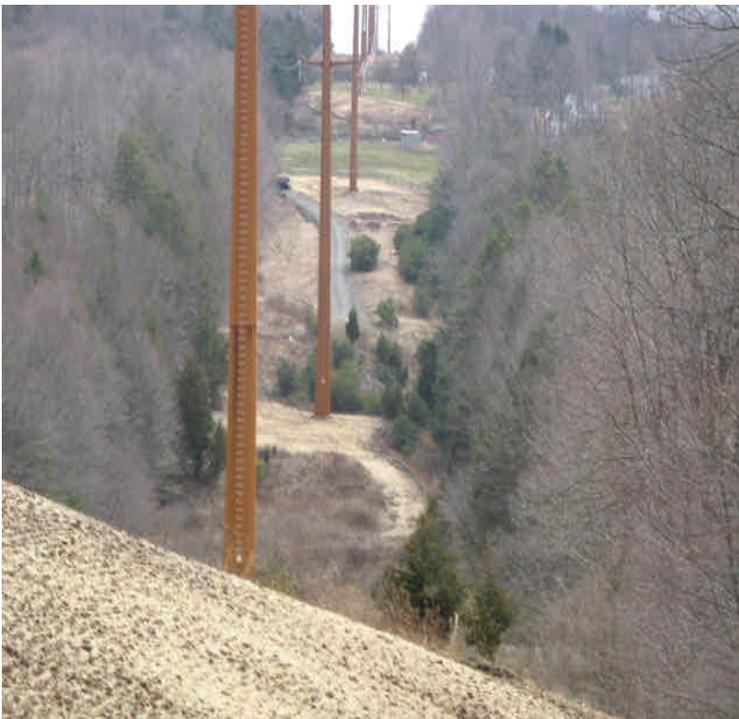
Johnson Ln: Final restoration efforts are complete, looking from Johnson Ln toward Foot Hills Rd.

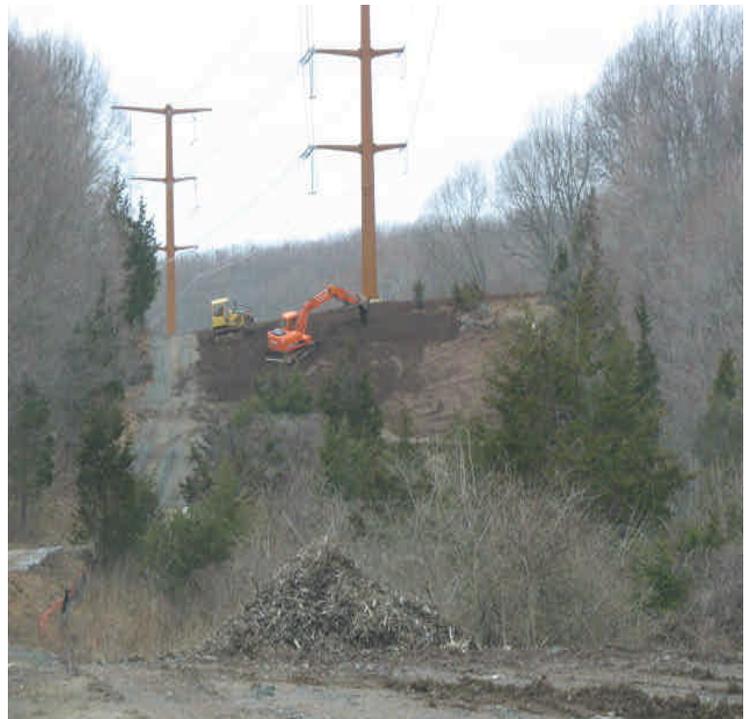
Arbutus St: Restoration continues moving west off Arbutus to the final pad upgradient from Ball Brook.

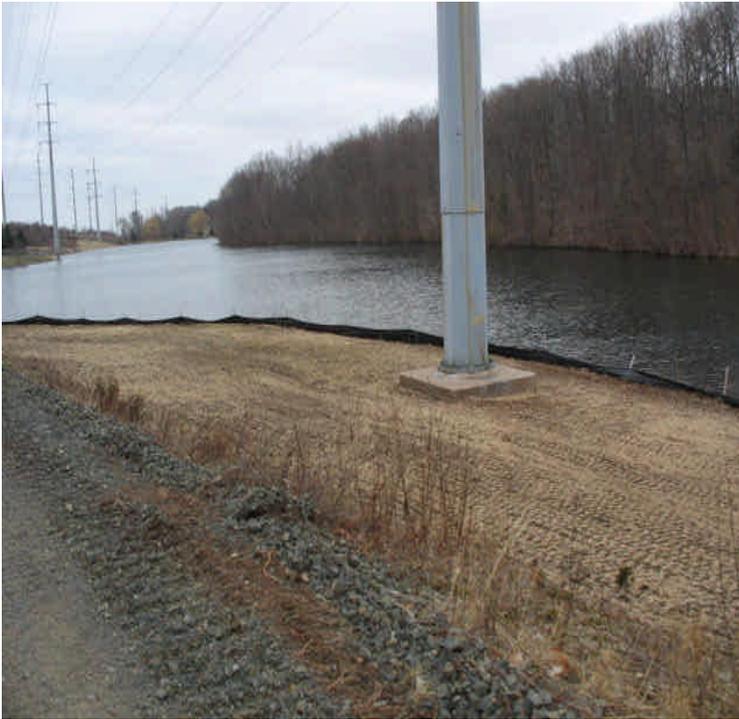
Final Pad accessed North of BSS (#24455): Controls are working well; final restoration efforts are complete.

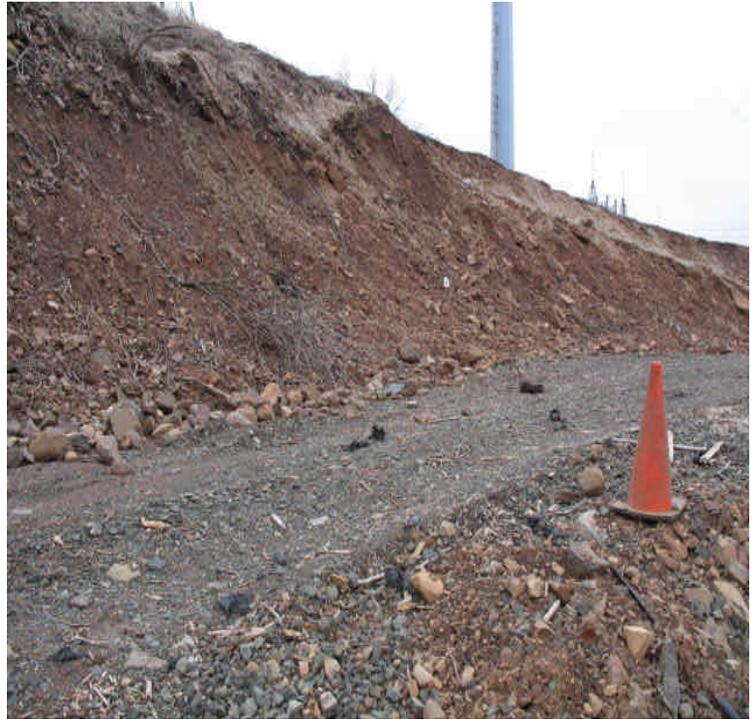
E. Meriden SS: Additional stabilization work has been approved for the exposed slope and erosion issues at structure #24462. Contractors should be implementing this shortly.

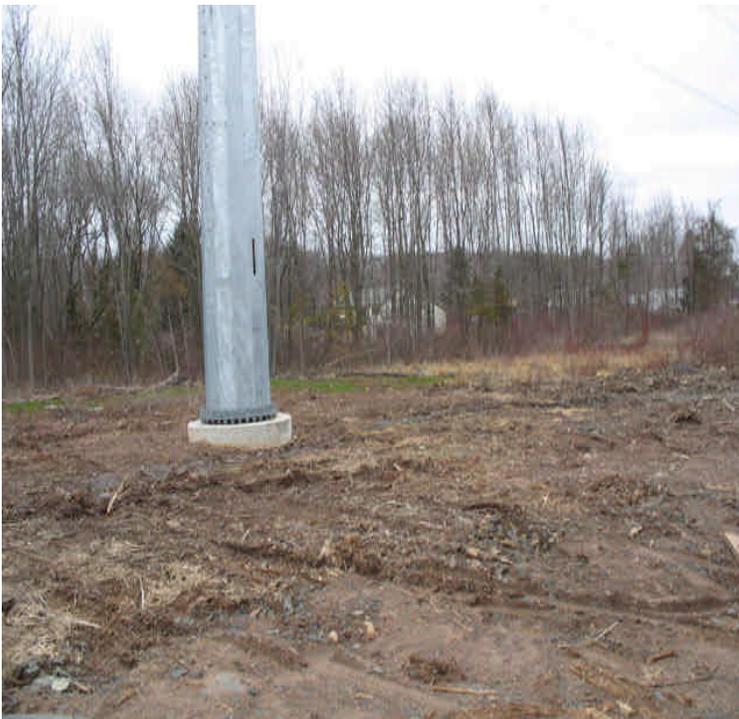
South of High Hill Rd: Final reclamation and stabilization needed at exposed pad sites. Restoration efforts are moving north from Beseck SS.

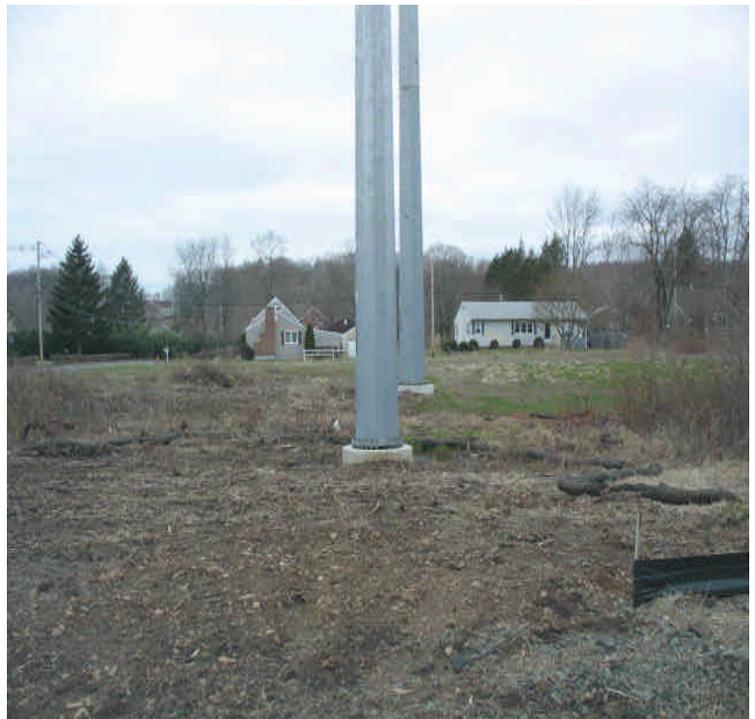
North of High Hill Rd: Final restoration and stabilization needed at exposed pad sites. Stream is clear and temporary controls are in place SS.
