Docket No. 272 – Development and Management Plan Inspection

Segment 1a Inspection

Date: April 29, 2008

Location: Segment 1a – Scovill Rock Switching Station to Chestnut Junction, Oxbow Junction to Beseck Switching Station (excluding Royal Oak Bypass), and Black Pond Junction to Beseck Switching Station

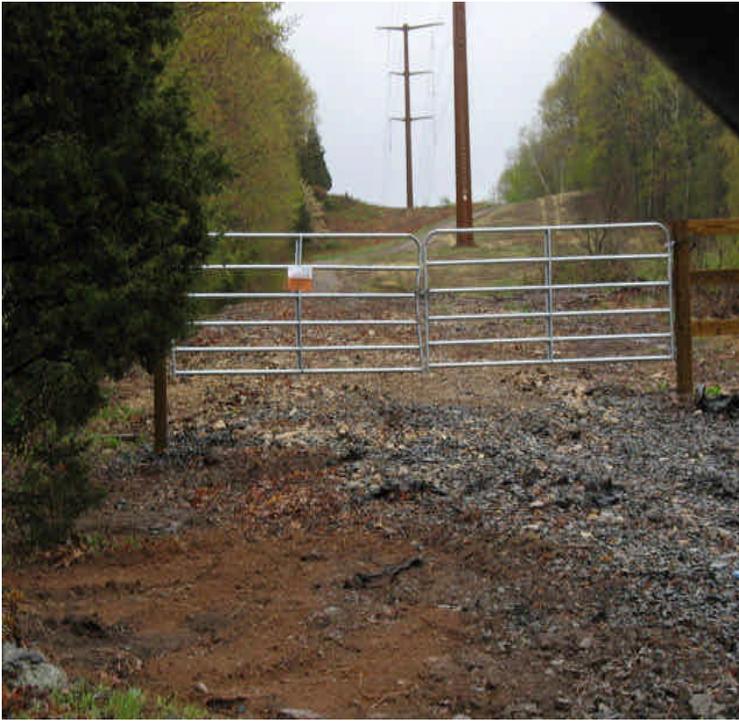
Arbutus Street: Final reclamation is complete along the access road and pads.

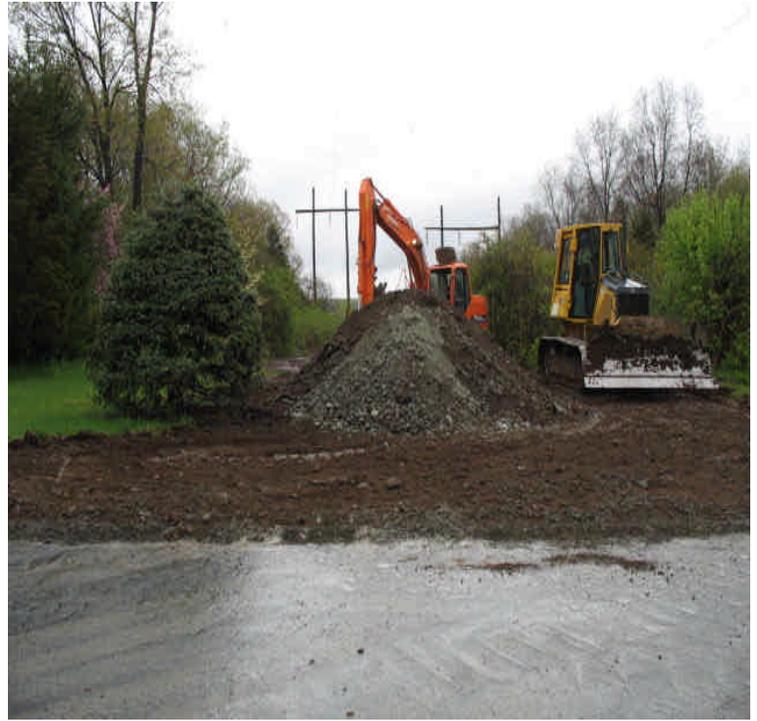
Black Walnut Dr: Final grading and access road restoration underway. Soils were being brought to the contractor receiving yard.

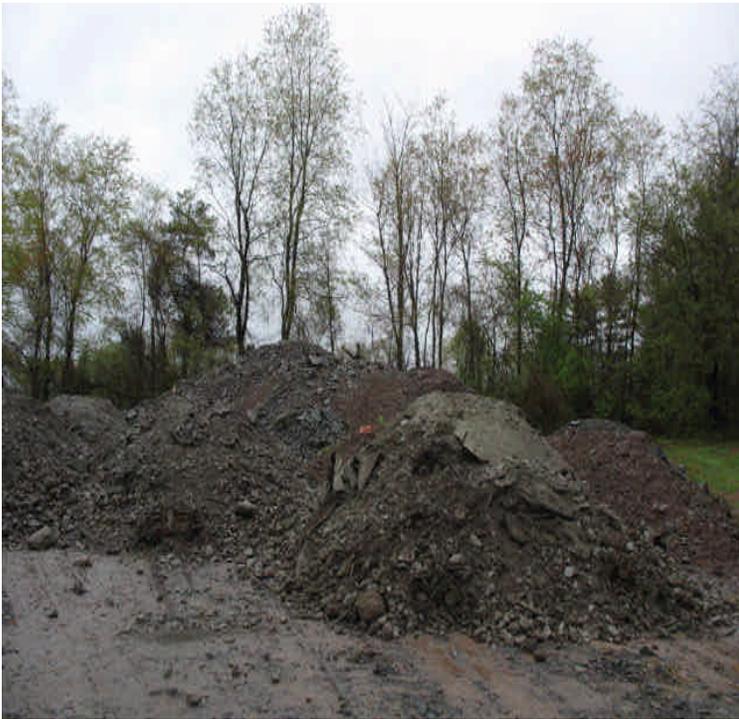
Contractor Yard: Stone and soil stockpiles from Black Walnut are being stockpiled at the edge of the field staging area. Controls are needed upon completion of work or stockpiles should be removed.

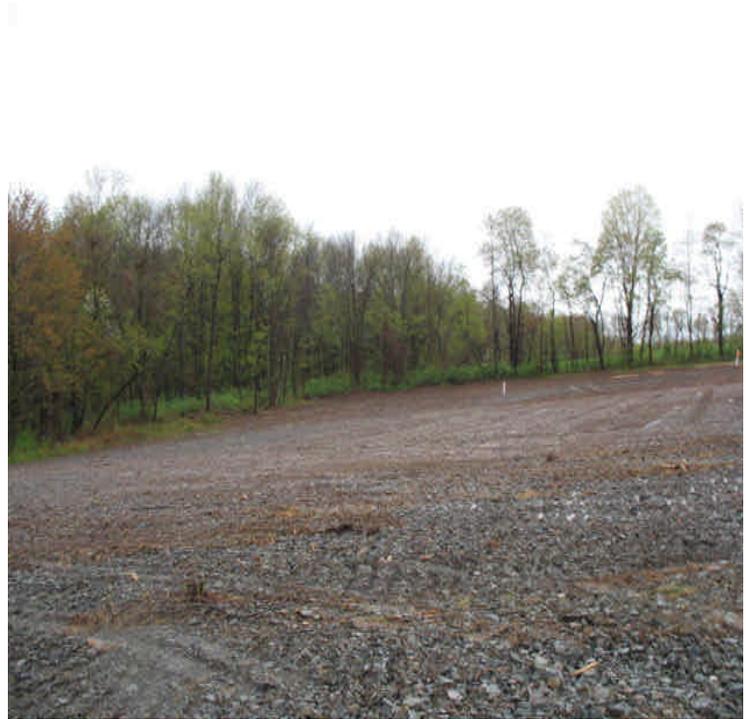
Contractor Yard: Final grading of the field staging area is complete as requested by the landowner. Hay and seed should be applied.

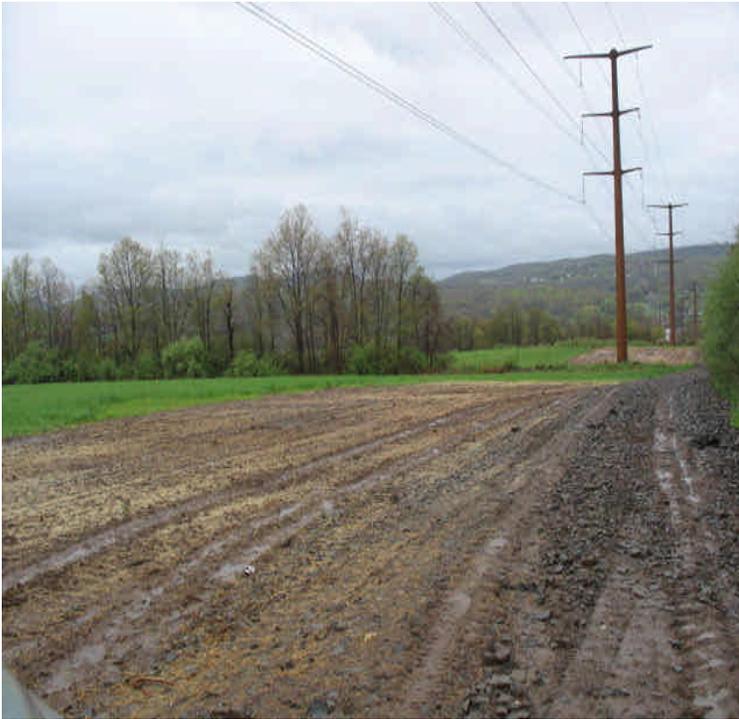
Little Lane: Stockpiles from last weeks work were removed and soils were graded, mulched, and seeded. Continue to monitor for vegetative cover.

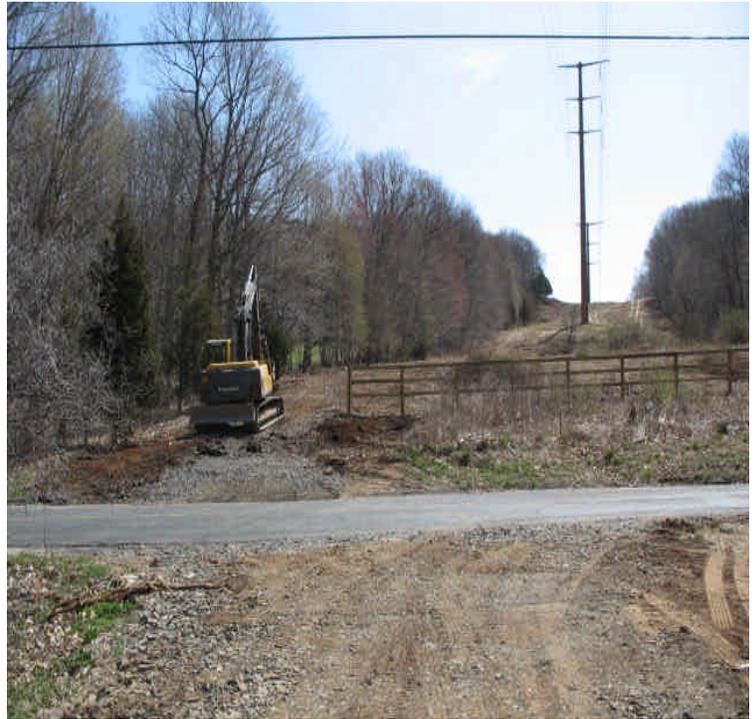
Arbutus Rd. East: Final grading and access road work is underway. Stabilize the exposed areas as needed and continue to monitor.

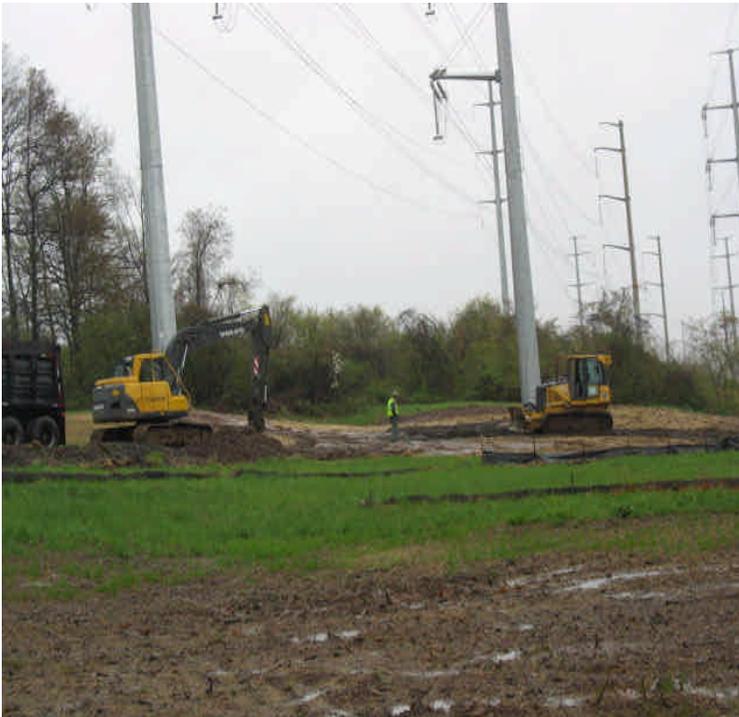
Fleming Rd: Pad and access road removal is underway. Controls are in place along the pond. Stabilize soils upon completion of work and ensure controls are in good shape until vegetation can establish.

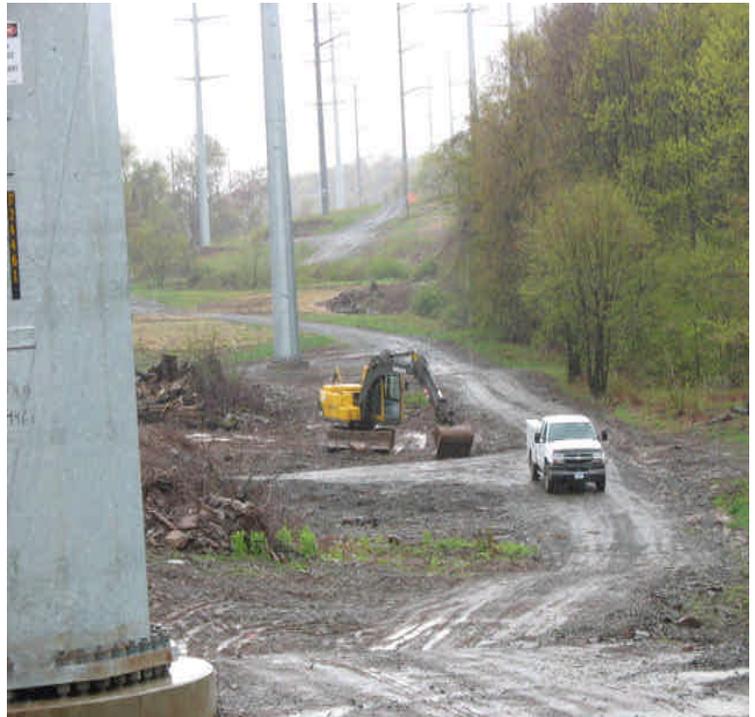
South of E. Meriden SS: Pad grading and site work underway. Stabilize the area upon completion of work.
