Docket No. 272 – Development and Management Plan Inspection

Segment 1a Inspection

Date: May 12, 2008

Location: Segment 1a – Scovill Rock Switching Station to Chestnut Junction, Oxbow Junction to Beseck Switching Station (excluding Royal Oak Bypass), and Black Pond Junction to Beseck Switching Station

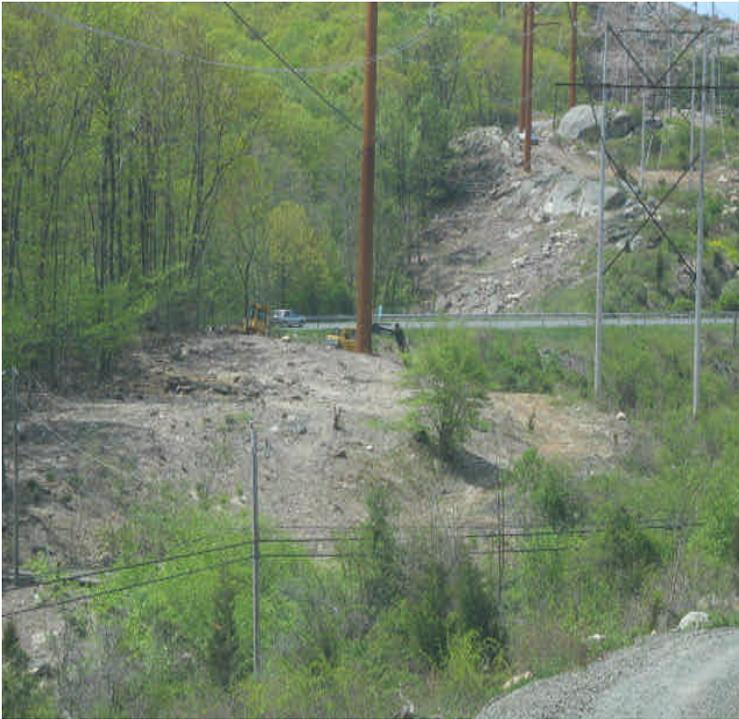
Rte 9: Final grading and reclamation underway.

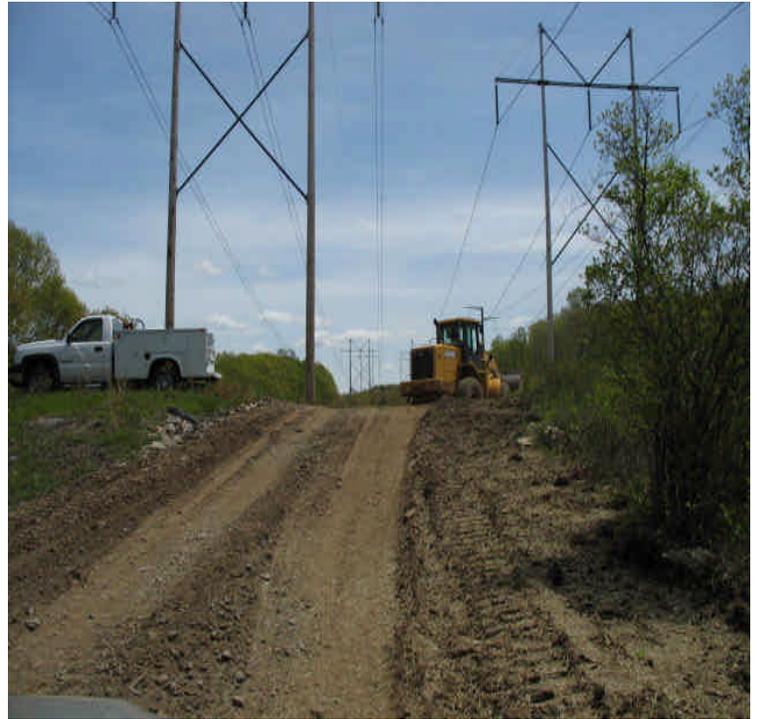
Shunpike Rd: Final grading and stabilization measures underway. Crews were removing the timber mats and resurfacing the access roads as needed.

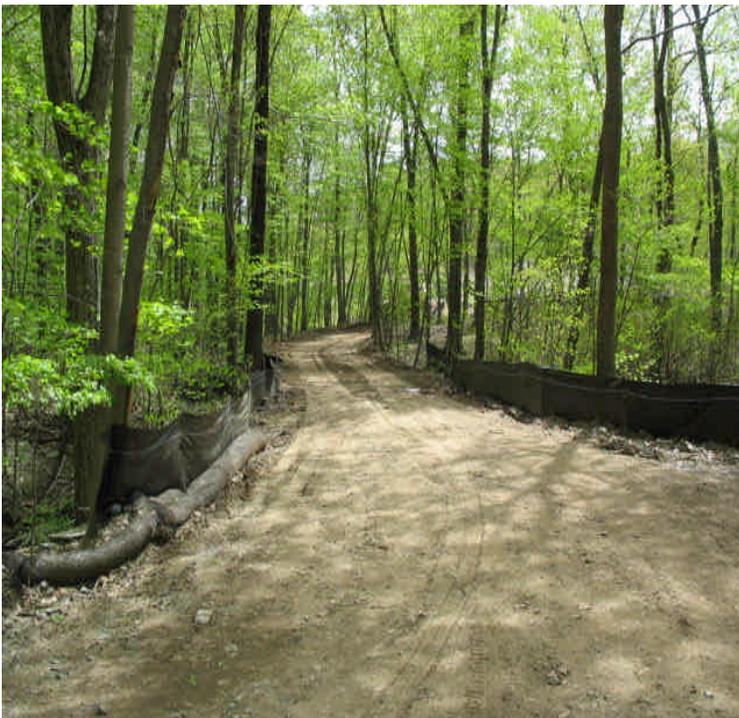
Shunpike Rd.: Access road crossing was regraded and new controls were installed or repairs were made prior to working in the area.

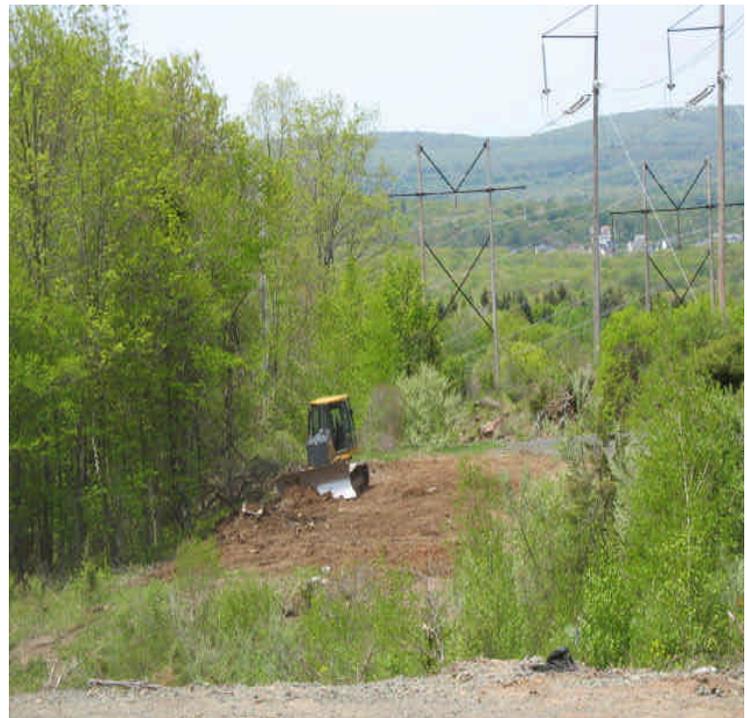
Chestnut Jct: Final grading and stabilization are underway.

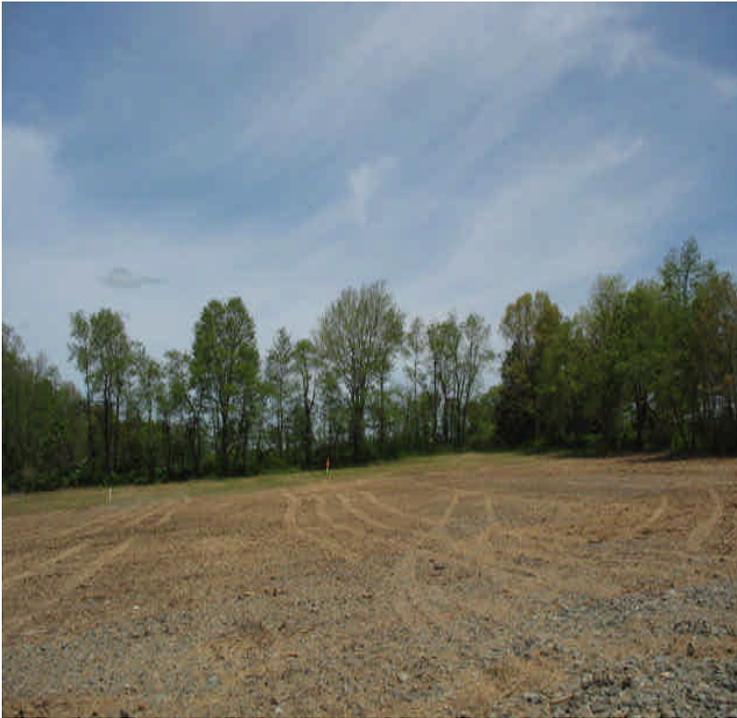
Contractor Yard: Hay and seed applied at the recently graded staging area.

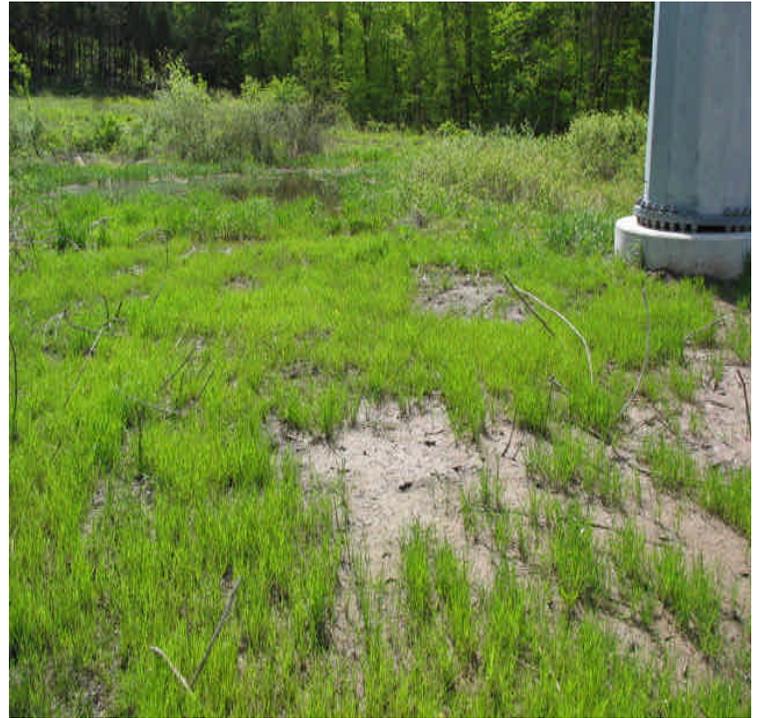
| Areas of Inspection | Observation | Recommended Action | Corrected Action |
|---|---|---|--|
| <p>East of Beseck SS</p> | <p>Some sediment and stone/soil from the old pad remain in the wetlands. (noted since 10/22) however, BSC evaluated this with B&M and agreed with their further assessment that native soils were also extremely stony in this area and that the previously proposed shaker attachment would likely remove too much material. 5/12/08</p> | <p>A few small areas of stone dust piles or trap rock remain in the pad and B&M agreed to clean up these areas by hand. 5/5-5/12/08</p> | <p>Area was evaluated and some minor, low-impact restoration will be provided.</p> |

East of BSS: Minor amounts of soil and stone remaining in wetlands will be removed by hand as the area dries out.

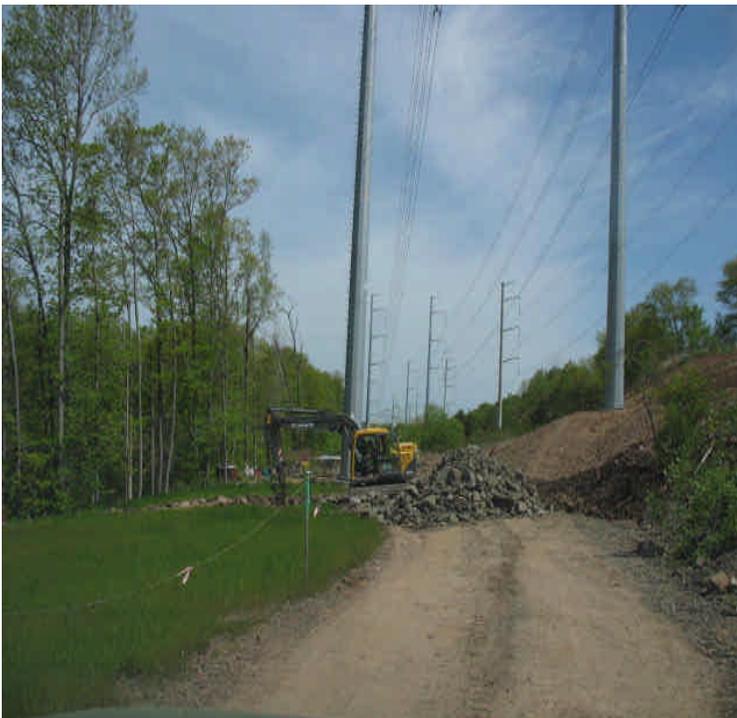
E. Meriden SS (west): Final grading was completed and seed and mulch have been applied at structure #24462. Contractor was installing a riprap channel to prevent future erosion problems near the pond.

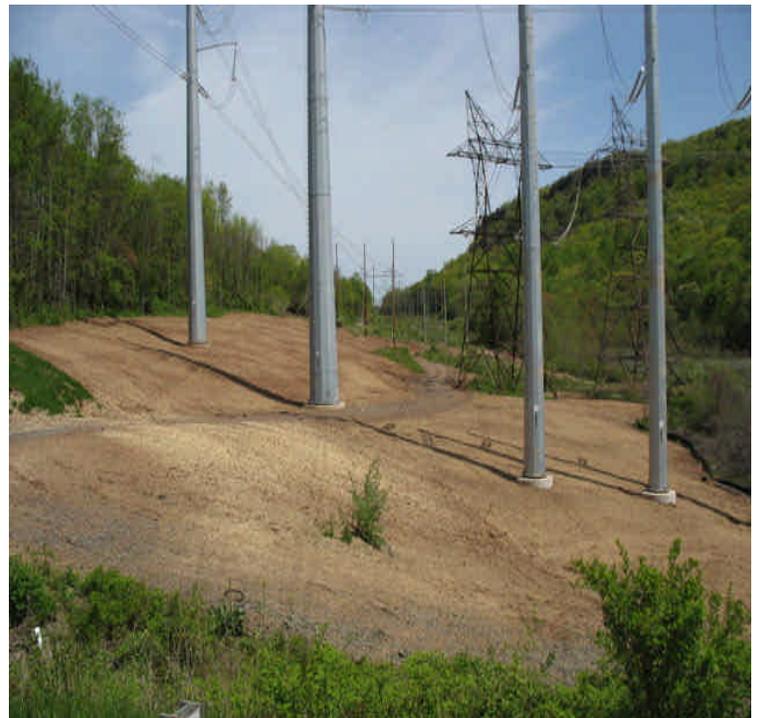
Black Pond Jct: Final grading complete and hay and seed applied over exposed soils. Controls remain intact. Continue to monitor for final cover.
