Docket No. 272 – Development and Management Plan Inspection

Segment 1a Inspection

Date: June 2, 2008

Location: Segment 1a – Scovill Rock Switching Station to Chestnut Junction, Oxbow Junction to Beseck Switching Station (excluding Royal Oak Bypass), and Black Pond Junction to Beseck Switching Station

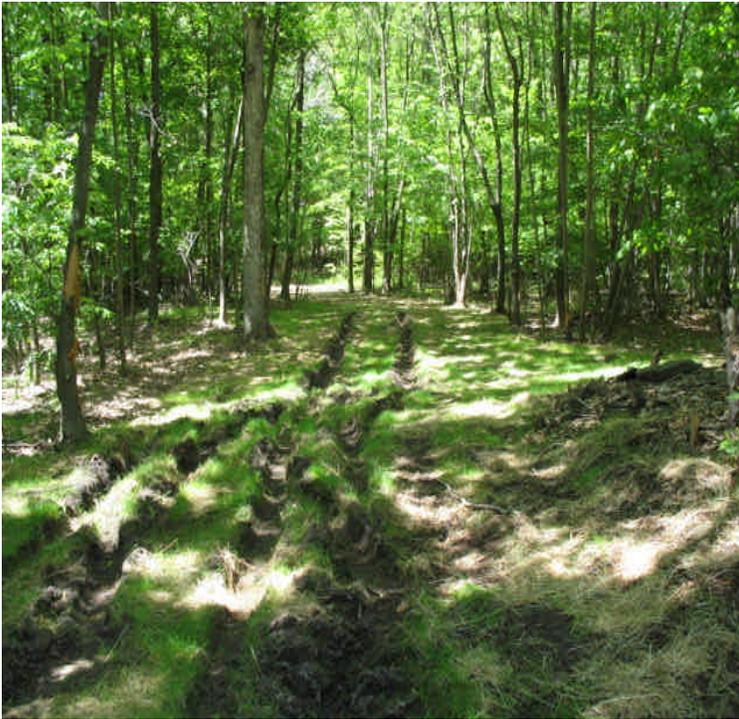
West of Shunpike Rd.: Final grading had previously occurred and Grass growth was noted, however vehicles had since tracked through.

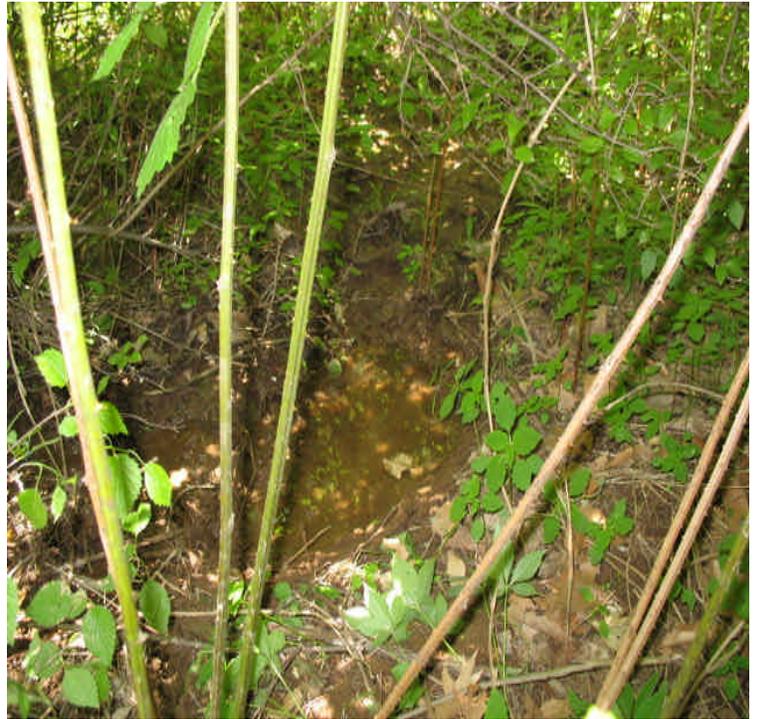
East Mount Rd: Sediment run-off deposits were removed by hand, from the wetland.

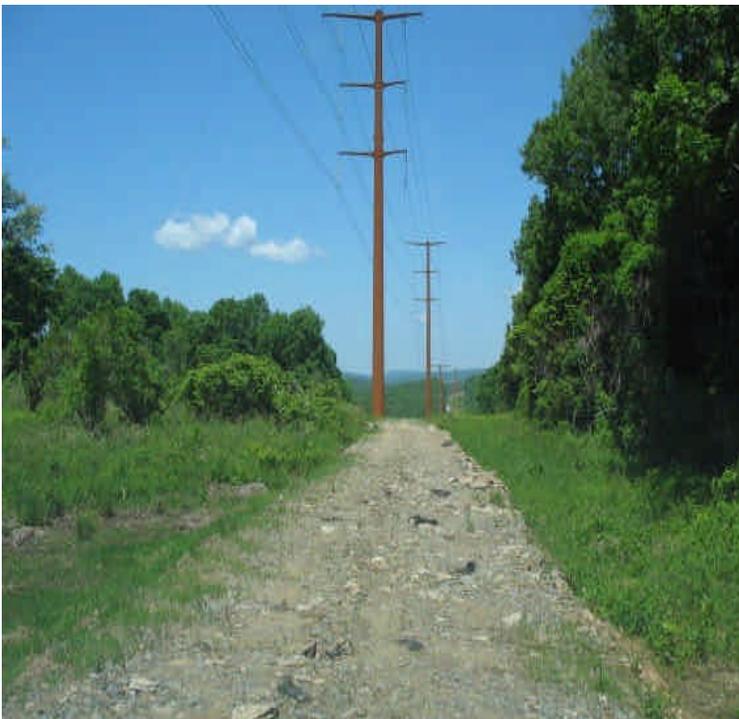
Haddam Quarter: Access road crossing is currently dry. Culverts should be installed to take advantage of the conditions.

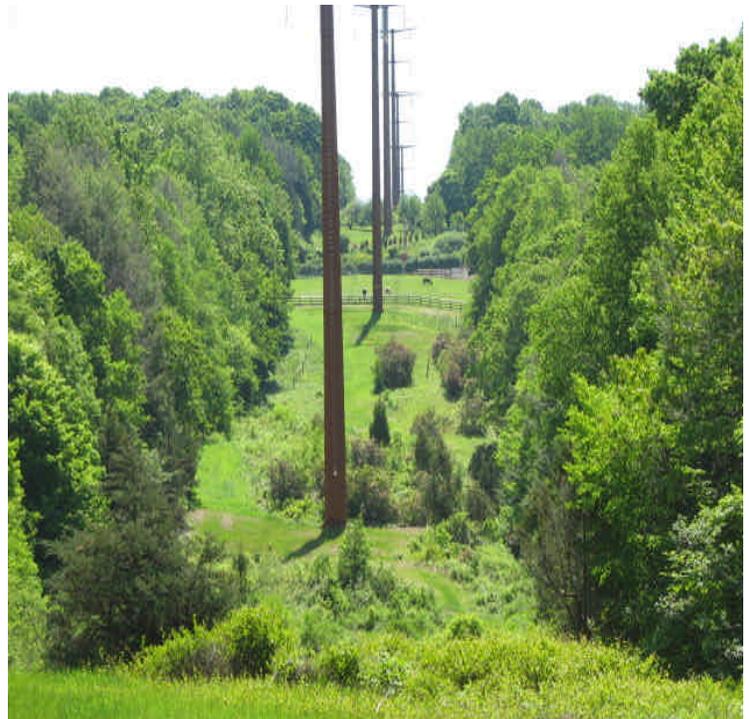
Johnson Ln: Final restoration complete and good grass growth noted. View looking from Johnson east to Foot Hills Rd at the restored access road and ROW.

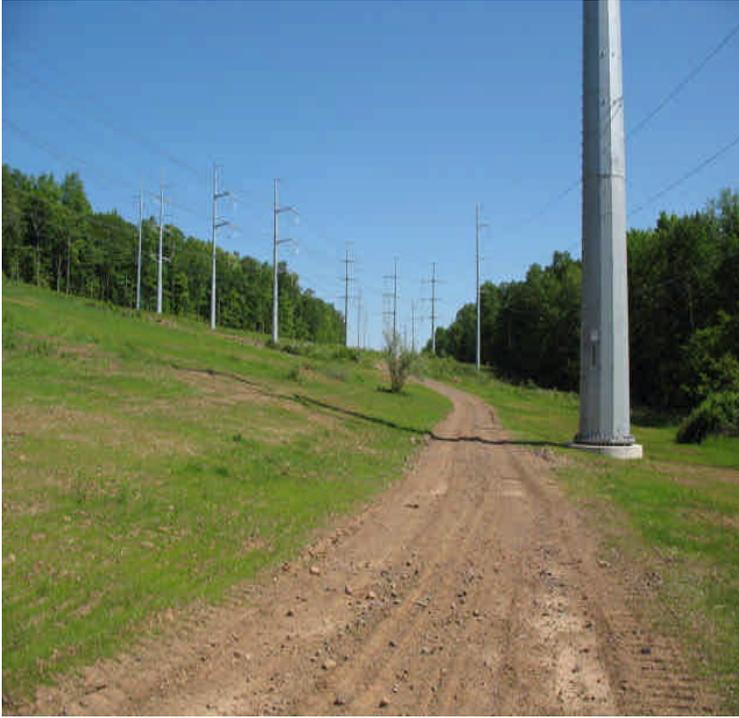
North of Beseck: Final restoration complete. Grass growth noted.

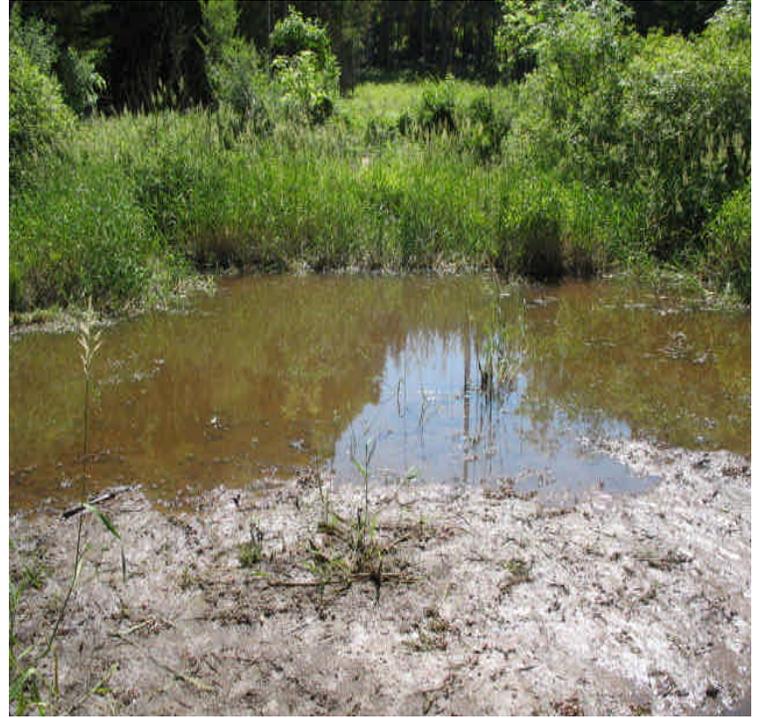
East of Beseck: Remaining minor amounts of stone were removed by hand, from the wetland.

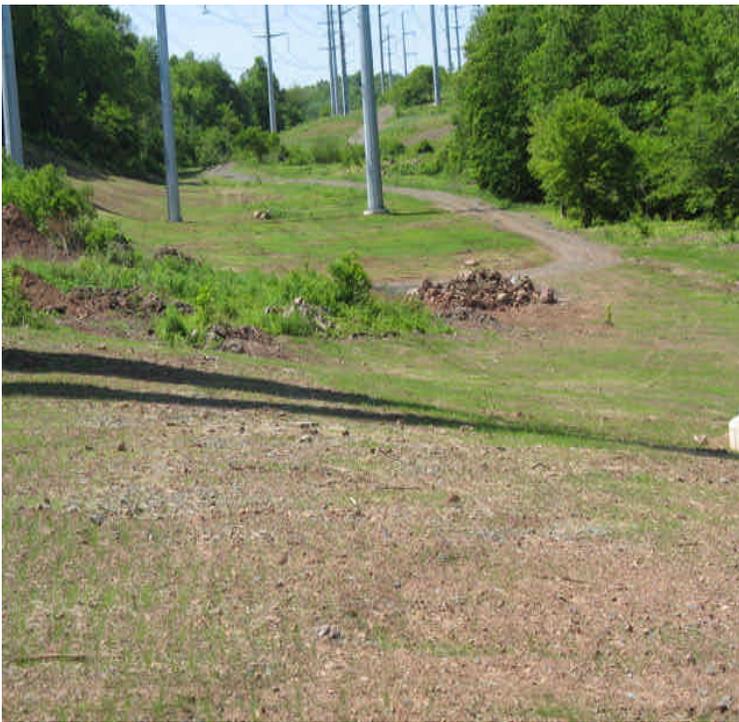
South from E. Meriden SS: Restoration complete. Small pile of stone remains.

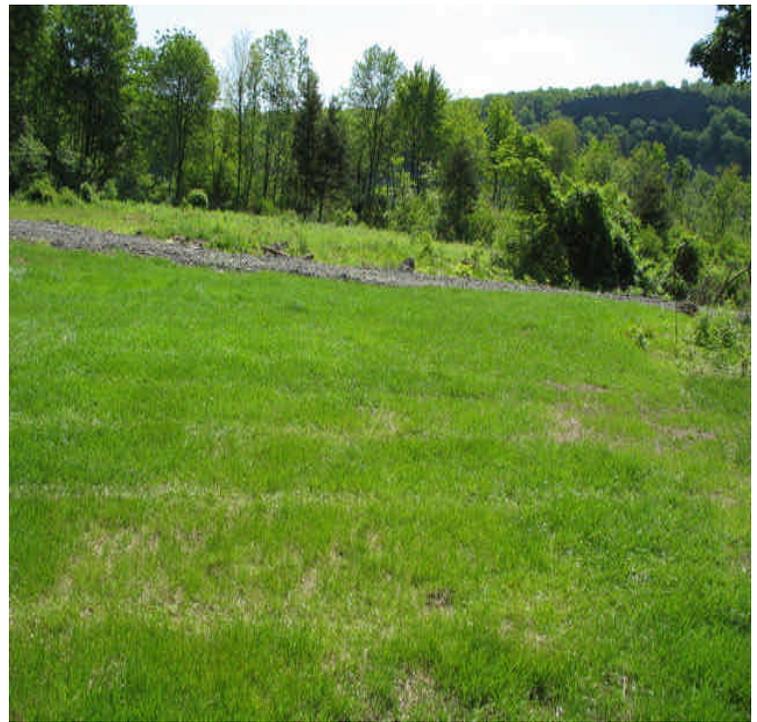
South of E. Main St: Final restoration complete. Grass growth noted at the site entrance.
