Docket No. 272 – Development and Management Plan Inspection

Segment 1a Inspection

Date: June 10, 2008

Location: Segment 1a – Scovill Rock Switching Station to Chestnut Junction, Oxbow Junction to Beseck Switching Station (excluding Royal Oak Bypass), and Black Pond Junction to Beseck Switching Station

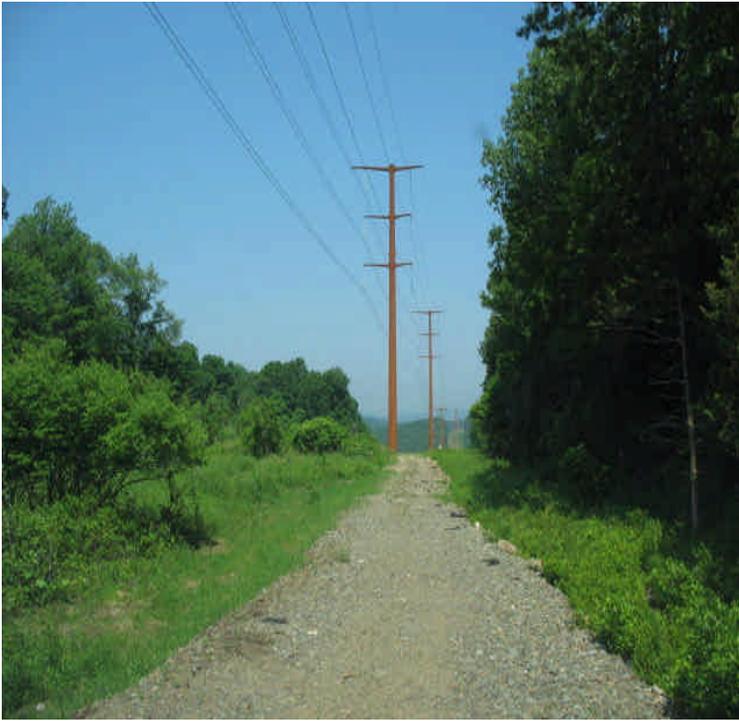
Areas of Inspection	Observation	Recommended Action	Corrected Action
<p>Oxbow Junction to Beseck SS Haddam Quarter Rd.</p>	<p>are likely not project related. (since 6/2) A gate has been installed. 6/10/08</p> <p>The permitted permanent access road remains in place. Stone fill bisects the wetland and no culverts were installed. 4/21-6/10/08</p>	<p>Contractors stated they will likely be installing a culvert to maintain the hydrologic connection within the wetland. Work may wait to be completed in a low flow period. 4/29-6/10/08</p>	<p>Needs evaluation. Contractors will be installing a culvert in appropriate conditions.</p>
<p>Foot Hills Rd. to Durham Rd. (east) Powder Hill Rd.</p>	<p>Topsoil, hay, and seed remain at the reclaimed access roads and pad sites. 6/10/08</p>	<p>Monitor reclaimed areas for erosion and add controls as needed. 6/10/08</p>	<p>Restoration complete</p>
<p>Durham Rd</p>	<p>The stone access road in the large wetland system remains. During restoration it will be brought to grade and narrowed. A small area near the entrance has been reclaimed. 6/10/08</p>	<p>Stabilize exposed areas as soon as possible and continue to reclaim the roadway. See inland wetland section. Be careful to remove material here and reduce impacts. 6/10/08</p>	<p>NA at this time. Restoration still scheduled here.</p>

Haddam Quarter Rd: Access road crossing. Vegetative growth noted. Conditions are dry and culvert installation should be considered at this time.

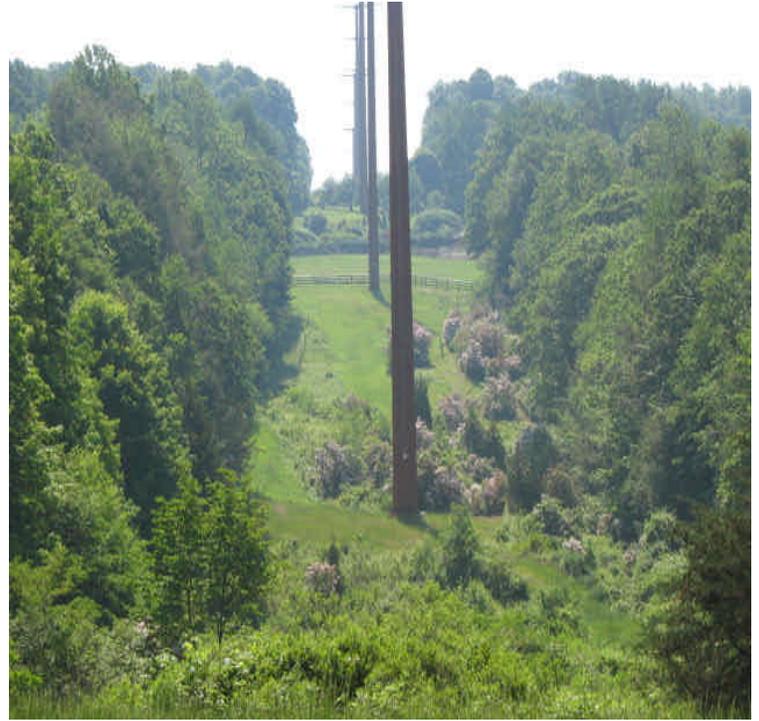
Johnson Ln: Final restoration complete and good vegetative cover noted. View looking from Johnson east to Foot Hills Rd at the restored access road and ROW.

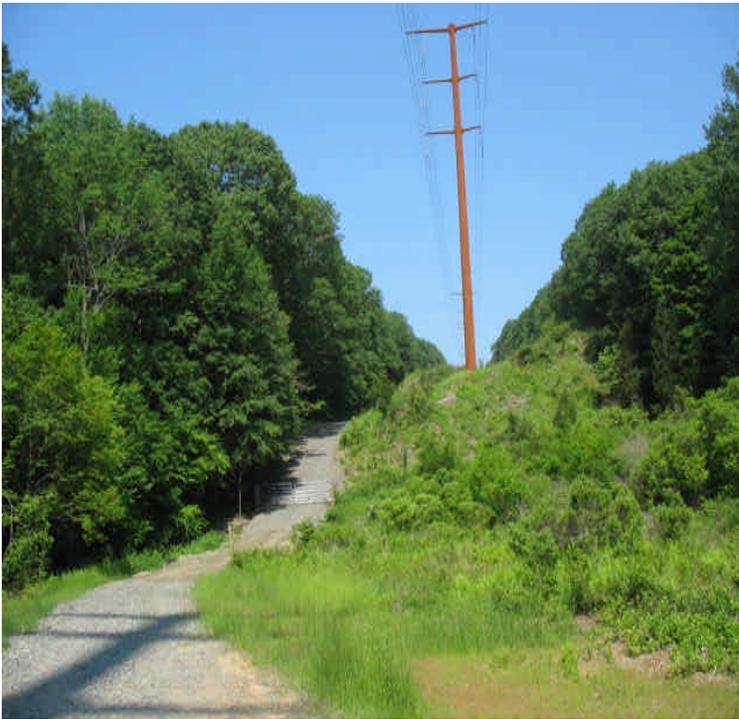
Johnson Ln: Final restoration complete and good vegetative cover noted. View looking from Johnson west toward Arbutus.

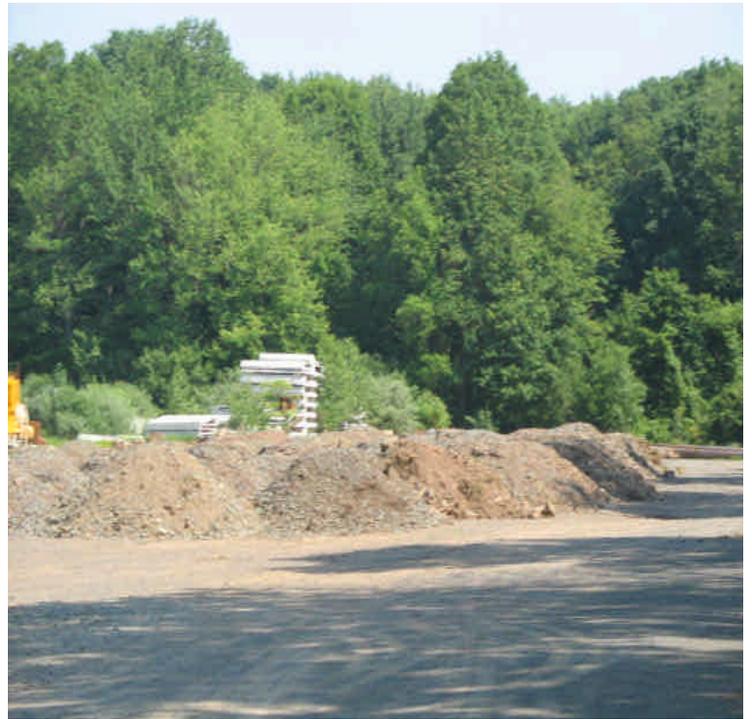
1A and 1B Contractor Receiving Yard and Staging Area	Materials are being stored in this area. Fuel tanks are not present. Soil/stone stockpiles from the reclamation of multiple sites were being stored here. 6/10/08	Continue to locate hazardous materials and equipment away from wetland inlets such as culverts and CBs. See erosion control section regarding stockpiles 6/10/08	NA
Additional Observations	NA	NA	NA

Contractor Receiving Yard: Additional soil/stone stockpiles continue to be added from several sites along the ROW. All stockpiles should be temporarily stabilized and/or removed as soon as possible.

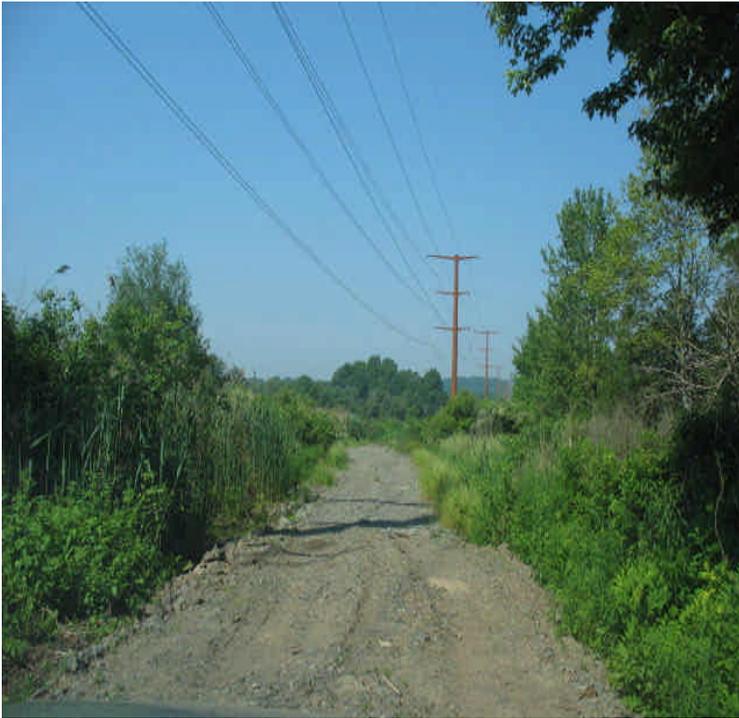
Durham Rd.	Timber mats and some of the stone from the access road were removed from this area. 6/10/08 BSC was informed that ACOE is allowing this road to remain at or within 2" of the adjacent grade so that sheet flow can occur. The road will also be narrowed. 6/10/08	When restoration occurs, the road base will remain at grade (for structure access). Remove the appropriate amount of stone and narrow the road to the extent feasible (This will likely be 15 feet based on NU's needs). Be extremely careful during this work to reduce impacts. 4/21-6/10/08	Reclamation will continue. Continue to monitor very carefully.
Powder Hill Rd.	The major crossing near the pond remains but all other crossings and channels remain restored 6/10/08	Monitor the exposed areas and controls closely in this area until stabilization is complete. 6/10/08	Continue to monitor.

Durham Rd: Access road will remain in the wetlands however, it will be brought to grade and narrowed.

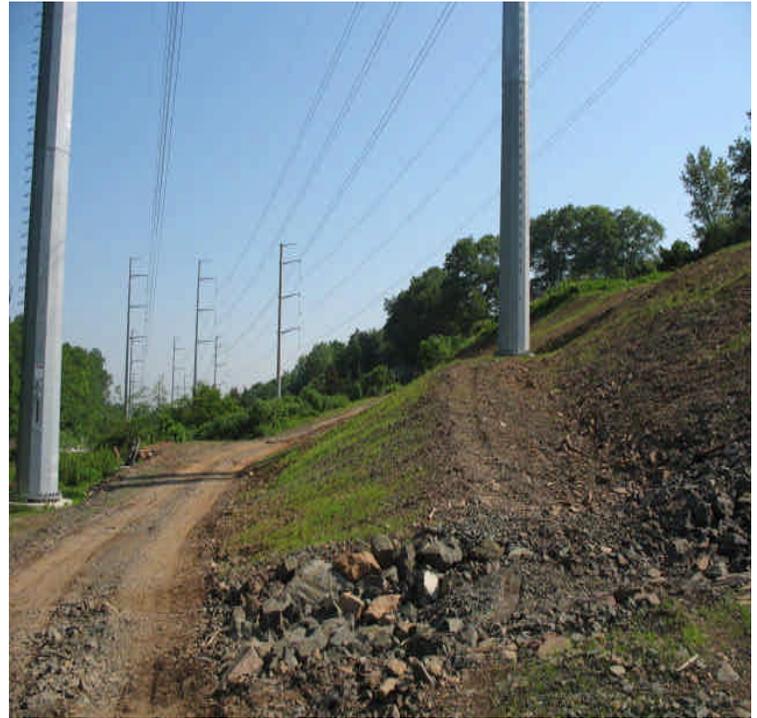
E Meriden SS: Final restoration complete. Some grass growth noted along the slope.

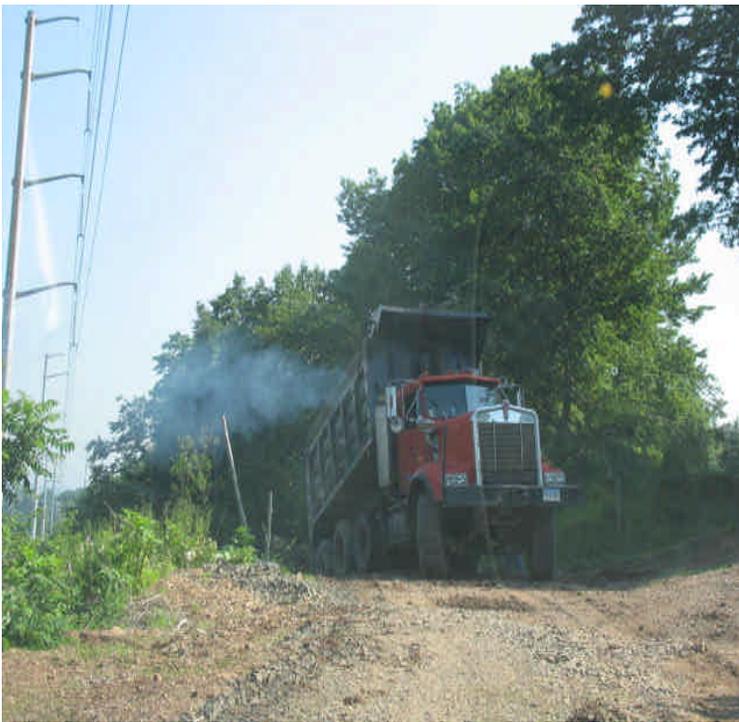
<p>East Meriden SS</p>	<p>Access road removal was underway at a homeowner's request.</p>	<p>Monitor for stabilization and add controls as needed along the slope.</p>	<p>NA at this time.</p>

E Meriden SS: Crews were removing a section of access road as per the homeowner's request. Topsoil, hay and seed were being added along the exposed slope.

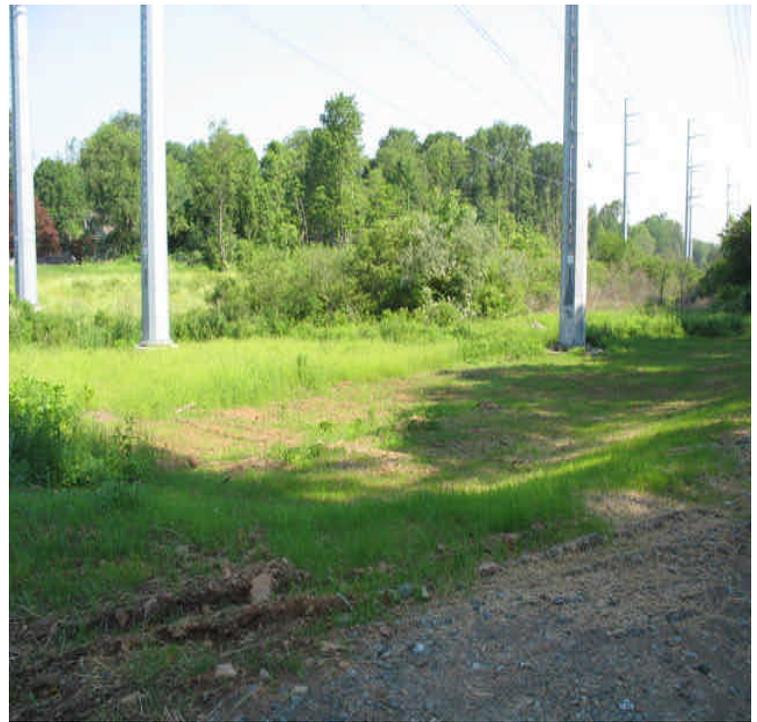
North of High Hill: Final restoration complete. Grass growth noted.
