Docket No. 272 – Development and Management Plan Inspection

Segment 1a Inspection

Date: June 23, 2008

Location: Segment 1a – Scovill Rock Switching Station to Chestnut Junction, Oxbow Junction to Beseck Switching Station (excluding Royal Oak Bypass), and Black Pond Junction to Beseck Switching Station

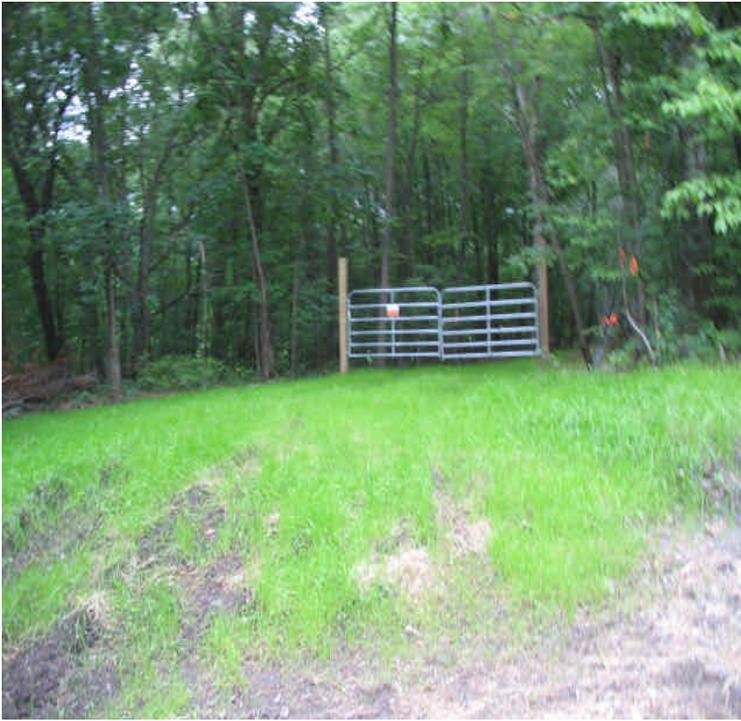
Shumpike Rd.	The gate remains in an effort to prevent further tracking in the recently restored access west off Shumpike Rd. Grass cover remains. 6/23/08	Continue to try and restrict access as feasible. 6/23/08	NA at this time.

Shumpike Rd: View of vegetative growth/cover at the access road gate.

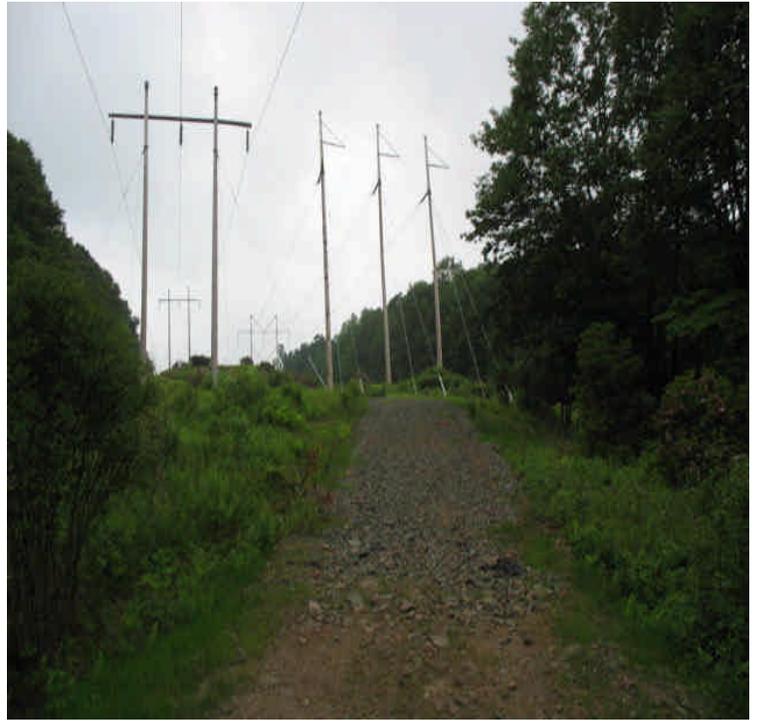
Bartholomew Rd: Final restoration complete, vegetative growth noted

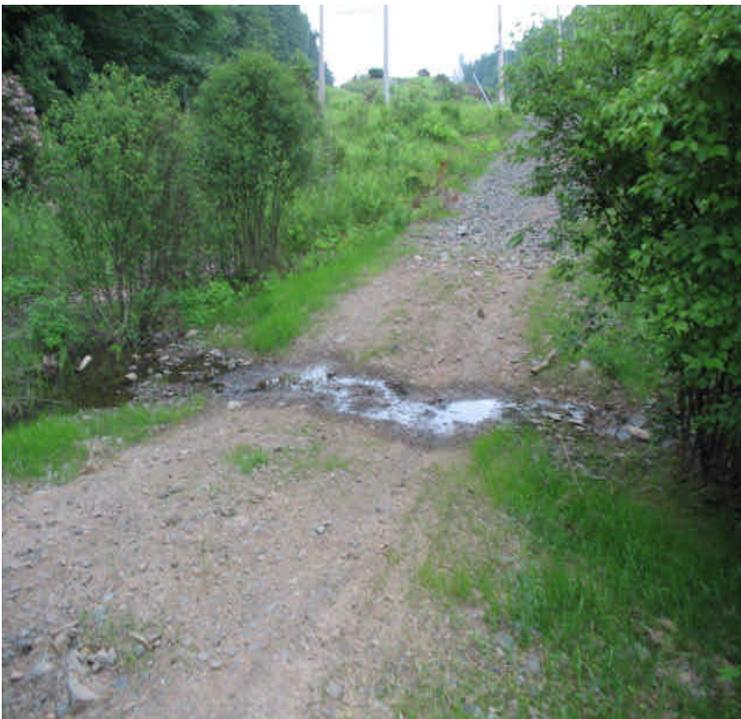
East Mount: View of the second wetland crossing following the reclamation/restoration activities.

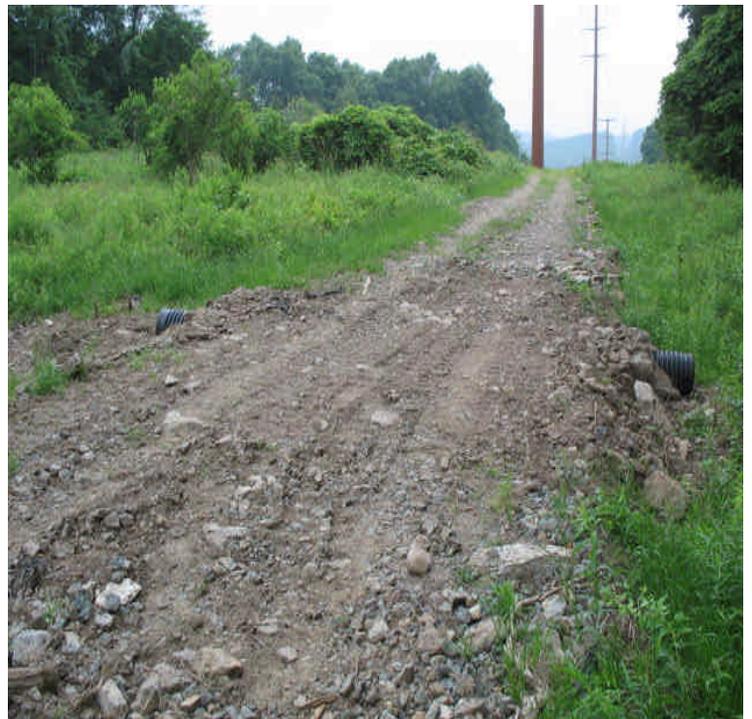
Haddam Quarter Rd: New culvert was installed at the previously bisected wetland crossing.

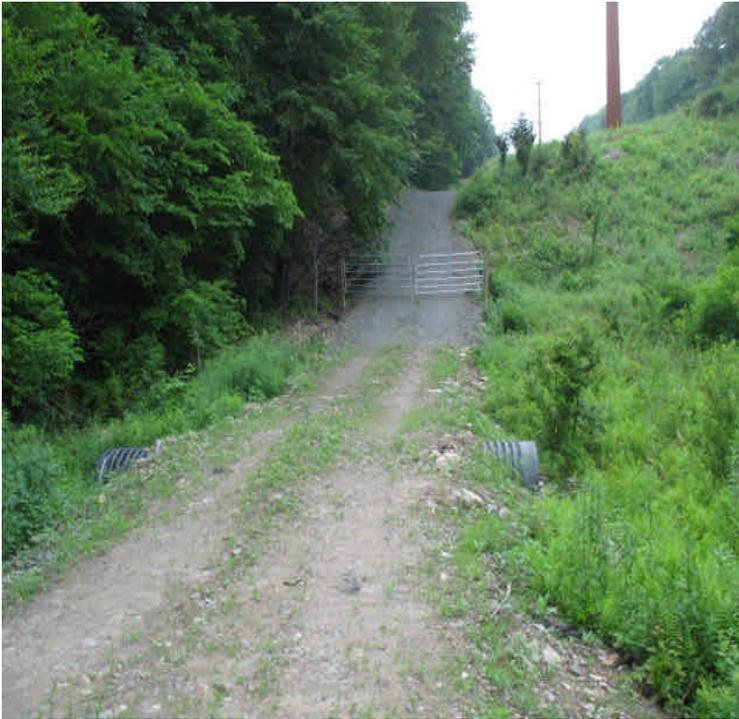
Johnson Ln: Wetland crossing water is clear and flowing through the culvert.

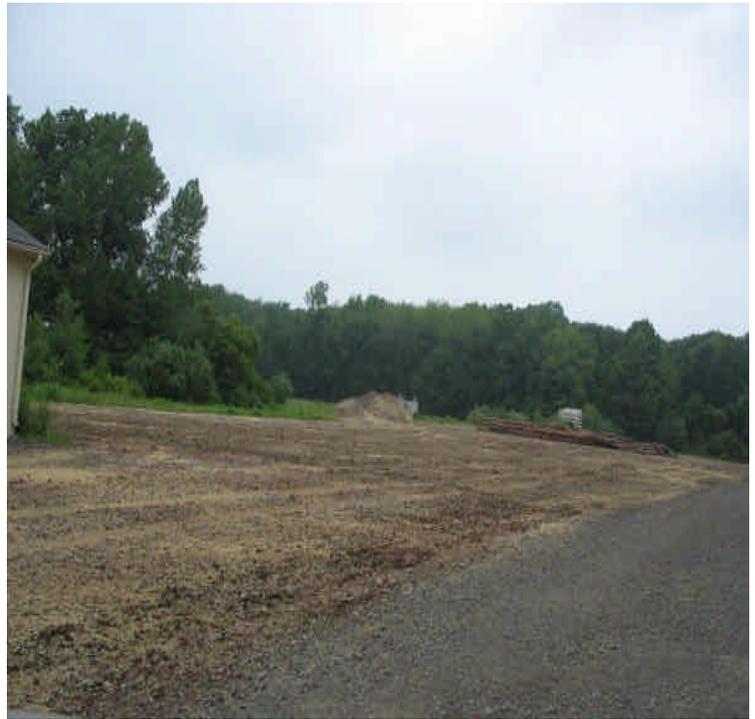
Contractor Yard: Stockpiles have been graded and the area was mulched and seeded.

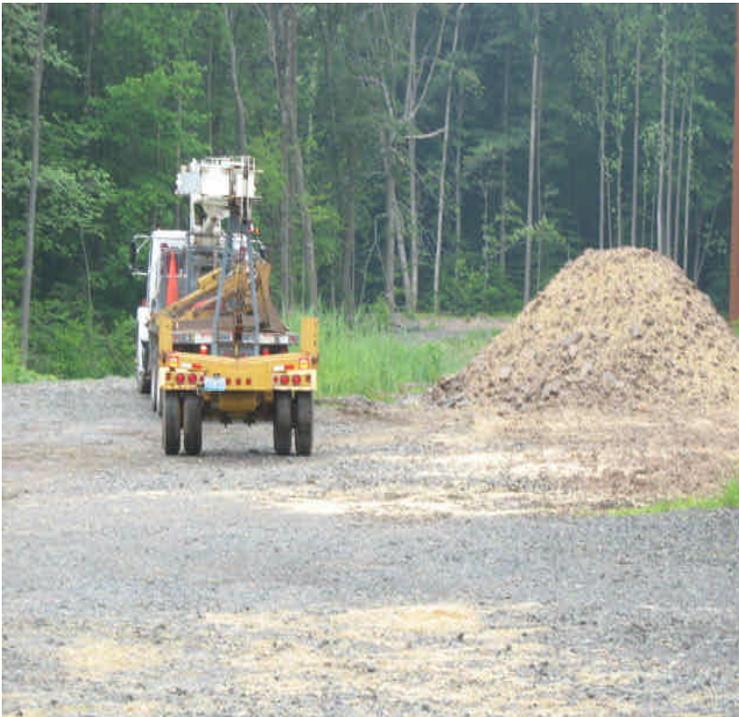
Contractor Yard: View of one of two remaining stockpiles left. The stockpile is located upgradient from the wetlands at the entrance to Segment 1B and is mulched for temporary stabilization.

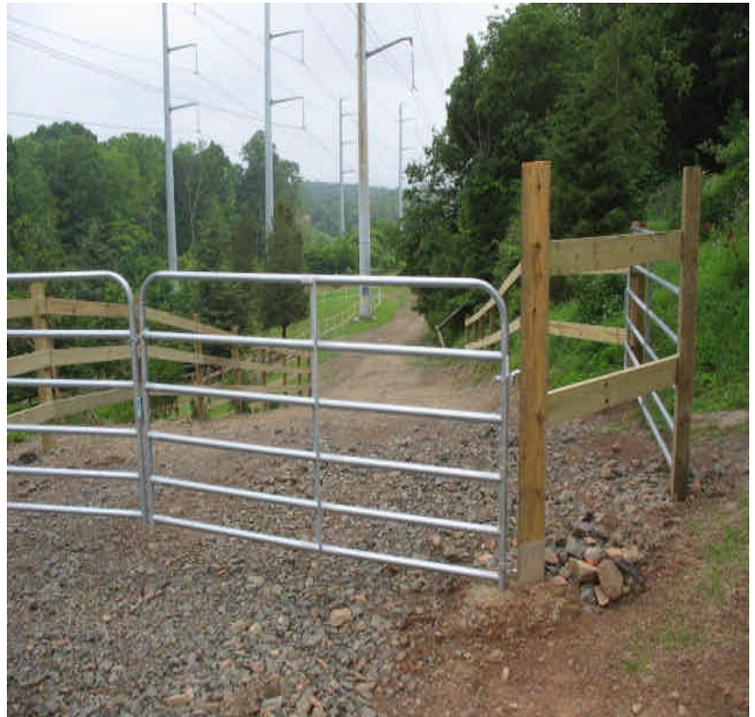
East Meriden SS	A fence was installed across the access road. Shrubs installed across the ROW. The re-graded access road remains mulched and seeded. 6/23/08	Monitor for stabilization and add controls as needed along the slope. Monitor newly planted shrubs until established. 6/23/08	New shrubs and a fence were installed.
Foundation and site construction	With the exception of Durham Rd. and a few minor areas. Reclamation is largely complete in Seg	None at this time. 6/23/08	NA at this time.

E. Meriden SS: New fence has been installed near the horse stable.
