Docket No. 272 – Development and Management Plan Inspection

Segment 1a Inspection

Date: June 30, 2008

Location: Segment 1a – Scovill Rock Switching Station to Chestnut Junction, Oxbow Junction to Beseck Switching Station (excluding Royal Oak Bypass), and Black Pond Junction to Beseck Switching Station

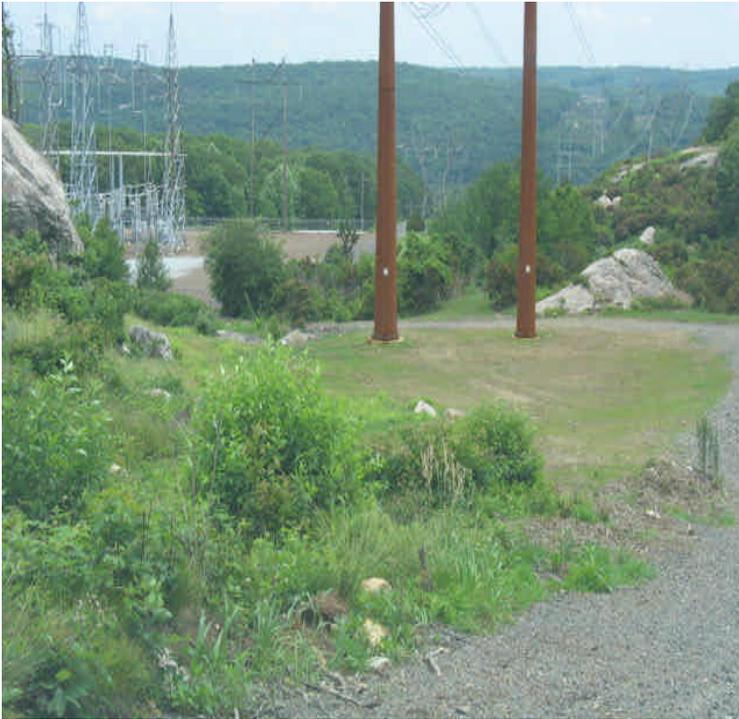
Scovill SS: View of vegetative growth at the last pad to the SS.

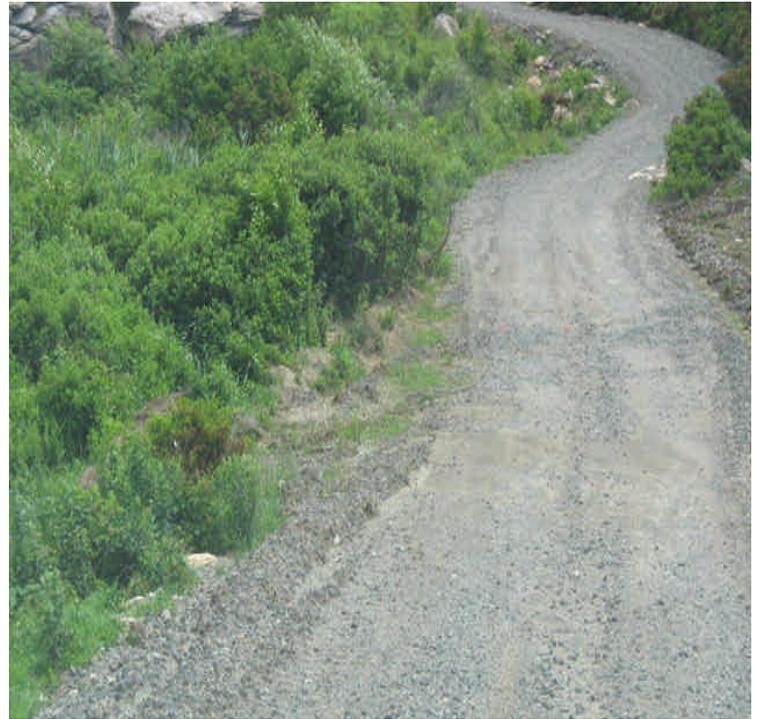
Route 9: Controls in place at the (currently dry) saturated crossing. Vegetation has grown over controls.

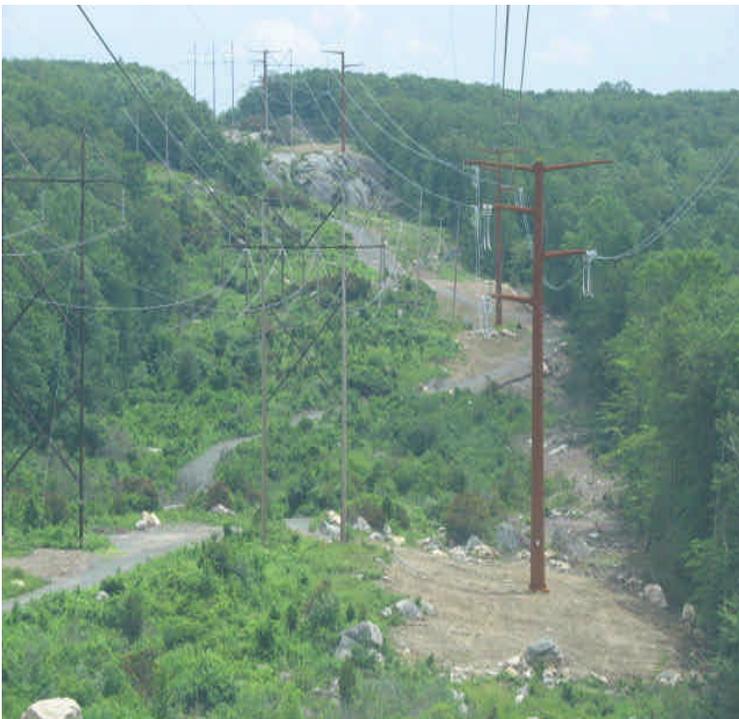
Route 9: From the hill top at Route 9 looking east toward Scovill SS. Several sparse areas are noted at old pad sites, likely due to the hot weather and reduced vegetative growth. Additional seed may be needed in these areas.

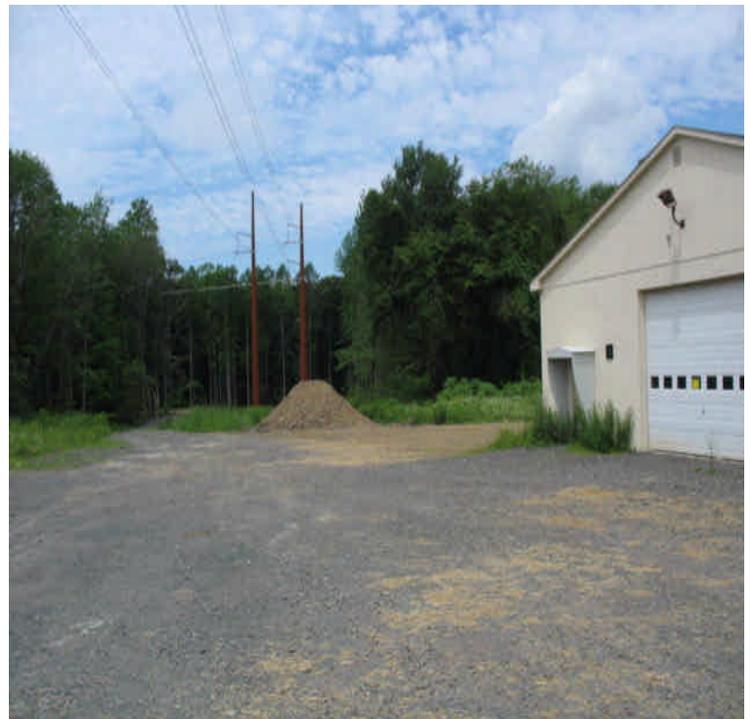
Contractor Yard: Even though it has been temporarily stabilized with seed and mulch, the stockpile located upgradient from the wetlands at 1B should be moved.

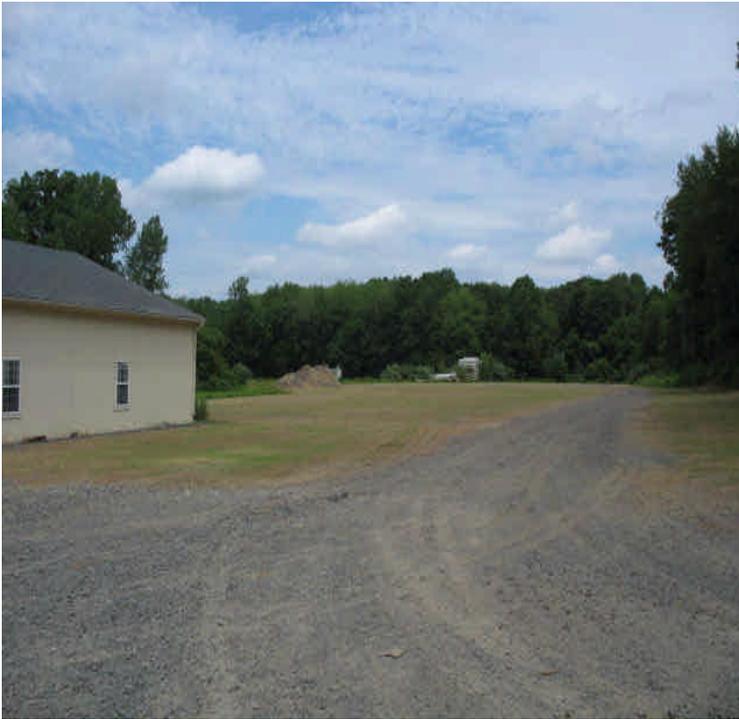
Contractor Yard: Stockpiles have been graded and the area was mulched and seeded.

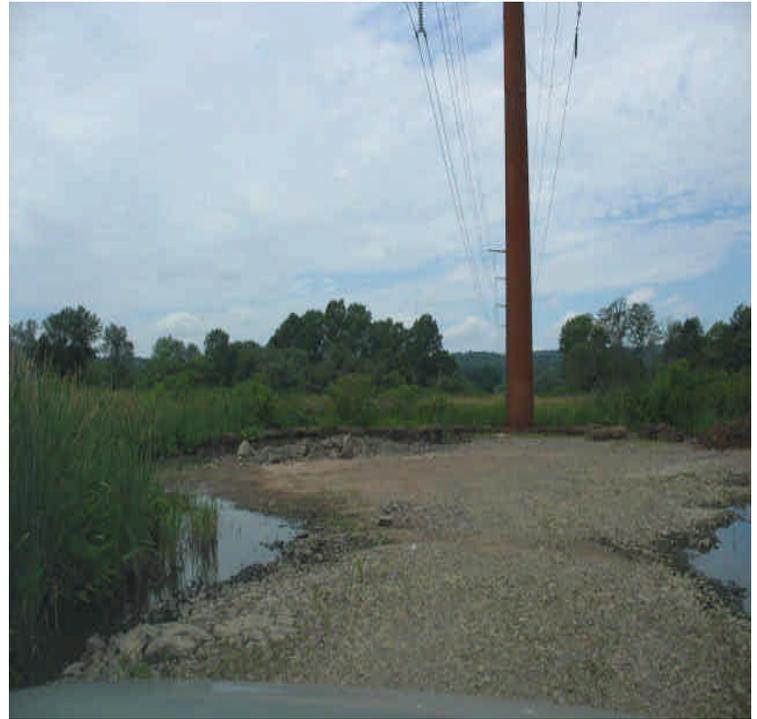
Durham Rd: Access road and pad remain in Durham Meadows. Stone will be brought to grade once the standing water subsides.

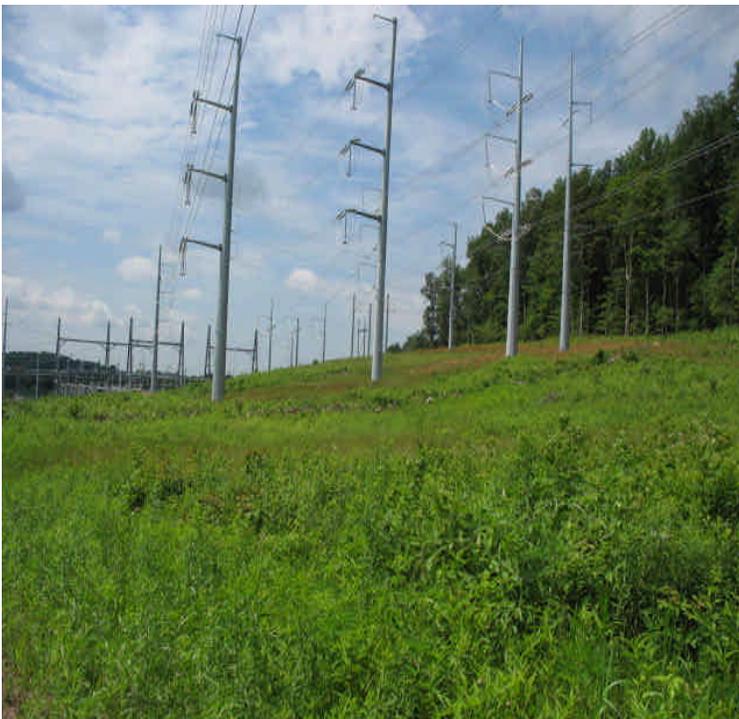
Beseck SS: Vegetation continues to grow well along the ROW north of the Beseck SS.

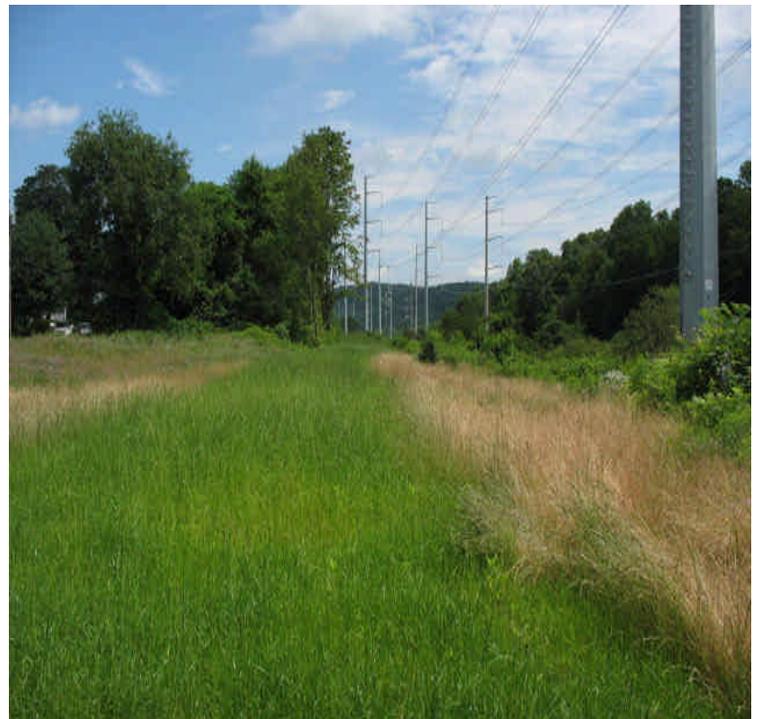
North of High Hill Rd: Old access road is stable with grass cover along the west side of the ROW.
