**Docket No. 272 – Development and Management Plan Inspection**

**Segment 1a Inspection**

**Date:** July 21, 2008

**Location:** Segment 1a – Scovill Rock Switching Station to Chestnut Junction, Oxbow Junction to Beseck Switching Station (excluding Royal Oak Bypass), and Black Pond Junction to Beseck Switching Station

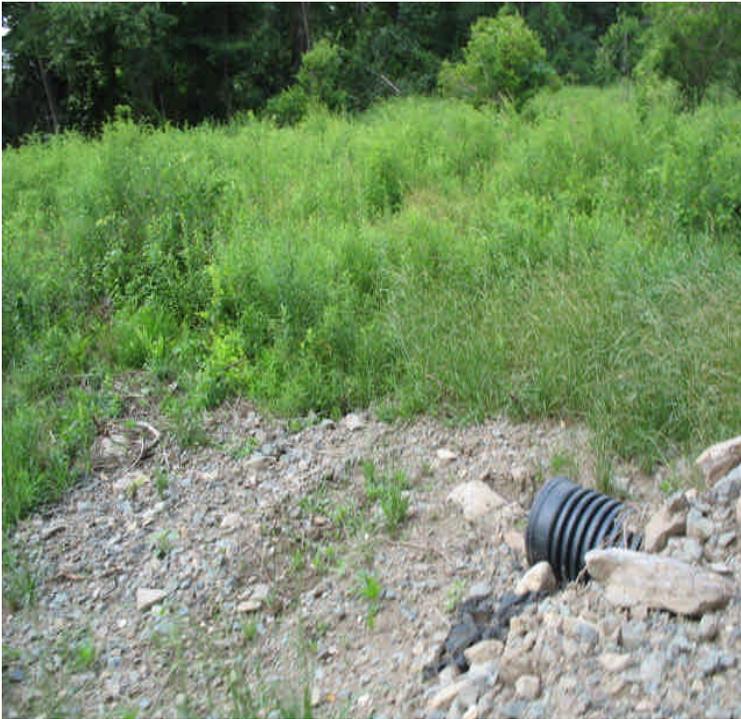
**Haddam Quarter Rd: Recently installed culverted crossing. Wetland is currently dry.**

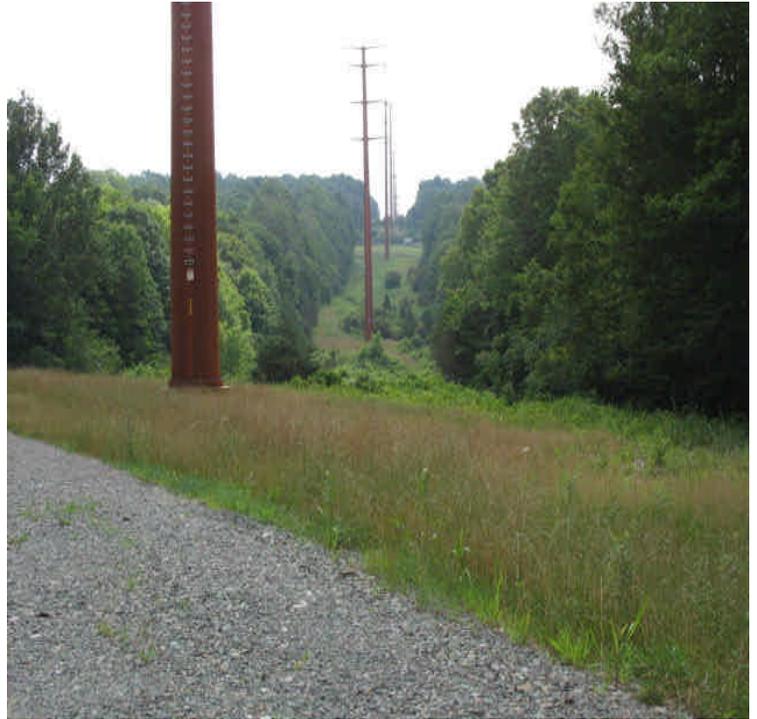
**Johnson Ln: View of vegetative growth/cover east toward Foot Hills R**

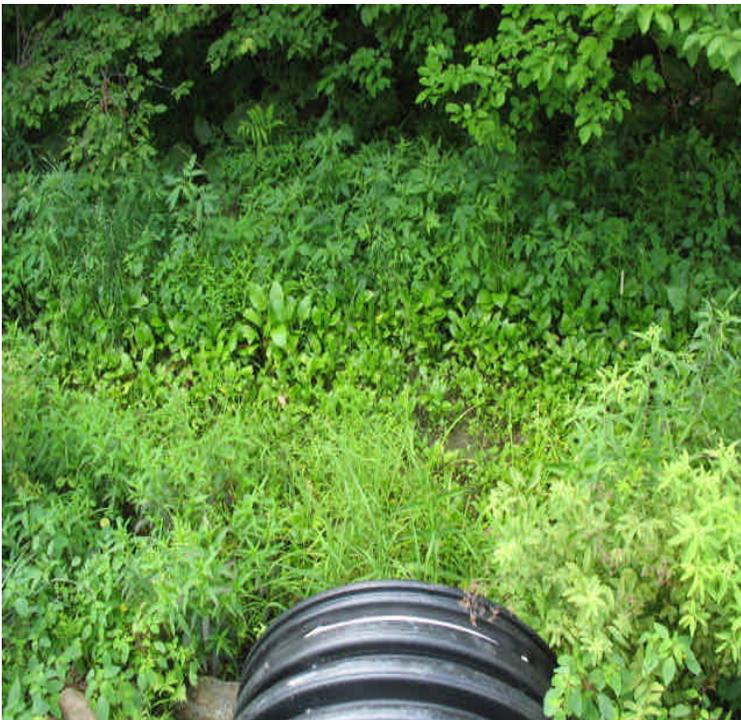
**Johnson Ln: Culverted crossing. Wetland is currently dry.**

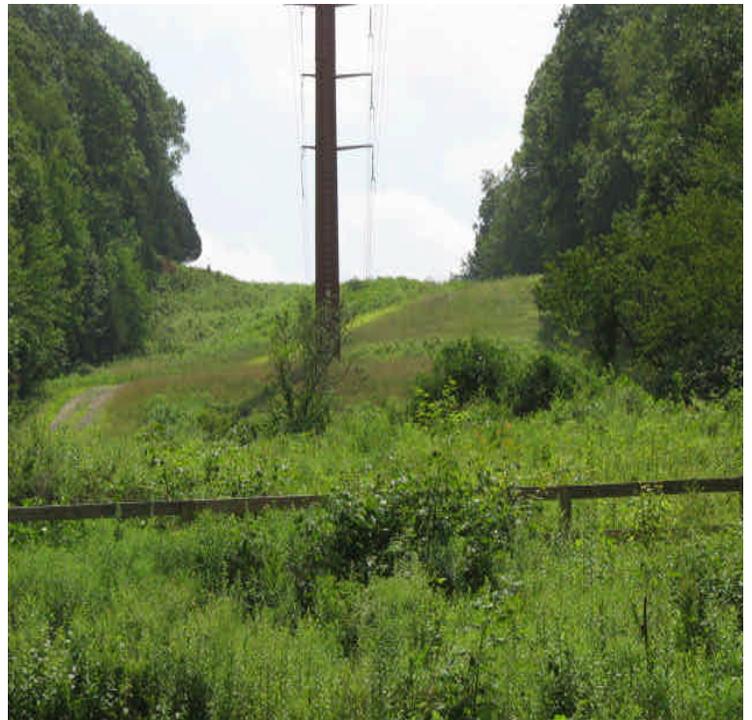
**Arbutus St: View of vegetative growth/cover looking east.**

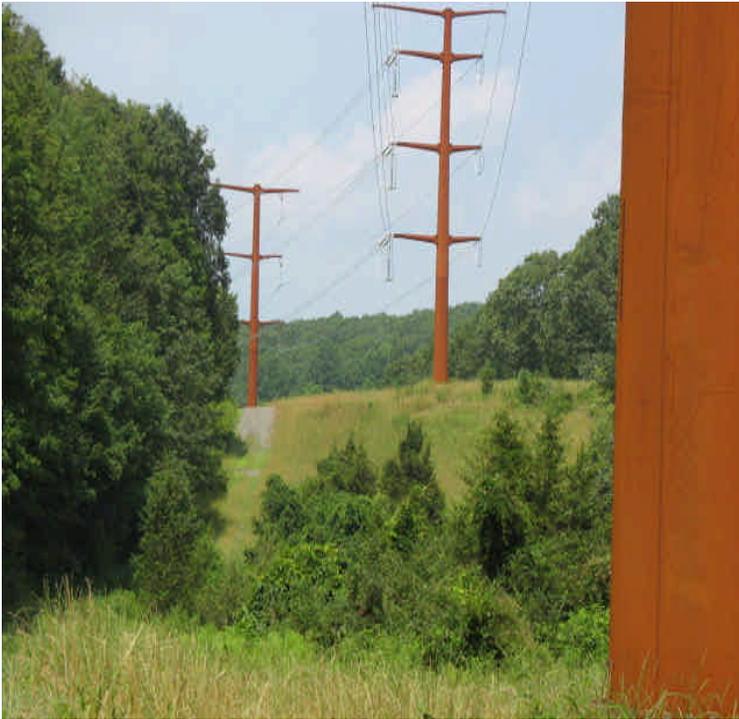
**Arbutus St:** View of the Ball Brook crossing from Arbutus Rd west. The slope is filling in with vegetation; continue to monitor.

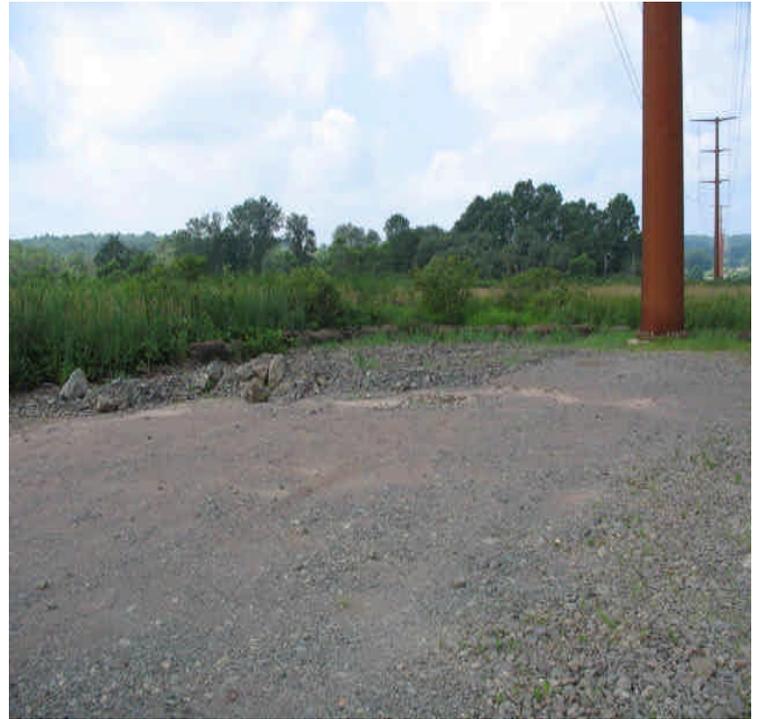
**Durham Rd:** Final pad to be removed within Durham Meadows. Some stone work was noted. Conditions appear to be drying out and crews should prepare to reclaim the area soon.

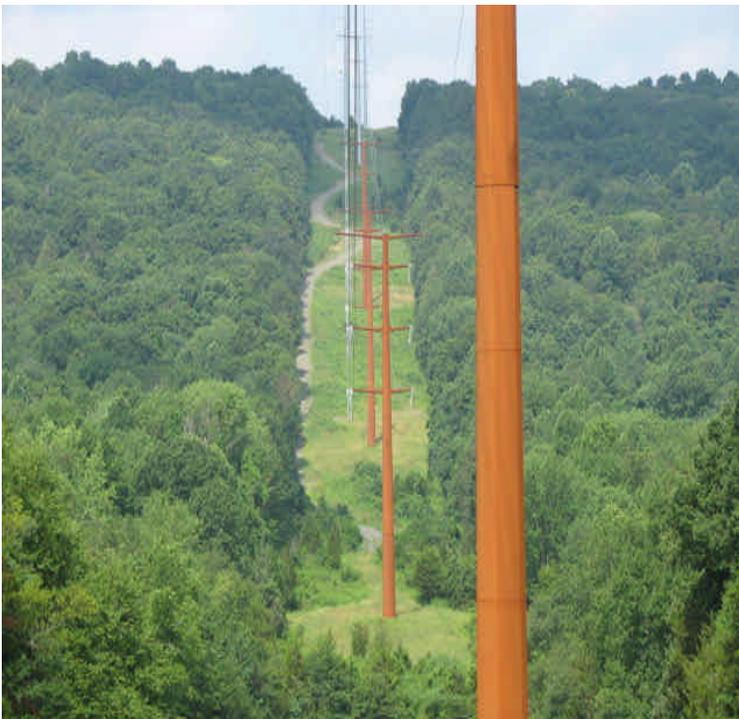
**Powder Hill Rd:** Vegetative growth/cover along the slope upgradient from the pond.

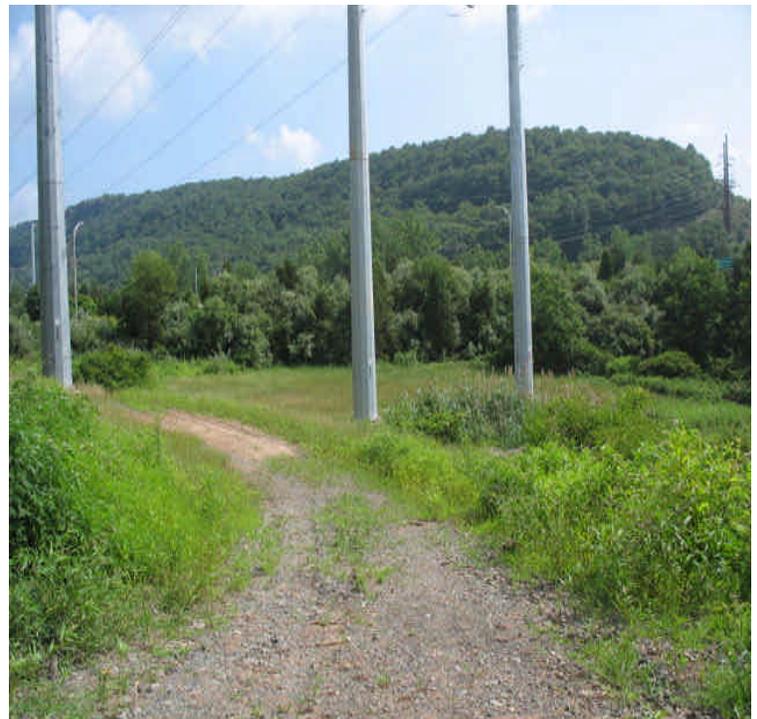
**North of E. Main St:** Vegetative growth/cover upgradient from the wetlands.
