Docket No. 272 – Development and Management Plan Inspection

Segment 1a Inspection

Date: August 5, 2008

Location: Segment 1a – Scovill Rock Switching Station to Chestnut Junction, Oxbow Junction to Beseck Switching Station (excluding Royal Oak Bypass), and Black Pond Junction to Beseck Switching Station

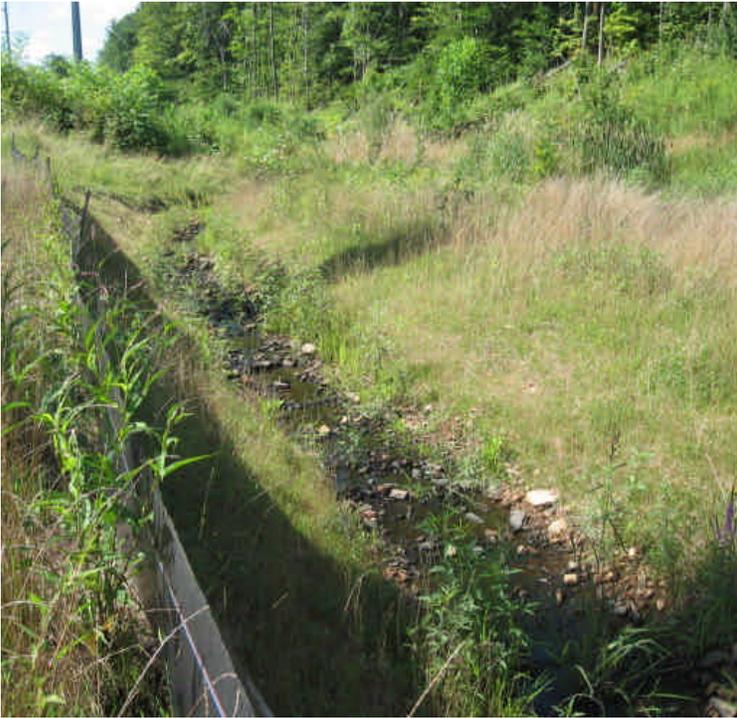
High Hill Rd: The stream and adjacent area near structure #24464 are fully stable with good vegetative cover. The silt fence that remains here can be removed.

Areas of Inspection	Observation	Recommended Action	Corrected Action
	<p>silt fence should be removed as final stabilization has been achieved. This include fence remaining near the well-restored stream at #24464. 8/5/08</p> <p>A small area of sparse vegetation was noted on the slopes near East Meriden Sub. Vegetation near Black Pond was also fairly sparse. 8/5/08</p>	<p>Continue to monitor and maintain controls until final stabilization and vegetative cover has established. Sparse areas of vegetation may need to be reseeded. 8/5/08</p>	<p>Additional seed may be needed below E. Meriden SS and at Black Pond Jct.</p>
<p>Inland Wetland and Watercourse encroachment and mitigation</p> <p>Scovill SS west to Chestnut Junction</p> <p>Oxbow Junction to Beseck SS Durham Rd. (Meadows)</p> <p>Powder Hill Rd.</p>	<p>ACOE permit is in hand.</p> <p>In accordance with the D&M Plan, all work occurring in and around wetlands should be expedited to minimize potential adverse impacts to wetlands and reduce disturbances to wetland soils. The majority of areas in this segment have been reclaimed. 8/5/08</p> <p>Timber mats have been removed except for the access at E. Mount Rd. 8/5/08</p> <p>Timber mats and some of the stone from the access road were removed from this area. BSC was informed that ACOE is allowing this road to remain at or within 2" of the adjacent grade so that sheet flow can occur. The road will also be narrowed. This should be occurring in the next week now that the construction restriction timing is over. 8/5/08</p> <p>The contractor informed BSC that the restored wetland encroachment in this</p>	<p>Perform work in wetlands under the permitted guidelines. 8/5/08</p> <p>Any additional work needed in and around wetlands should be expedited to allow for final stabilization procedures to commence. 8/5/08</p> <p>Remove remaining mats unless additional access is needed 8/5/08</p> <p>When restoration occurs, the road base will remain at grade (for structure access). Remove the appropriate amount of stone and narrow the road to the extent feasible (This will likely be 15 feet based on NU's needs). Be extremely careful during this work to reduce impacts. 4/21-8/5/08</p> <p>The ruts will likely not be repaired by the project since the contractor</p>	<p>NA</p> <p><i>Restoration is almost complete.</i></p> <p>Timber mats should be removed when feasible.</p> <p>Continue to monitor very carefully and be prepared to work when dry conditions allow.</p> <p><i>Crews should take advantage of currently low water levels now that the rare species construction windows allow.</i></p> <p>Continue to monitor.</p>

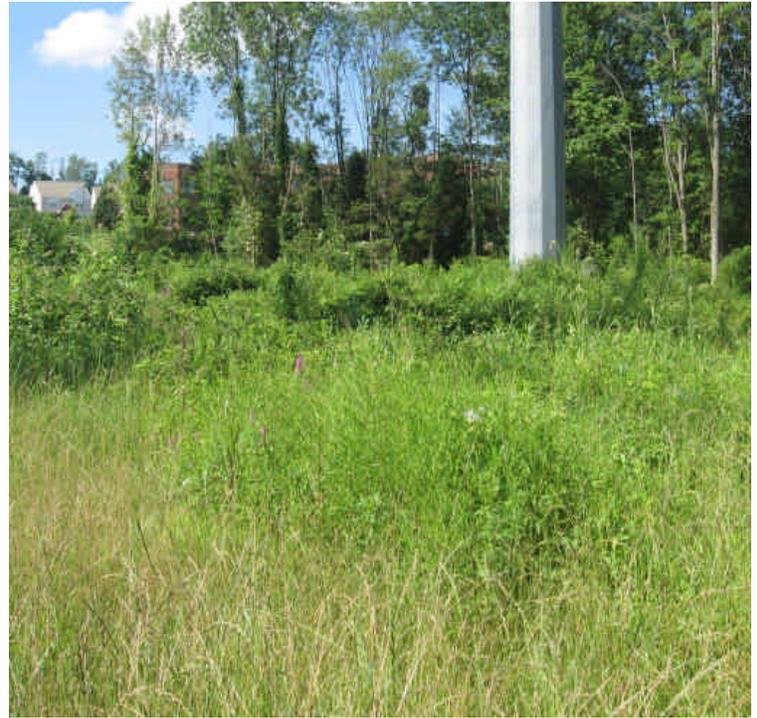
High Hill Rd: The restored wetlands and pad at structure #24465 are fully stable with good vegetative cover.

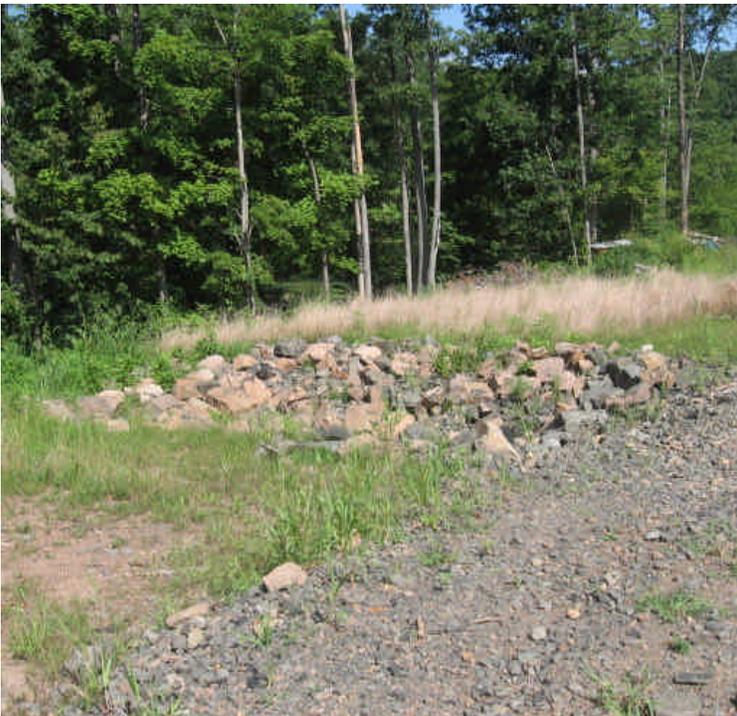
East Meriden Sub: View of the riprap swale/pad installed to prevent erosion near the pond from the run-off at the steep slope.

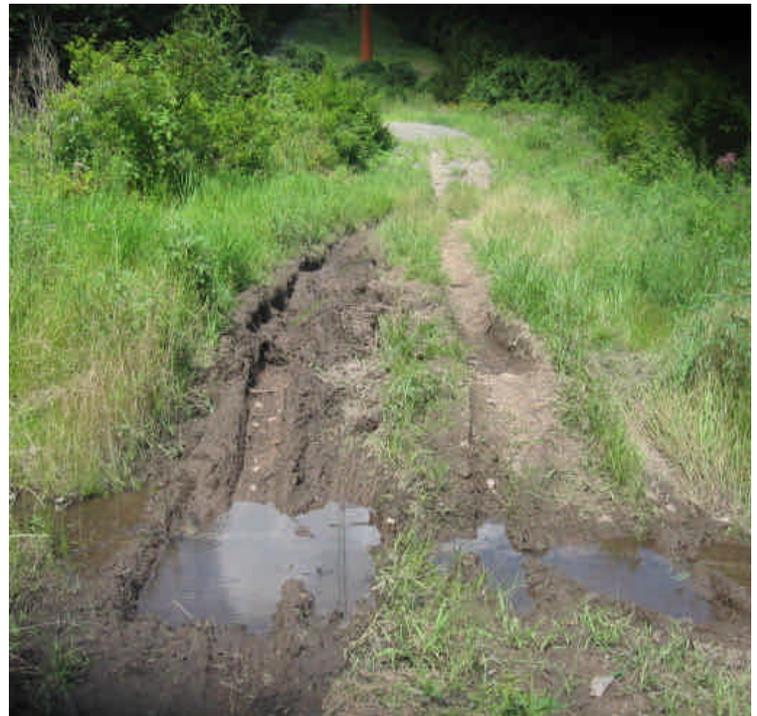
Powder Hill Rd: Ruts were observed in the wetlands in several locations in this section due to vehicle access. BSC was informed the vehicles belonged to private landowners and are not related to the project.

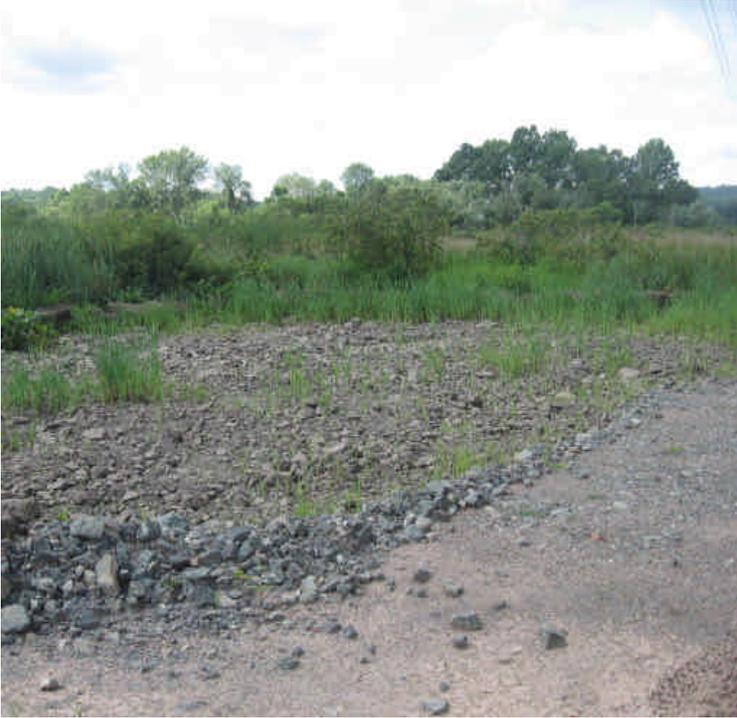
Durham Meadows: Stone remains in place from the pad and access road. Conditions are currently dry and contractors will be performing restoration shortly. Timing restrictions had previously been in place for state-listed species.

Durham Rd (Meadows)	The stone access road in the large wetland system remains. During restoration it will be brought to grade and narrowed. A small area	Continue to monitor and prepare to reclaim the roadway when water levels are at their lowest. See inland wetland section. Be careful to	Restoration still scheduled here. Contractors were waiting for a rare species timing restriction.. Conditions were

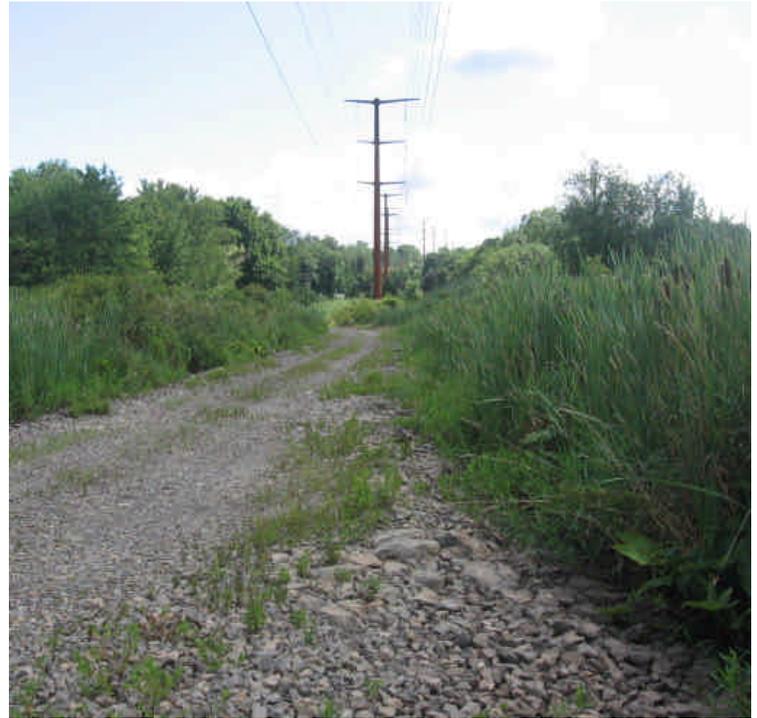
Durham Meadows: Another view of the access road that will be narrowed and brought to grade.

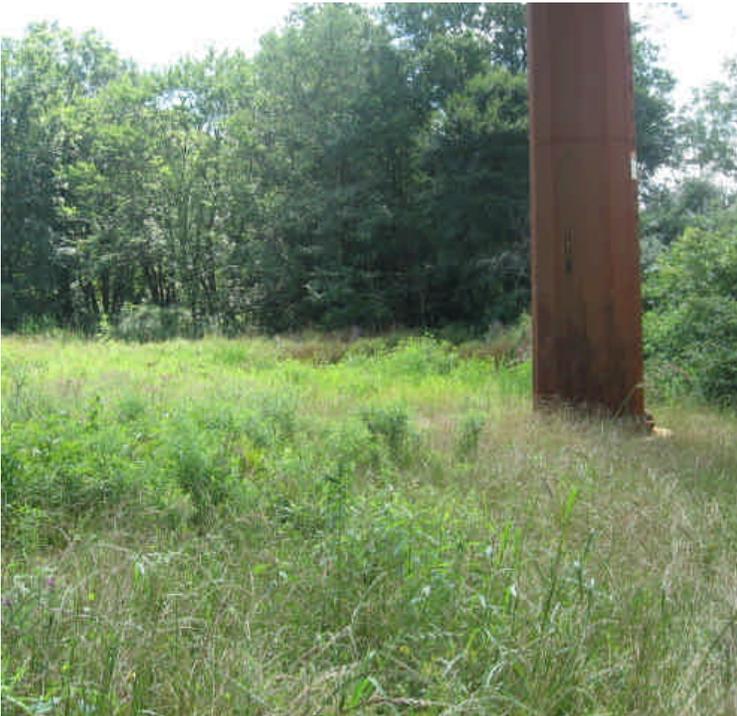
View of a well-restored, stable area along the ROW, with good vegetative cover.

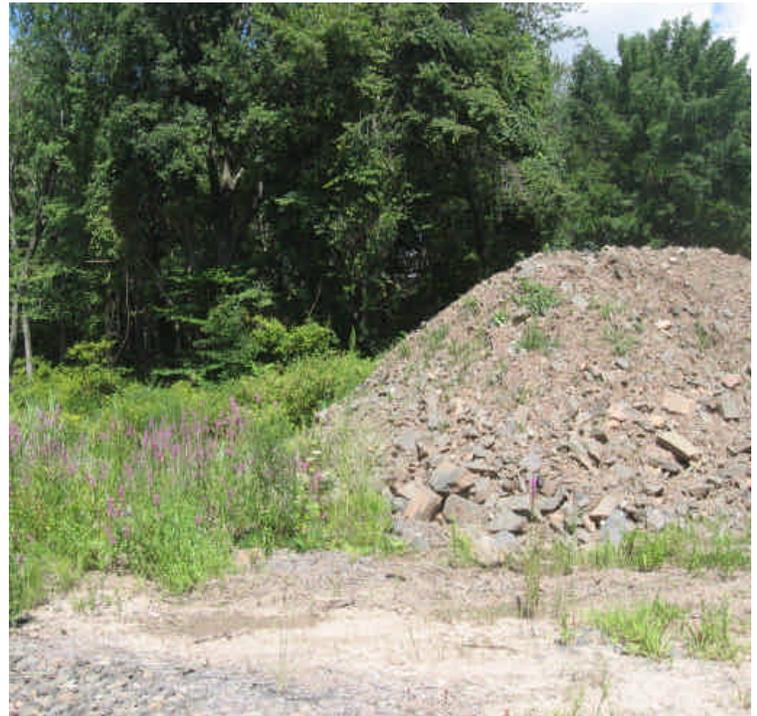
Contractor Yard: A stockpile remains adjacent to wetlands. A filter sock is in place at the base but the material should be removed. Contractors will be evaluating this.
