Docket No. 272 – Development and Management Plan Inspection

Segment 1a Inspection

Date: August 11, 2008

Location: Segment 1a – Scovill Rock Switching Station to Chestnut Junction, Oxbow Junction to Beseck Switching Station (excluding Royal Oak Bypass), and Black Pond Junction to Beseck Switching Station

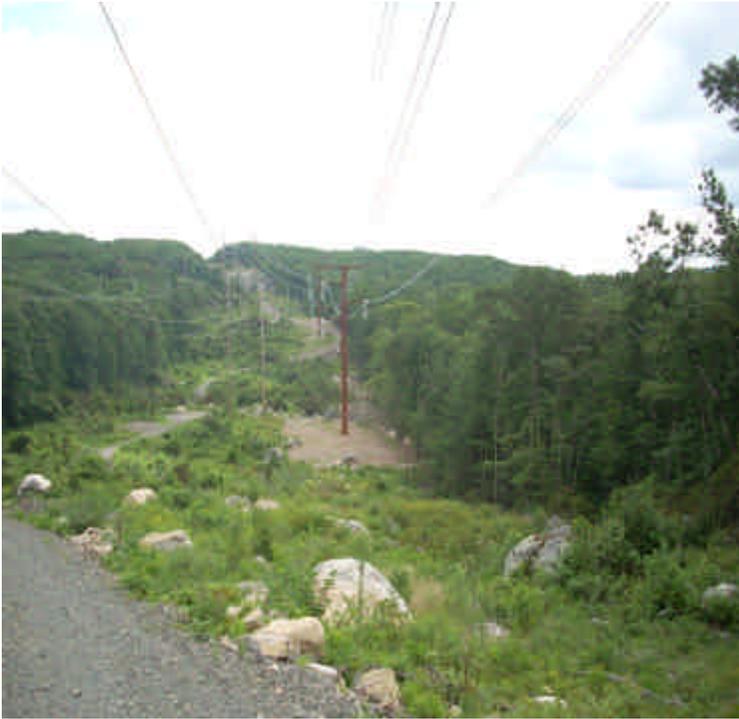
Scovill SS: Vegetative growth has started but is still sparse in many reclaimed areas from Rte. 9 to Scovill SS.

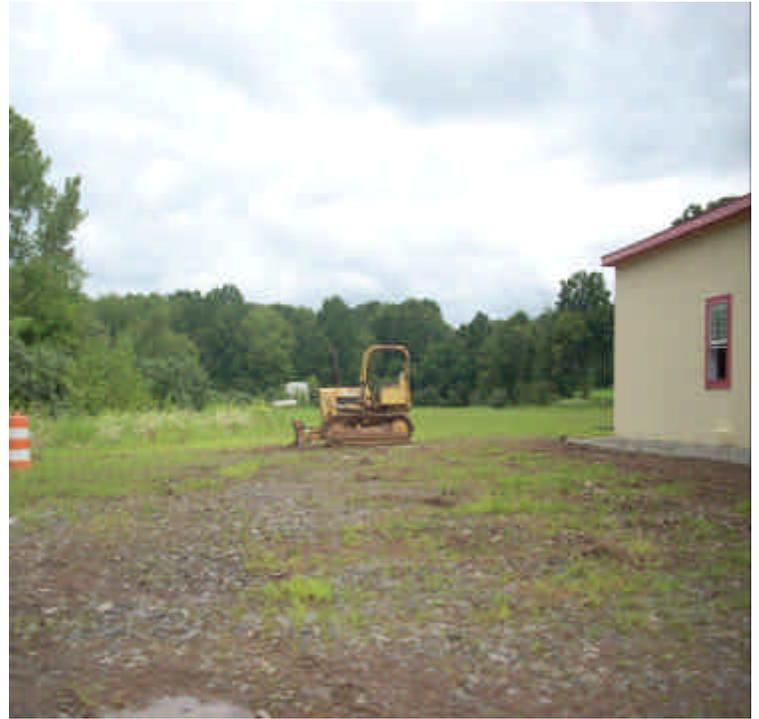
Contractor Yard: Some grass growth was noted in the most recently restored portion of the yard. The stockpile upgradient from wetlands should be evaluated and relocated.

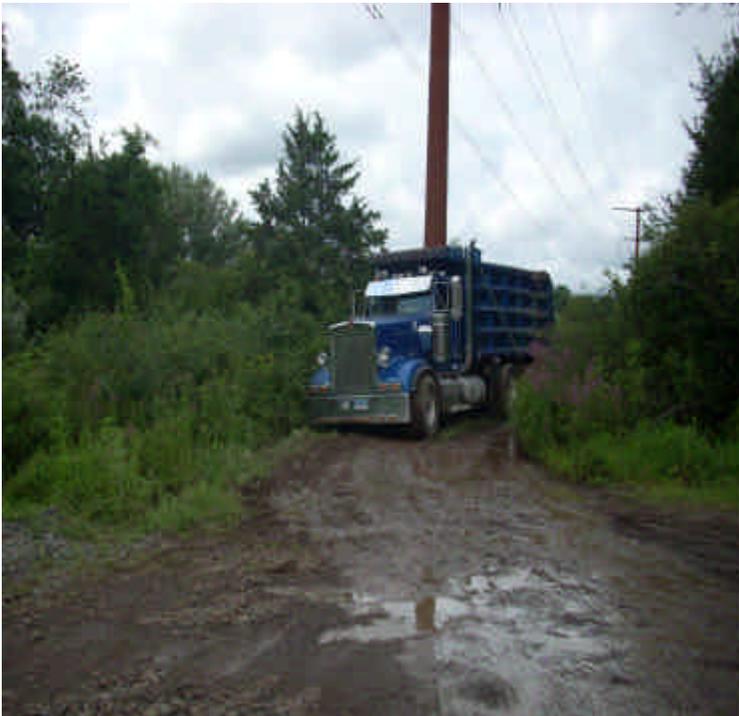
Durham Rd	The stone access road in the large wetland system was being removed during the inspection. It will be brought to grade and narrowed. 8/11/08	Monitor removal closely for runoff and maintain controls until stable. See inland wetland section. Be careful to remove material here and reduce	Restoration is underway. No sediment tracking noted.

Durham Rd: Final restoration underway within Durham Meadows. Check controls and monitor the area until stable.

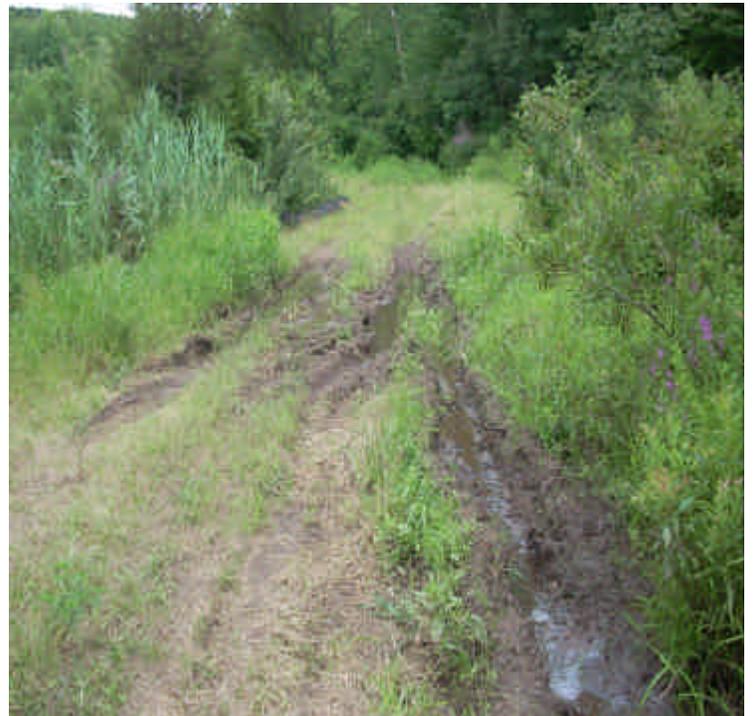
Powder Hill Rd.	<p>Restoration is complete. Slopes appear to be well vegetated and stabilizing. Vehicles drove through this section causing ruts in several wetland crossings. However, the contractor maintains that vehicles were private and not project related (noted 8/5). 8/11/08</p>	<p>The wetland ruts will likely not be repaired as the contractor maintains the damage was caused by private landowners after the project efforts had restored the area. 8/11/08</p>	<p>NA at this time.</p>
East of Beseck SS	<p>The drainage channel around BSS and nearby uplands have stabilized and water in the riprap sediment basin has been clear in recent storms. 8/11/08</p>	<p>Continue to monitor and add/replace controls as needed. 8/11/08</p>	<p>NA</p>
Black Pond Junction to Beseck SS ROW, North of Beseck SS to Black Pond Jct.	<p>All pads north of Beseck to Black Pond Jct. have been reclaimed well and the ROW is in good condition. Any remaining silt fence should be removed as final stabilization has been</p>	<p>Any silt fence will have to be removed now that areas are stabilized. 8/11/08</p>	<p>Good cover is noted in many areas.</p>

Powder Hill Rd: Ruts were observed in the wetlands in several locations in this section due to vehicle access. BSC was informed the vehicles belonged to private landowners and are not related to the project.
