**Docket No. 272 – Development and Management Plan Inspection**

**Segment 1a Inspection**

**Date:** August 18, 2008

**Location:** Segment 1a – Scovill Rock Switching Station to Chestnut Junction, Oxbow Junction to Beseck Switching Station (excluding Royal Oak Bypass), and Black Pond Junction to Beseck Switching Station

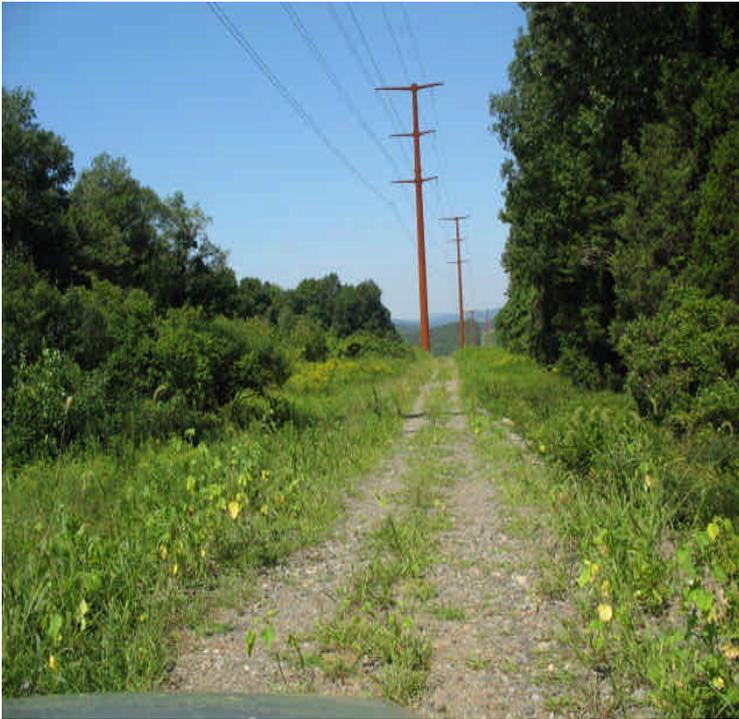
**Haddam Quarter: Vegetative growth has stabilized the ROW and wetland crossing**

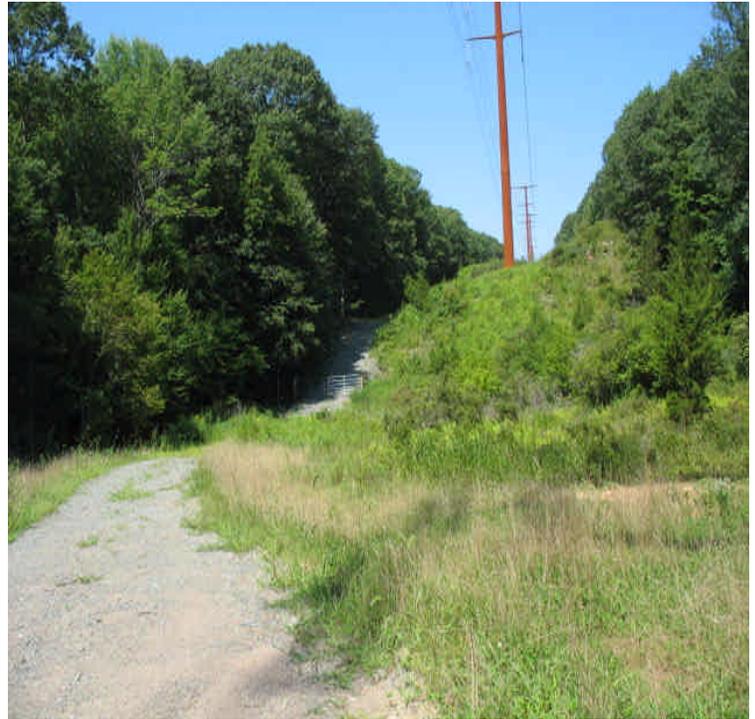
**Johnson Ln: Vegetative cover has stabilized the ROW and wetlands.**

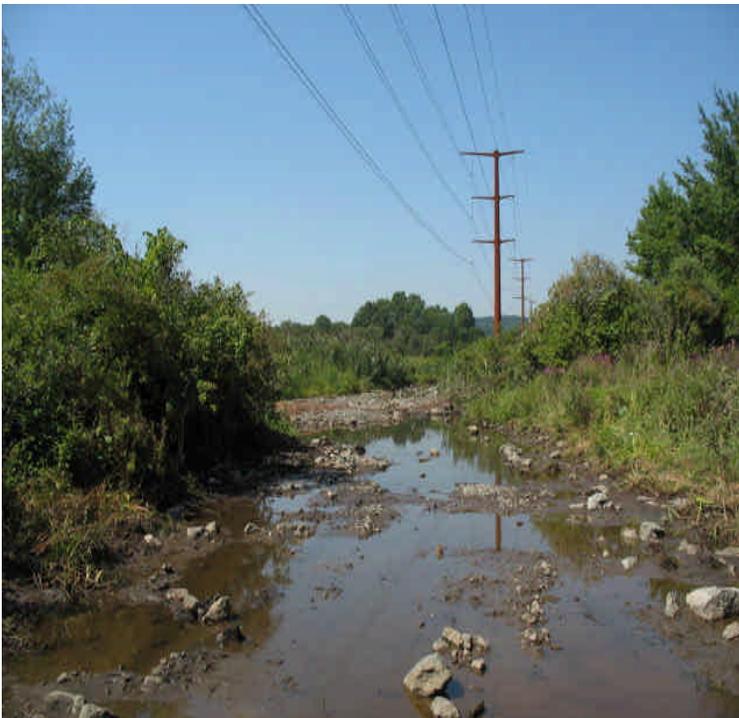
Durham Rd (Meadows)	The stone access road in the large wetland system was reclaimed last week. The road was reduced to grade and the water around the access road	Monitor this area closely until it is stable. Additional controls and/or seed should be applied to stabilize the exposed soils if standing	Access road removal in wetlands is complete.  Soils should be stabilized.

**Durham Rd: Final restoration complete within Durham Meadows. Check/add controls and monitor the area until stable. The access road has been brought to grade, allowing sheet flow.**

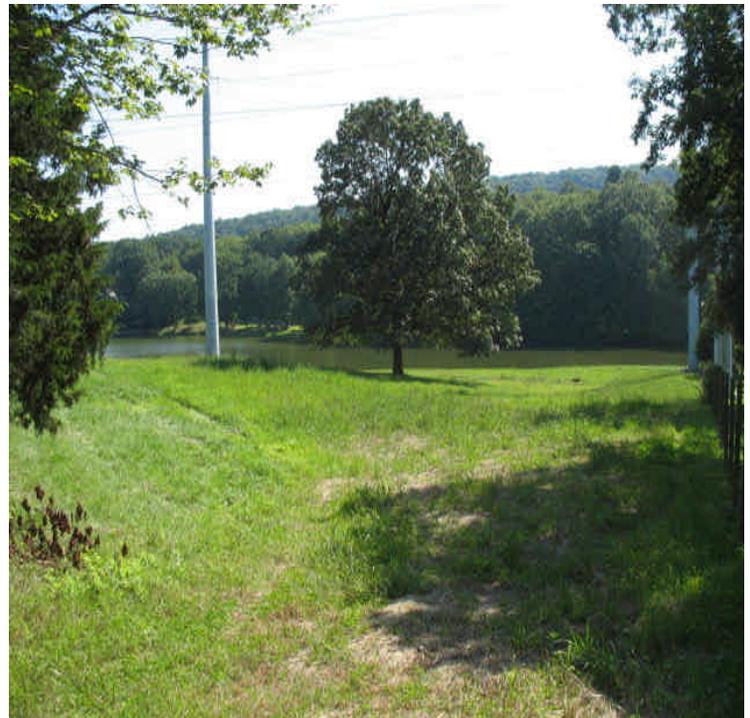
**Fleming Rd: Reclaimed soils are stable with vegetative cover.**
