Docket No. 272 – Development and Management Plan Inspection

Segment 1a Inspection

Date: September 8, 2008

Location: Segment 1a – Scovill Rock Switching Station to Chestnut Junction, Oxbow Junction to Beseck Switching Station (excluding Royal Oak Bypass), and Black Pond Junction to Beseck Switching Station

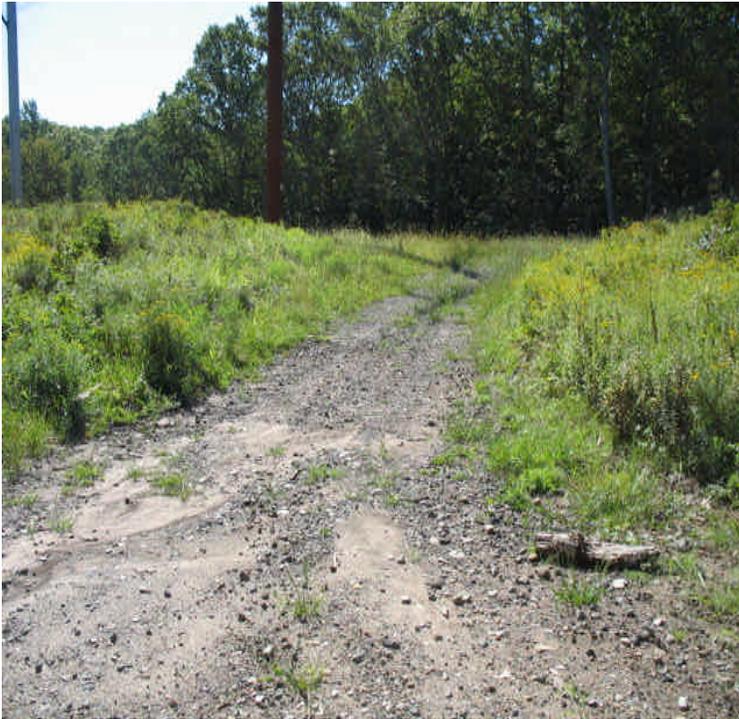
Shumpike Rd: Restoration complete. A few sparse areas remain.

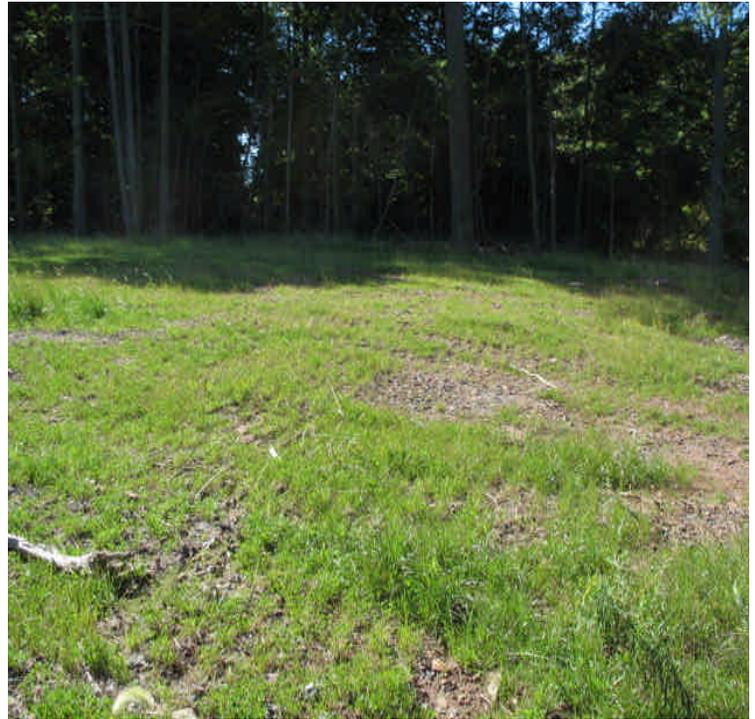
East Mount Rd: A few small sparse areas of vegetation are slowly starting to fill in with vegetation. Identify whether areas can be considered 70% vegetated overall even though some areas remain exposed.

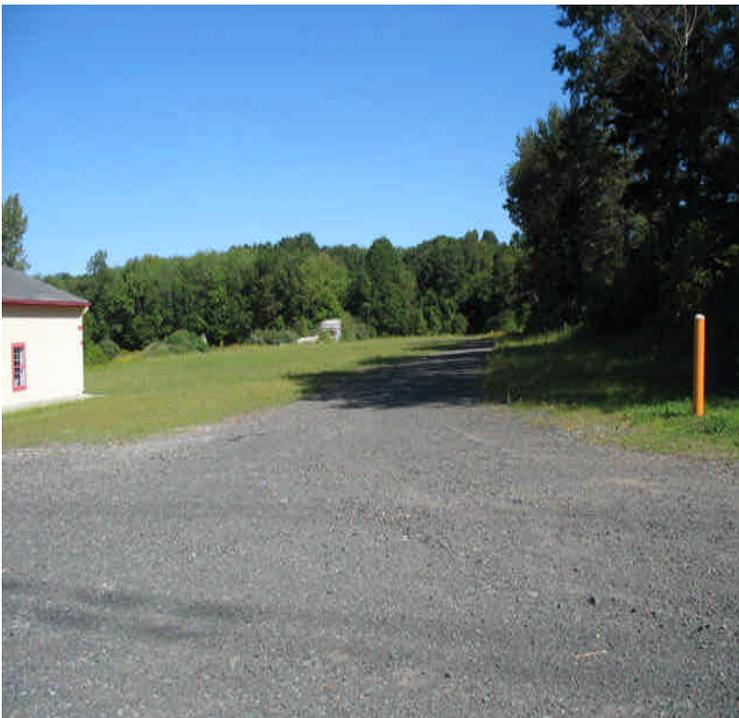
Contractor Yard: Yard is almost completely stable and all equipment has been removed.

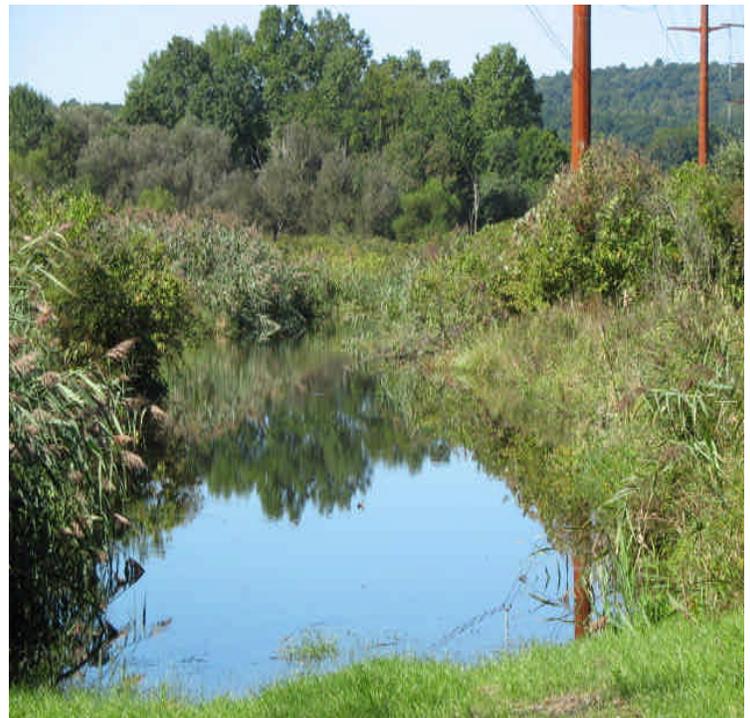
Durham Rd	The stone access road in the large wetland system was removed (noted 8/11). The road was reduced to grade and the	Monitor this area closely until it is stable. Additional controls and/or seed should be applied to stabilize the	Access road removal in wetlands is complete. Exposed soils are flooded.

Durham Rd: Final restoration complete within Durham Meadows. Check/add controls and monitor the area until stable. Area is flooded.
