Docket No. 272 – Development and Management Plan Inspection

Segment 1a Inspection

Date: September 16, 2008

Location: Segment 1a – Scovill Rock Switching Station to Chestnut Junction, Oxbow Junction to Beseck Switching Station (excluding Royal Oak Bypass), and Black Pond Junction to Beseck Switching Station

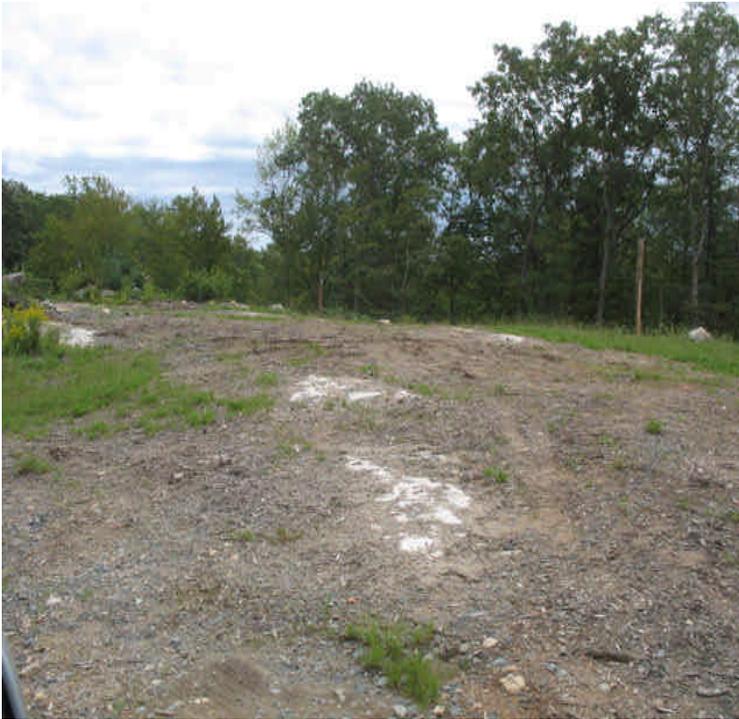
Scovill SS: Several exposed soil areas remain along the ROW from Scovill SS to the west, following reclamation efforts over the summer.

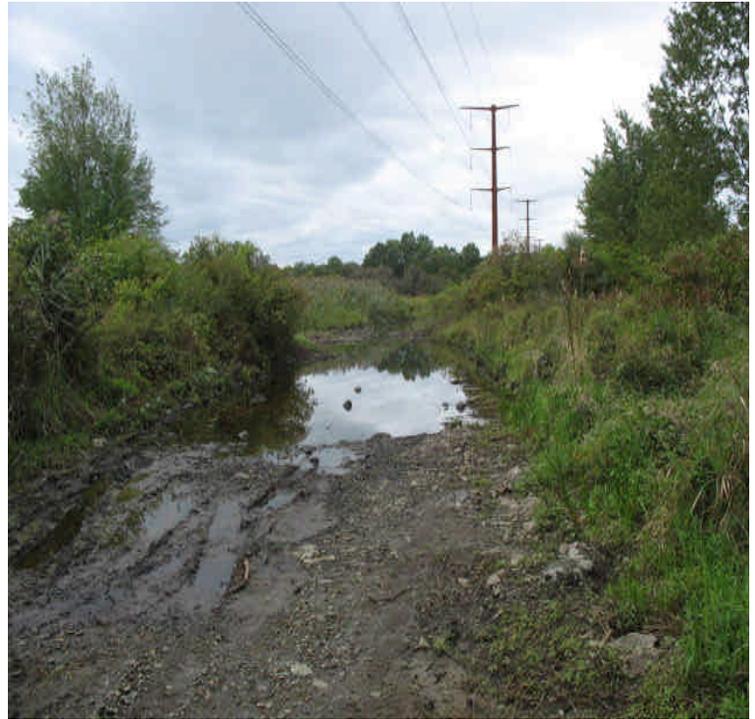
Durham Rd	The stone access road in the large wetland system was removed (noted 8/11). The road was reduced to grade and the	Monitor this area closely until it is stable. Additional controls and/or seed should be applied to stabilize the	Access road removal in wetlands is complete. Exposed soils are flooded.

Durham Rd: Exposed soil remains in areas where standing water regularly inundates and then recedes. Ensure these areas become stable.

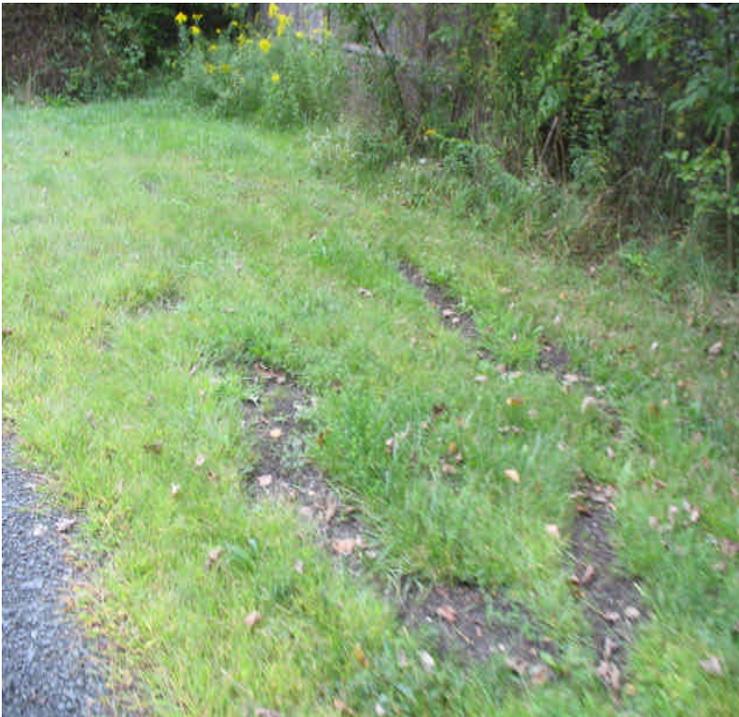
Rte 157 Private Driveway: Ruts have been filled and seeded; however the area has been slow to establish full vegetative cover. The area does not appear to present an issue.

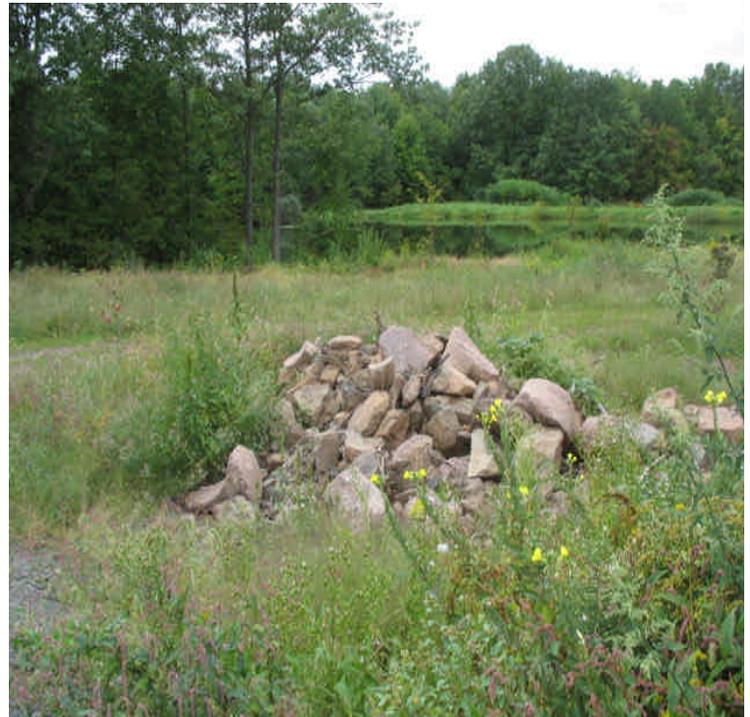
E. Meriden SS: Old stone stockpile remains south of E. Meriden SS.
