**Docket No. 272 – Development and Management Plan Inspection**

**Segment 1a Inspection**

**Date:** September 23, 2008

**Location:** Segment 1a – Scovill Rock Switching Station to Chestnut Junction, Oxbow Junction to Beseck Switching Station (excluding Royal Oak Bypass), and Black Pond Junction to Beseck Switching Station

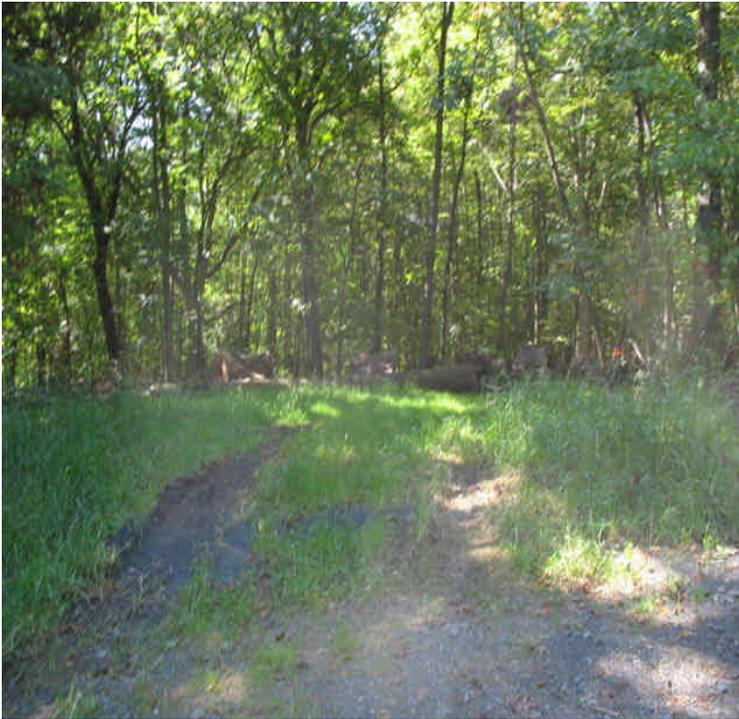
**Shumpike Rd:** View of western site access. Tire tracks are not project related.

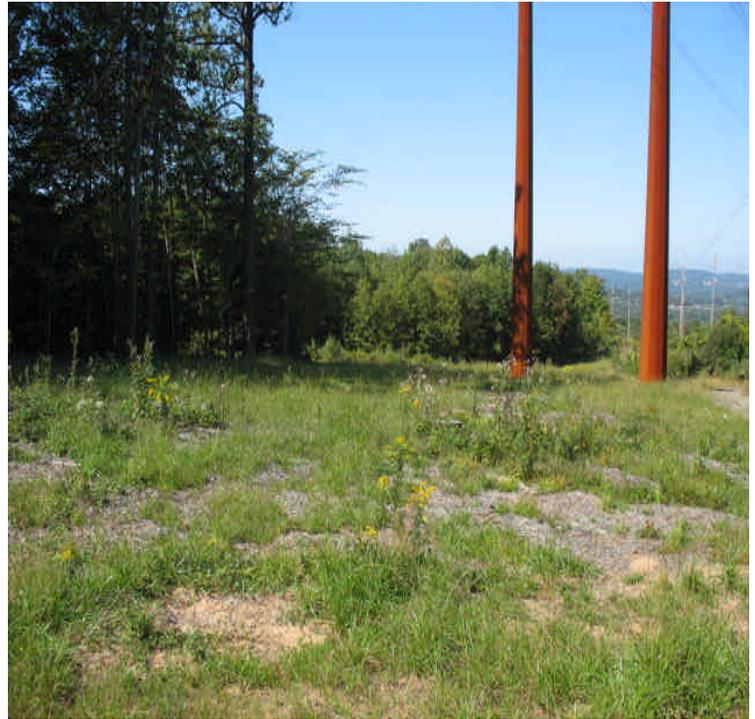
**E. Mount Rd:** Some patches of exposed soils were noted at the the final structure. Determine when areas are 70% vegetated overall.

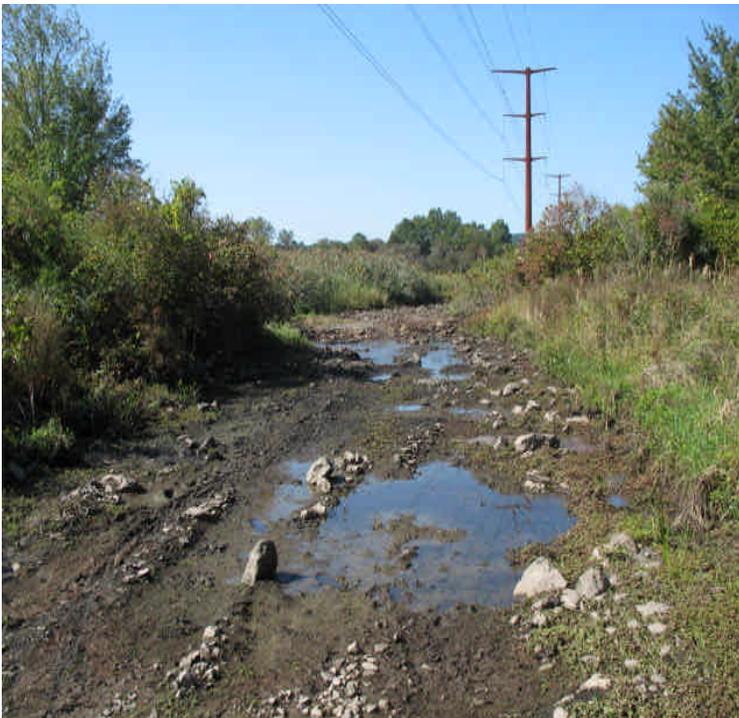
<b>Oxbow Junction to Beseck SS Durham Rd</b>	<b>The stone access road in the large wetland system was removed (noted 8/11). The road was reduced to grade and the water around the access road is clear. Water regularly floods and recedes over exposed soils. 9/23/08</b>	<b>Monitor this area closely until it is stable. It will be difficult to stabilize the area with traditional measures such as mulch or seed. See inland wetland section. 9/23/08</b>	<b>Exposed soils are regularly flooded.</b>

**Durham Rd:** Access road remains at final grade. Area is regularly inundated with standing water and will be difficult to stabilize the traditional way with seed and mulch.

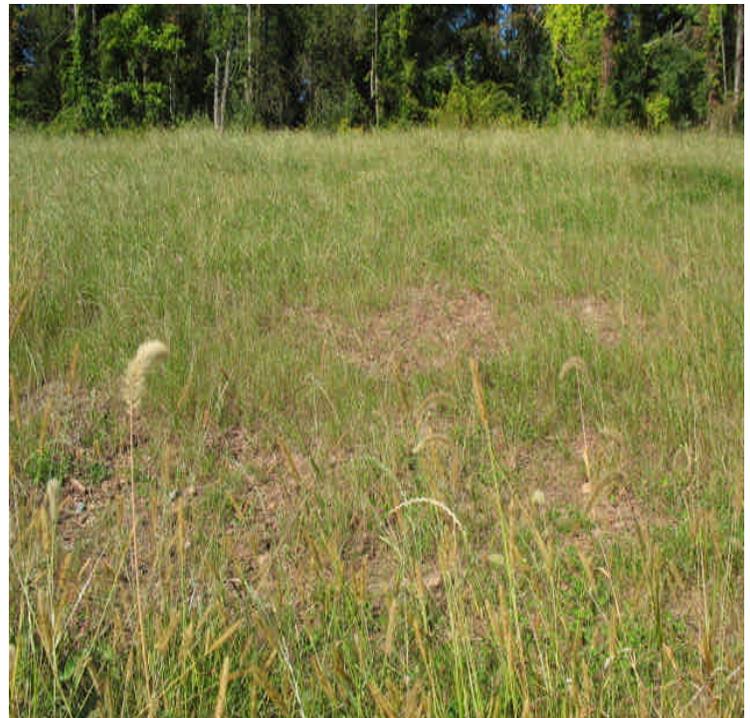
Areas of Inspection	Observation	Recommended Action	Corrected Action
<p><b>Beseck SS to Black Pond Junction ROW, North of Beseck SS to Black Pond Jct.</b></p>	<p><b>A small area of sparse vegetation was noted on the slopes north of BSS at the first gate, the slopes near East Meriden Sub and near Black Pond. However, most bare areas are relatively small and will not pose an issue. 9/23/08</b></p>	<p><b>Determine if areas have 70% cover overall despite the presence of exposed areas. Sparse areas of vegetation may need to be reseeded. 9/23/08</b></p>	<p><b>Additional seed may be needed in sparse areas but most appear stable.</b></p>
<p><b>Inland Wetland and Watercourse encroachment and mitigation</b></p> <p><b>Scovill SS west to Chestnut Junction</b></p> <p><b>Oxbow Junction to Beseck SS Durham Rd.</b></p>	<p><b>ACOE permit is in hand.</b></p> <p><b>In accordance with the D&amp;M Plan, all work occurring in and around wetlands should be expedited to minimize potential adverse impacts to wetlands and reduce disturbances to wetland soils. The majority of areas in this segment have been reclaimed and no longer need inspection. 9/23/08</b></p> <p><b>Timber mats remain at the entrance at E. Mount and at the major crossing off Rte 9. 9/23/08</b></p> <p><b>The contractor has reduced the grade and width of the access road allowing water to sheet flow across. Standing water was present across the road. Adjacent areas were mulched. 9/23/08</b></p>	<p><b>Perform work in wetlands under the permitted guidelines. 9/23/08</b></p> <p><b>Any additional work needed in and around wetlands should be expedited. 9/23/08</b></p> <p><b>Remove remaining mats unless additional access is needed 9/23/08</b></p> <p><b>Stabilize soils in exposed areas to the extent feasible to minimize impacts to surrounding wetlands. 9/23/08</b></p>	<p><b>NA</b></p> <p><i>Restoration is complete and many areas no longer need inspection.</i></p> <p><b>Timber mats should be removed when feasible.</b></p> <p><b>Some of the soils remain inundated while adjacent areas were mulched.</b></p>

**Black Pond Jct:** Sparse vegetation remains along some slopes at Black Pond Jct. but area will be evaluated for 70% cover overall.
